Geotechnical Investigation

Geotechnical Investigation – Shannon Farm Private Plan Change

144 Ripponvale Road,
Cromwell

February 2019
GeoSolve Ref: 180137.01

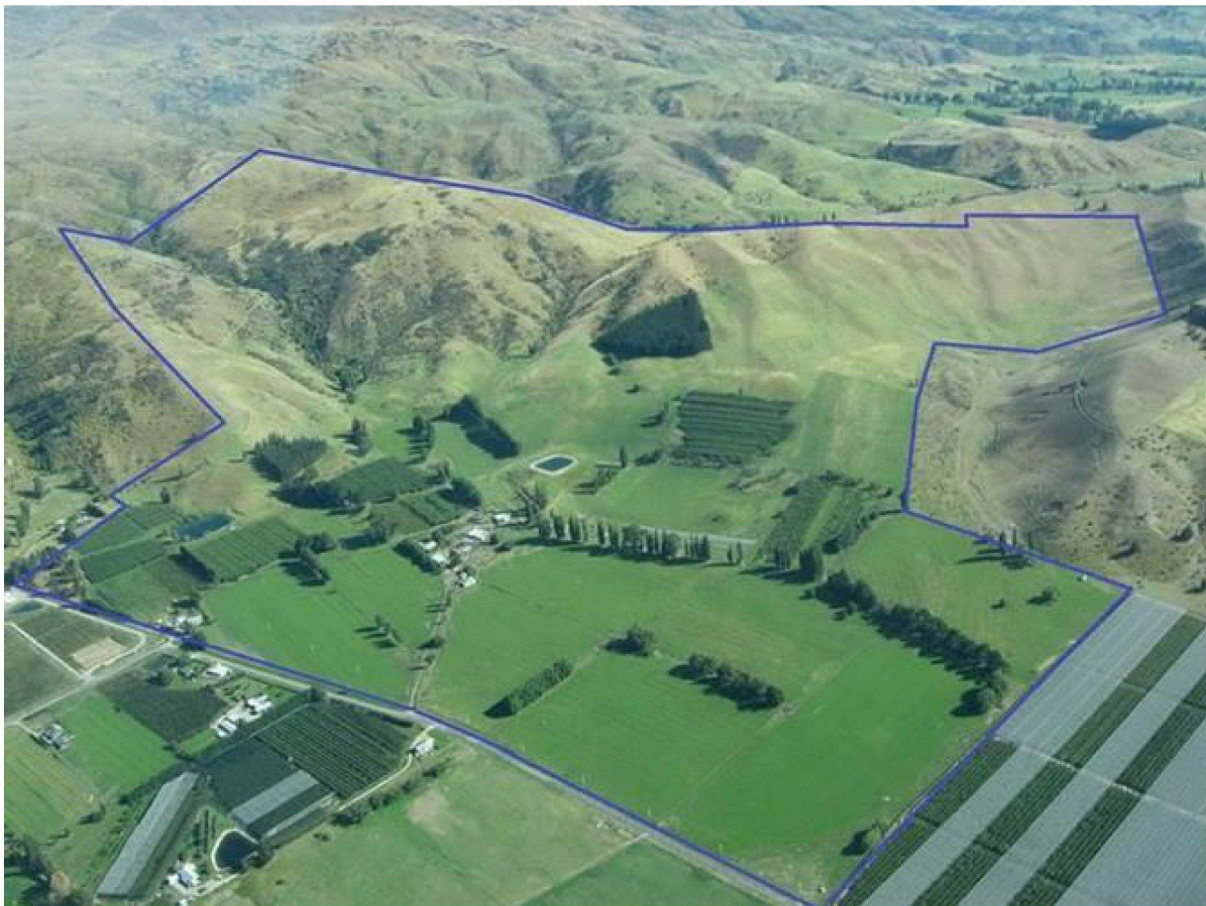
Photo 1 – Property Boundary at 144 Ripponvale Road, Cromwell

The southern part of the property, including the area of the existing buildings, is gently sloping (see Photo 1). Slopes increase from moderate to steep in the north and west.

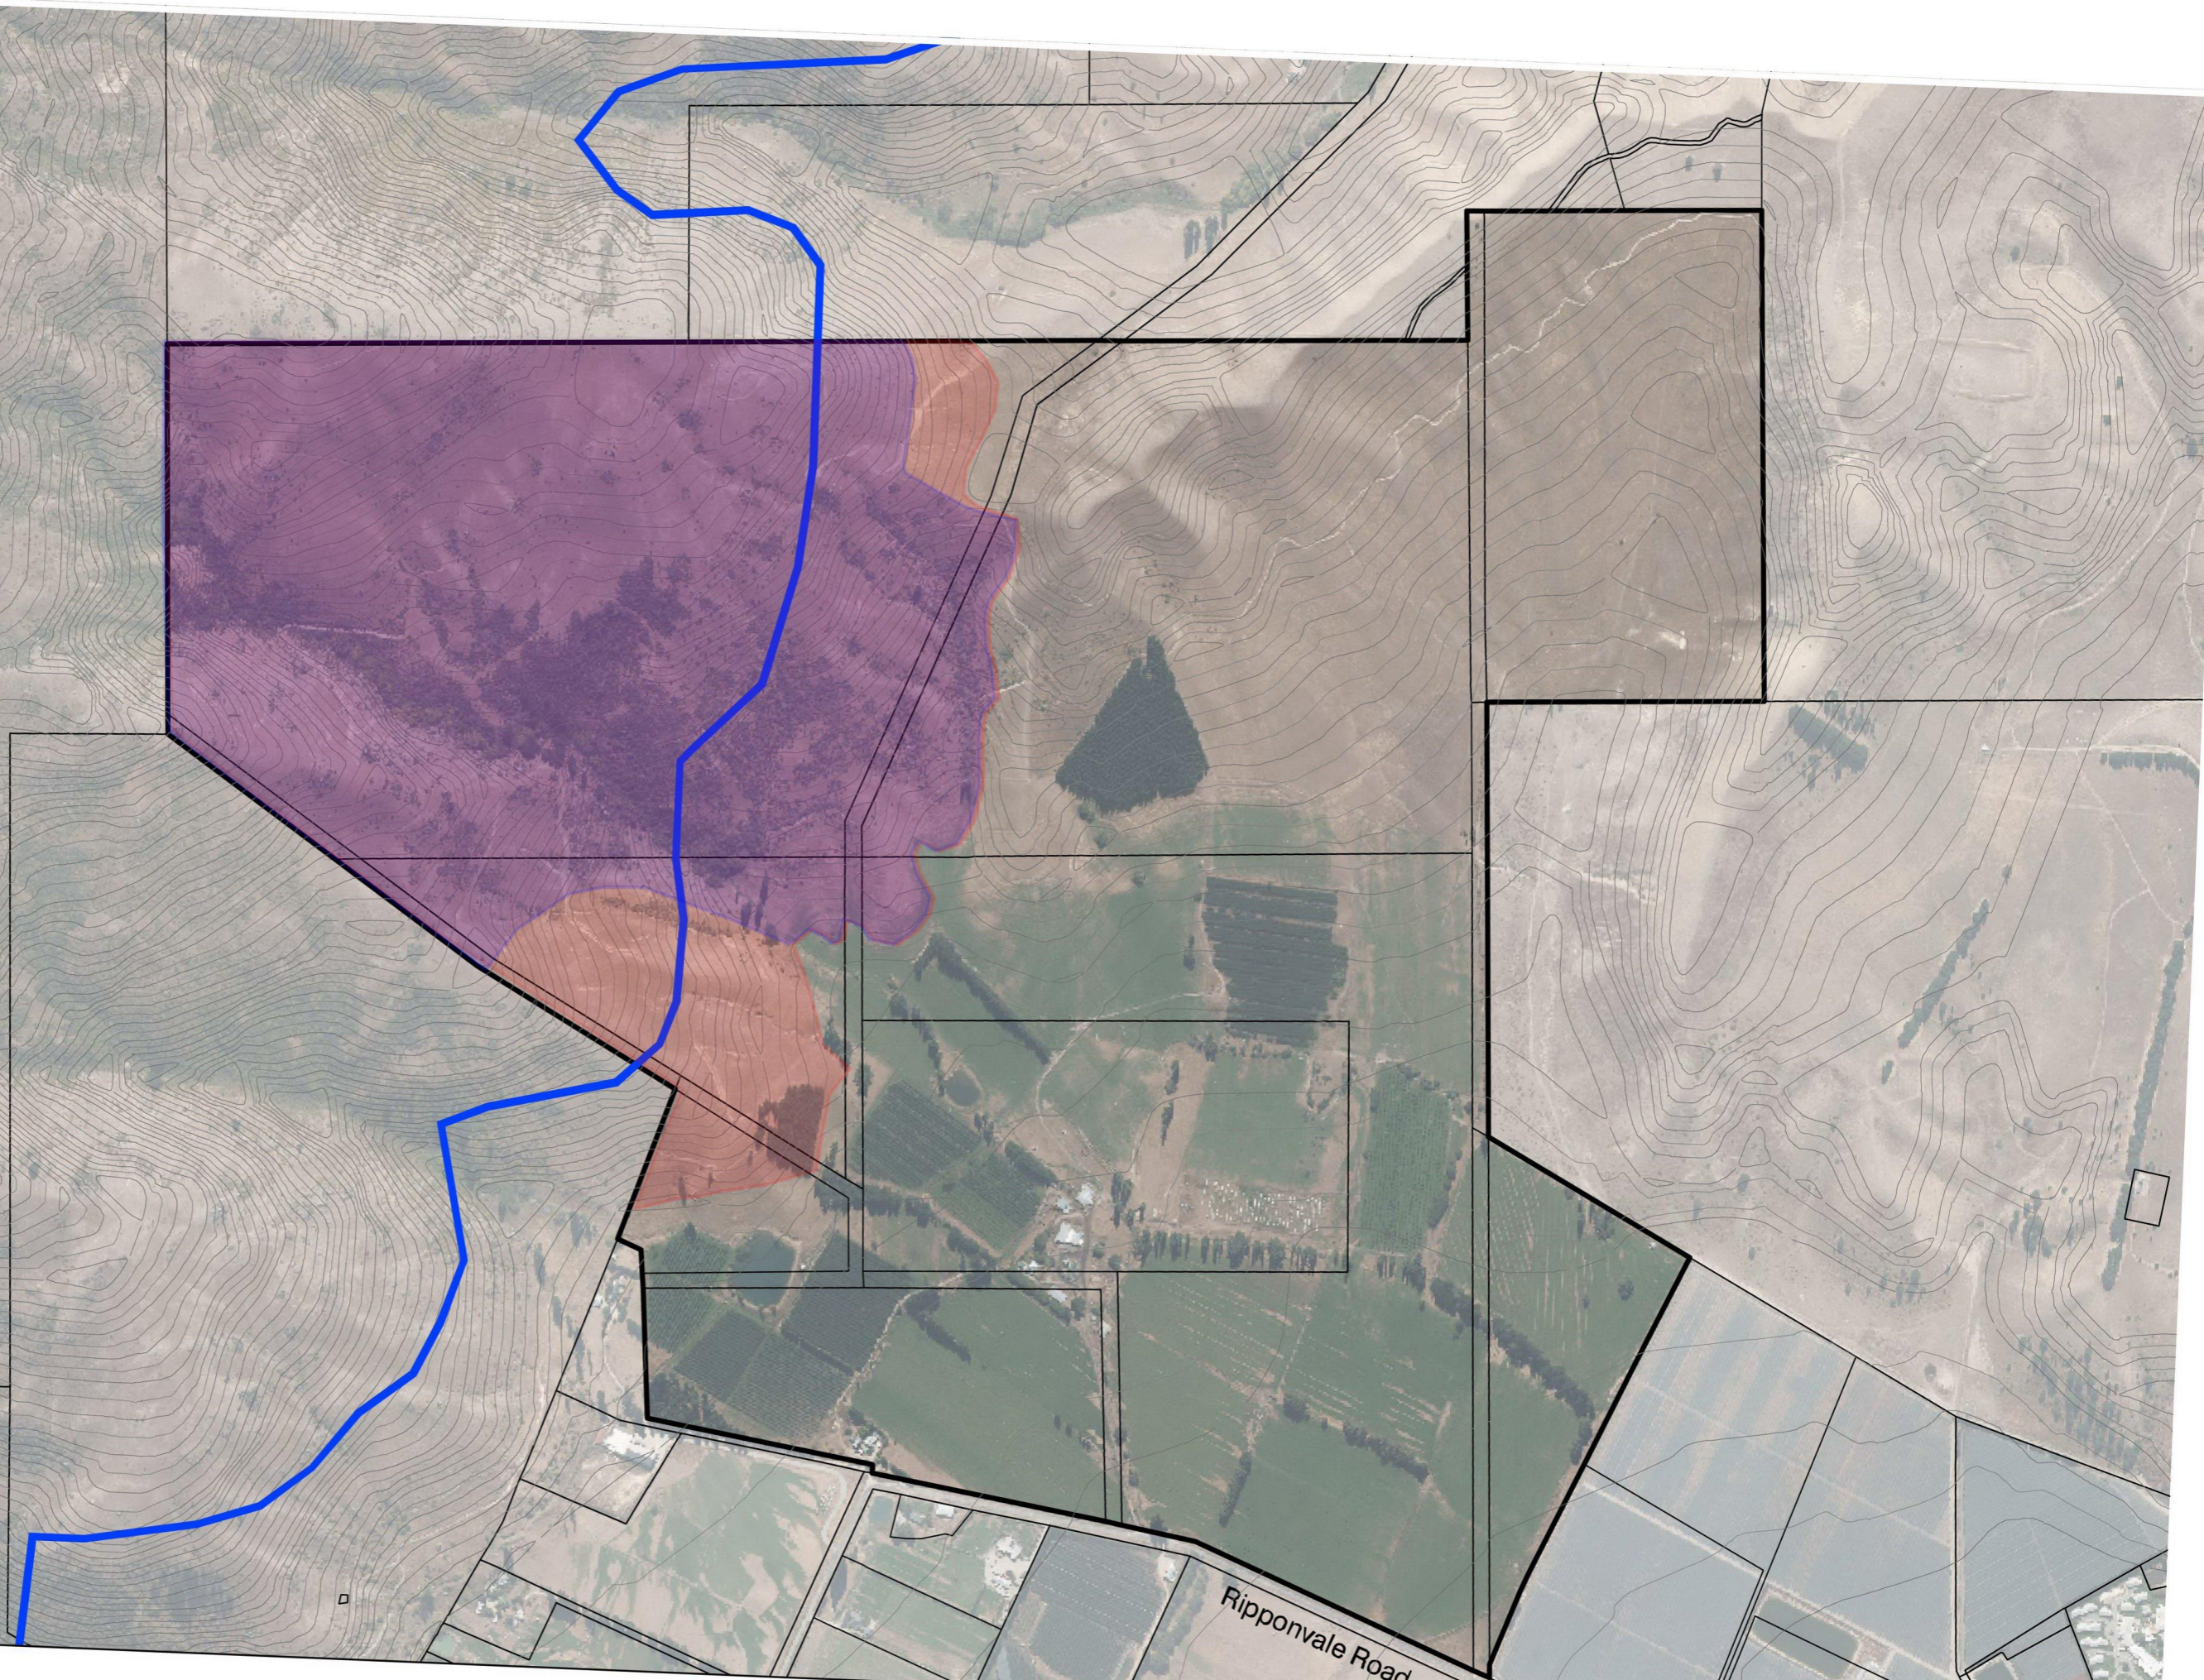
FIG No: APPENDIX A FIGURE 2

Areas with no potential for rural residential built form (i.e building sites) are shaded in purple on Appendix A, Figure 2. All terrain mapped as schist debris landslide in Appendix A, Figure 1 and Figure 2 shaded in red could be developed. An area which will require further clarification is the southwest forestry area which obscures identification of movement and the accurate location of the contact between landslide and alluvial fan as mentioned above.

Development is not considered feasible on the landslides slopes other than those identified with development potential in Appendix A, Figure 2 due to the steeper gradients and evidence of movement. Creep rates of these slopes are likely to be significant (possibly up to 100 mm in prolonged wet periods).

Episodic creep of schist debris landslides may affect the western gully slopes at the base of the Pisa Range. This area shows areas susceptible to landsliding and within this a marginal zone of land (Appendix A, Figure 2) that could be subject to further investigations. There is a significant prospect that successful investigation and possible remedial measures, involving control of groundwater systems would enable rural residential development, in this area.

Areas of the landslide that have the potential for development will require further monitoring and investigation would be required to confirm geotechnical requirements. It is expected that this information would form part of future applications for resource consent.

For future building sites which are located on or in close proximity to schist debris landslides mapped in Appendix A, Figure 2, an investigation programme at selected locations with one or more vertical drillholes can be established to establish feasibility and quantify remedial measures.

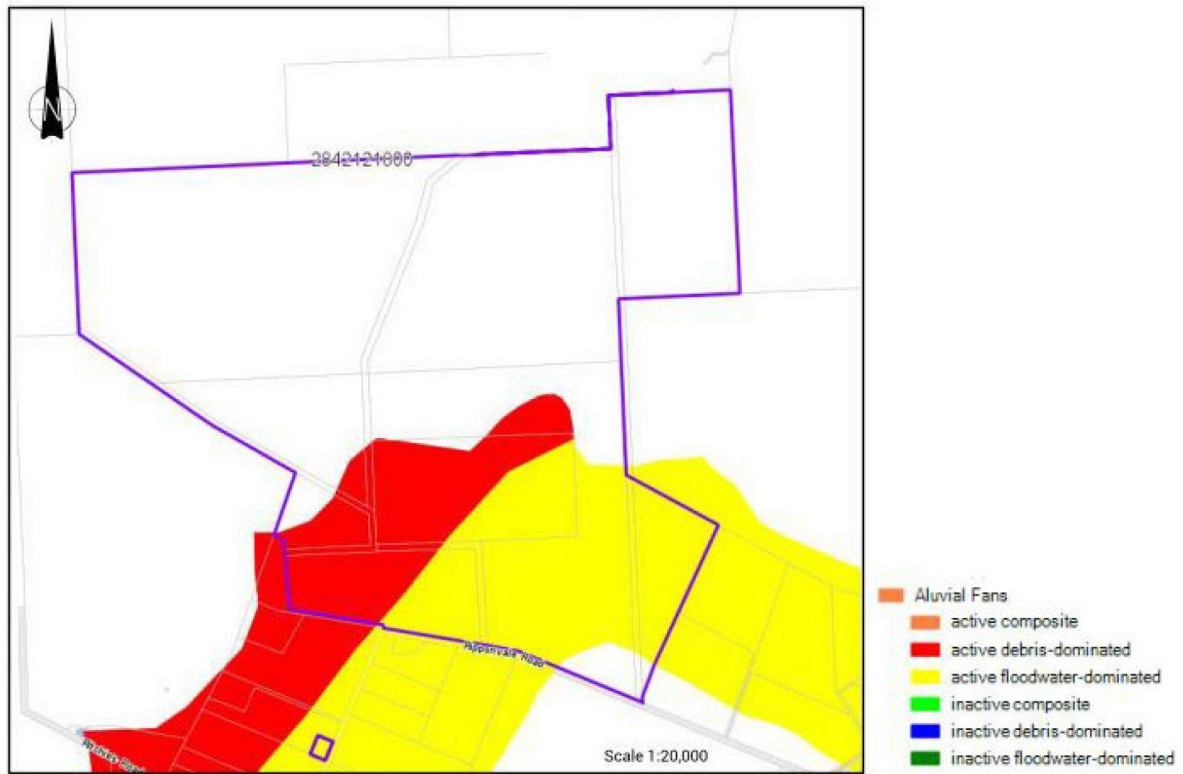
As indicated in Appendix B, Figure 1, the regional mapping indicates that there are 'active debris-dominated' and 'active floodwater-dominated' alluvial fans within the property bounds. These are confined to the lower section of the property, where slopes are largely sub-horizontal with areas towards the far eastern bounds gently inclined.

Figure 1 – Regional Alluvial Fan Mapping. Source: <http://hazards.orc.govt.nz>

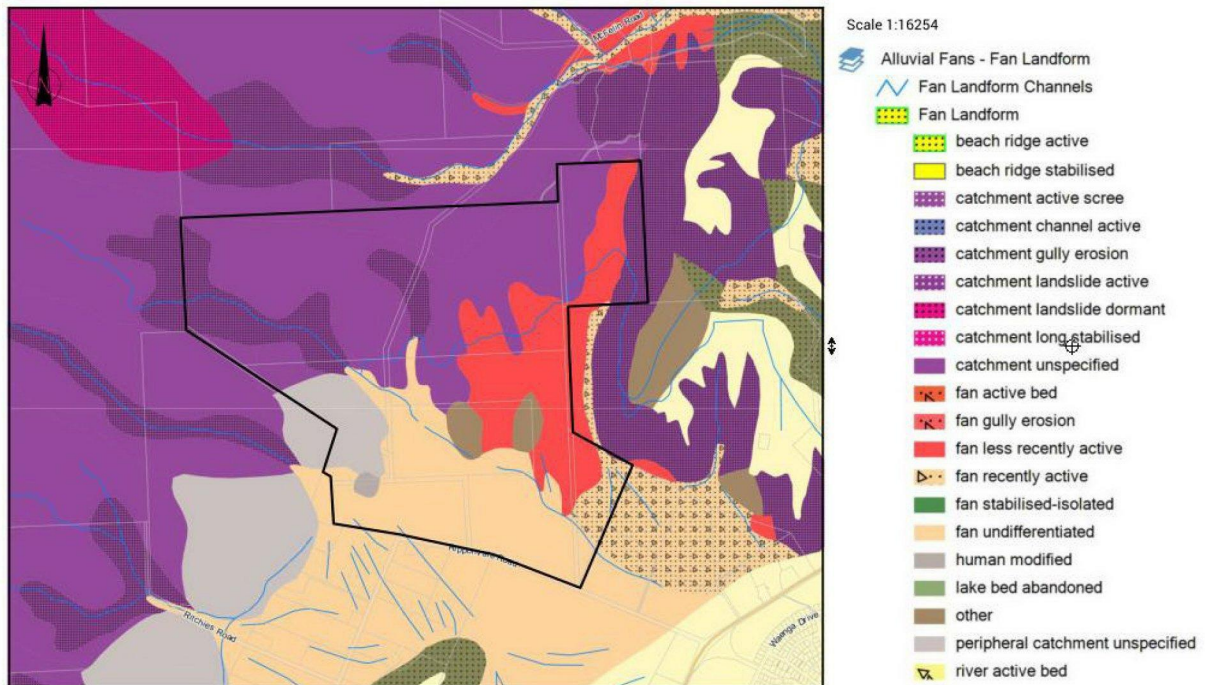
The existing fan mapping from the ORC database as seen Appendix B, Figure 2, shows several fan landforms within the boundaries of the property. The northern extent is mapped as 'catchment gully erosion' in two gullies, identified in field mapping; with the area surrounding as 'catchment unspecified', a default term for areas not studied in detail. The eastern gully is mapped as a 'fan less recently active' which is described as areas with stream activity >300 years. The southern extent is mapped as 'fan undifferentiated', this refers to areas that were not studied in detail. A small section on the south-eastern boundary is mapped as 'fan recently active' in which there is relatively recent (<300 years) stream activity.

Figure 2 - Alluvial Fan- Fan Landform. Source: <http://hazards.orc.govt.nz>

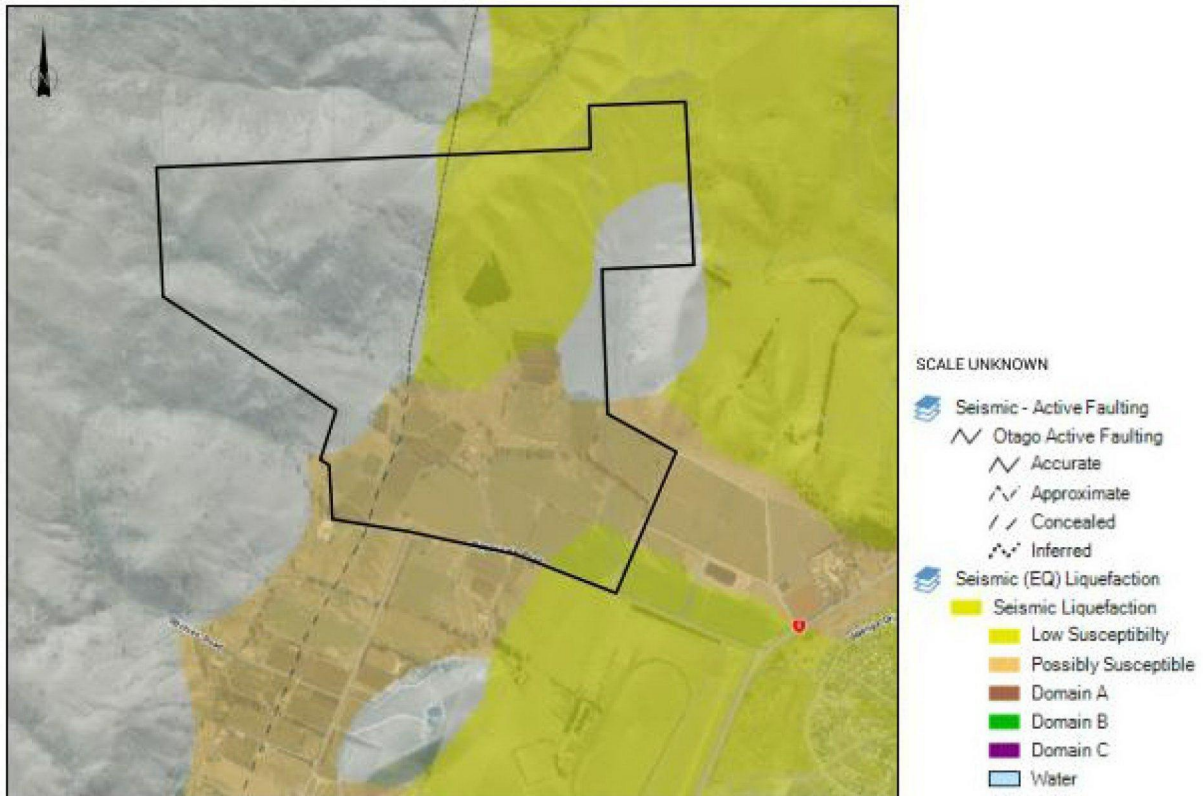
The ORC database has marked an inferred location of the Pisa Fault which cuts through the property as seen in Appendix B, Figure 3. The southern area of the property is mapped as 'possibly susceptible' to liquefaction with a large area to the northeast 'low susceptibility'. However, these categories were apparently assigned without reference to watertable depths, which are discussed below.

A review of stereo photography from Wanaka- Cromwell, Run 2692, 1958 showed an active channel in the lower eastern gully, which is mapped in Appendix B, Figure 3 as 'fan recently active'. However, it is evident in the images that the fan is associated with a washout from the Early Settlers water race, where the scarp is still visible today. No other evidence of recent fan or landslide activity is evident in the stereo pairs.

Figure 3 – Seismic and Faulting Mapping. Source: <http://hazards.orc.govt.nz>
