CENTRAL OTAGO DISTRICT - BRIDGE NO. 152

MAINTENANCE REPORT

Project No.: 18800.46

Project Name: Bridge 152, Styx - Patearoa Road, Taieri River.

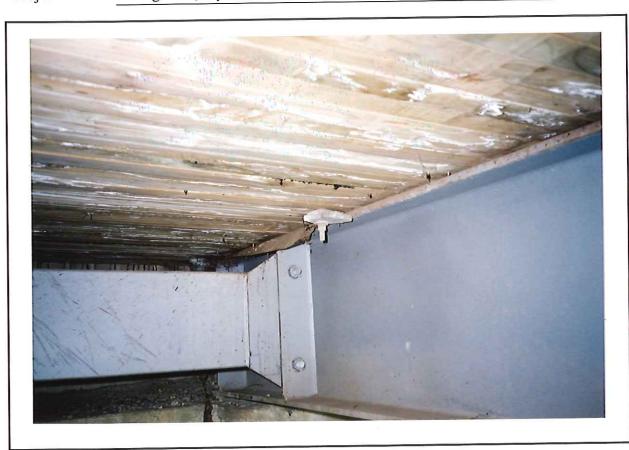
- 1. Remove build-up of debris around abutment bearings of beams.
- 2. A number of deck fixing plates have worked loose and some have dropped off. Check all deck fixing plates and tighen or replace as necessary.
- 3. Minor settlement in road surface behind Patearao abutment. Build up depression with cold mix or hot mix as appropriate.

Description: Typical decking fixing

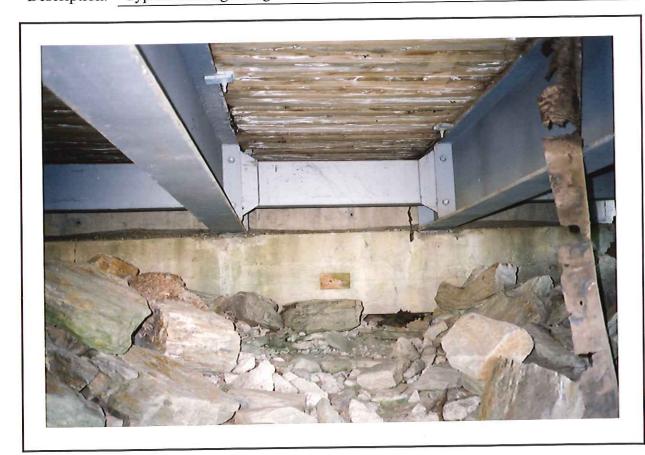
Description: View under at TL abutment
