# Geotechnical Investigation – Shannon Farm Private Plan Change

144 Ripponvale Road,  
Cromwell

February 2019  
GeoSolve Ref: 180137.01

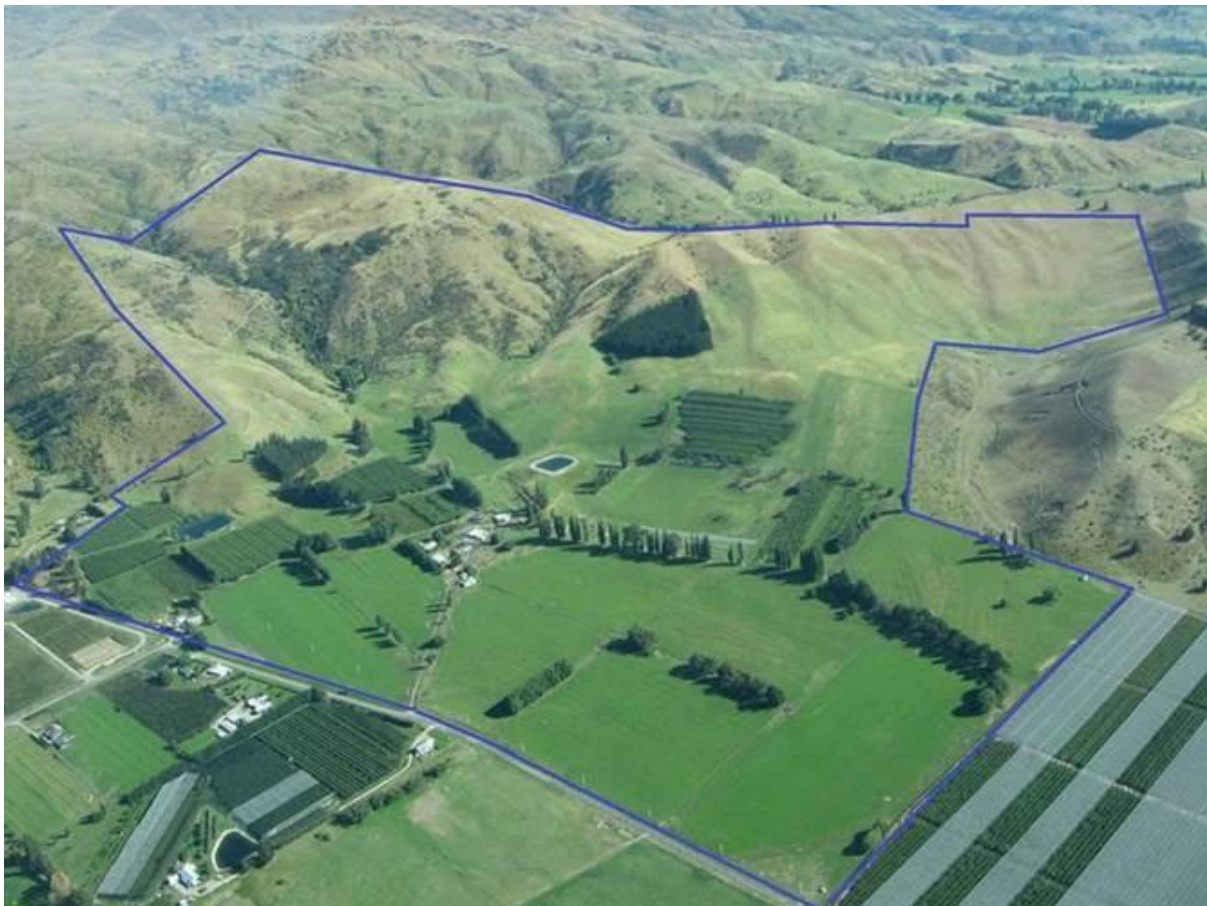
Photo 1 – Property Boundary at 144 Ripponvale Road, Cromwell

The southern part of the property, including the area of the existing buildings, is gently sloping (see Photo 1). Slopes increase from moderate to steep in the north and west.

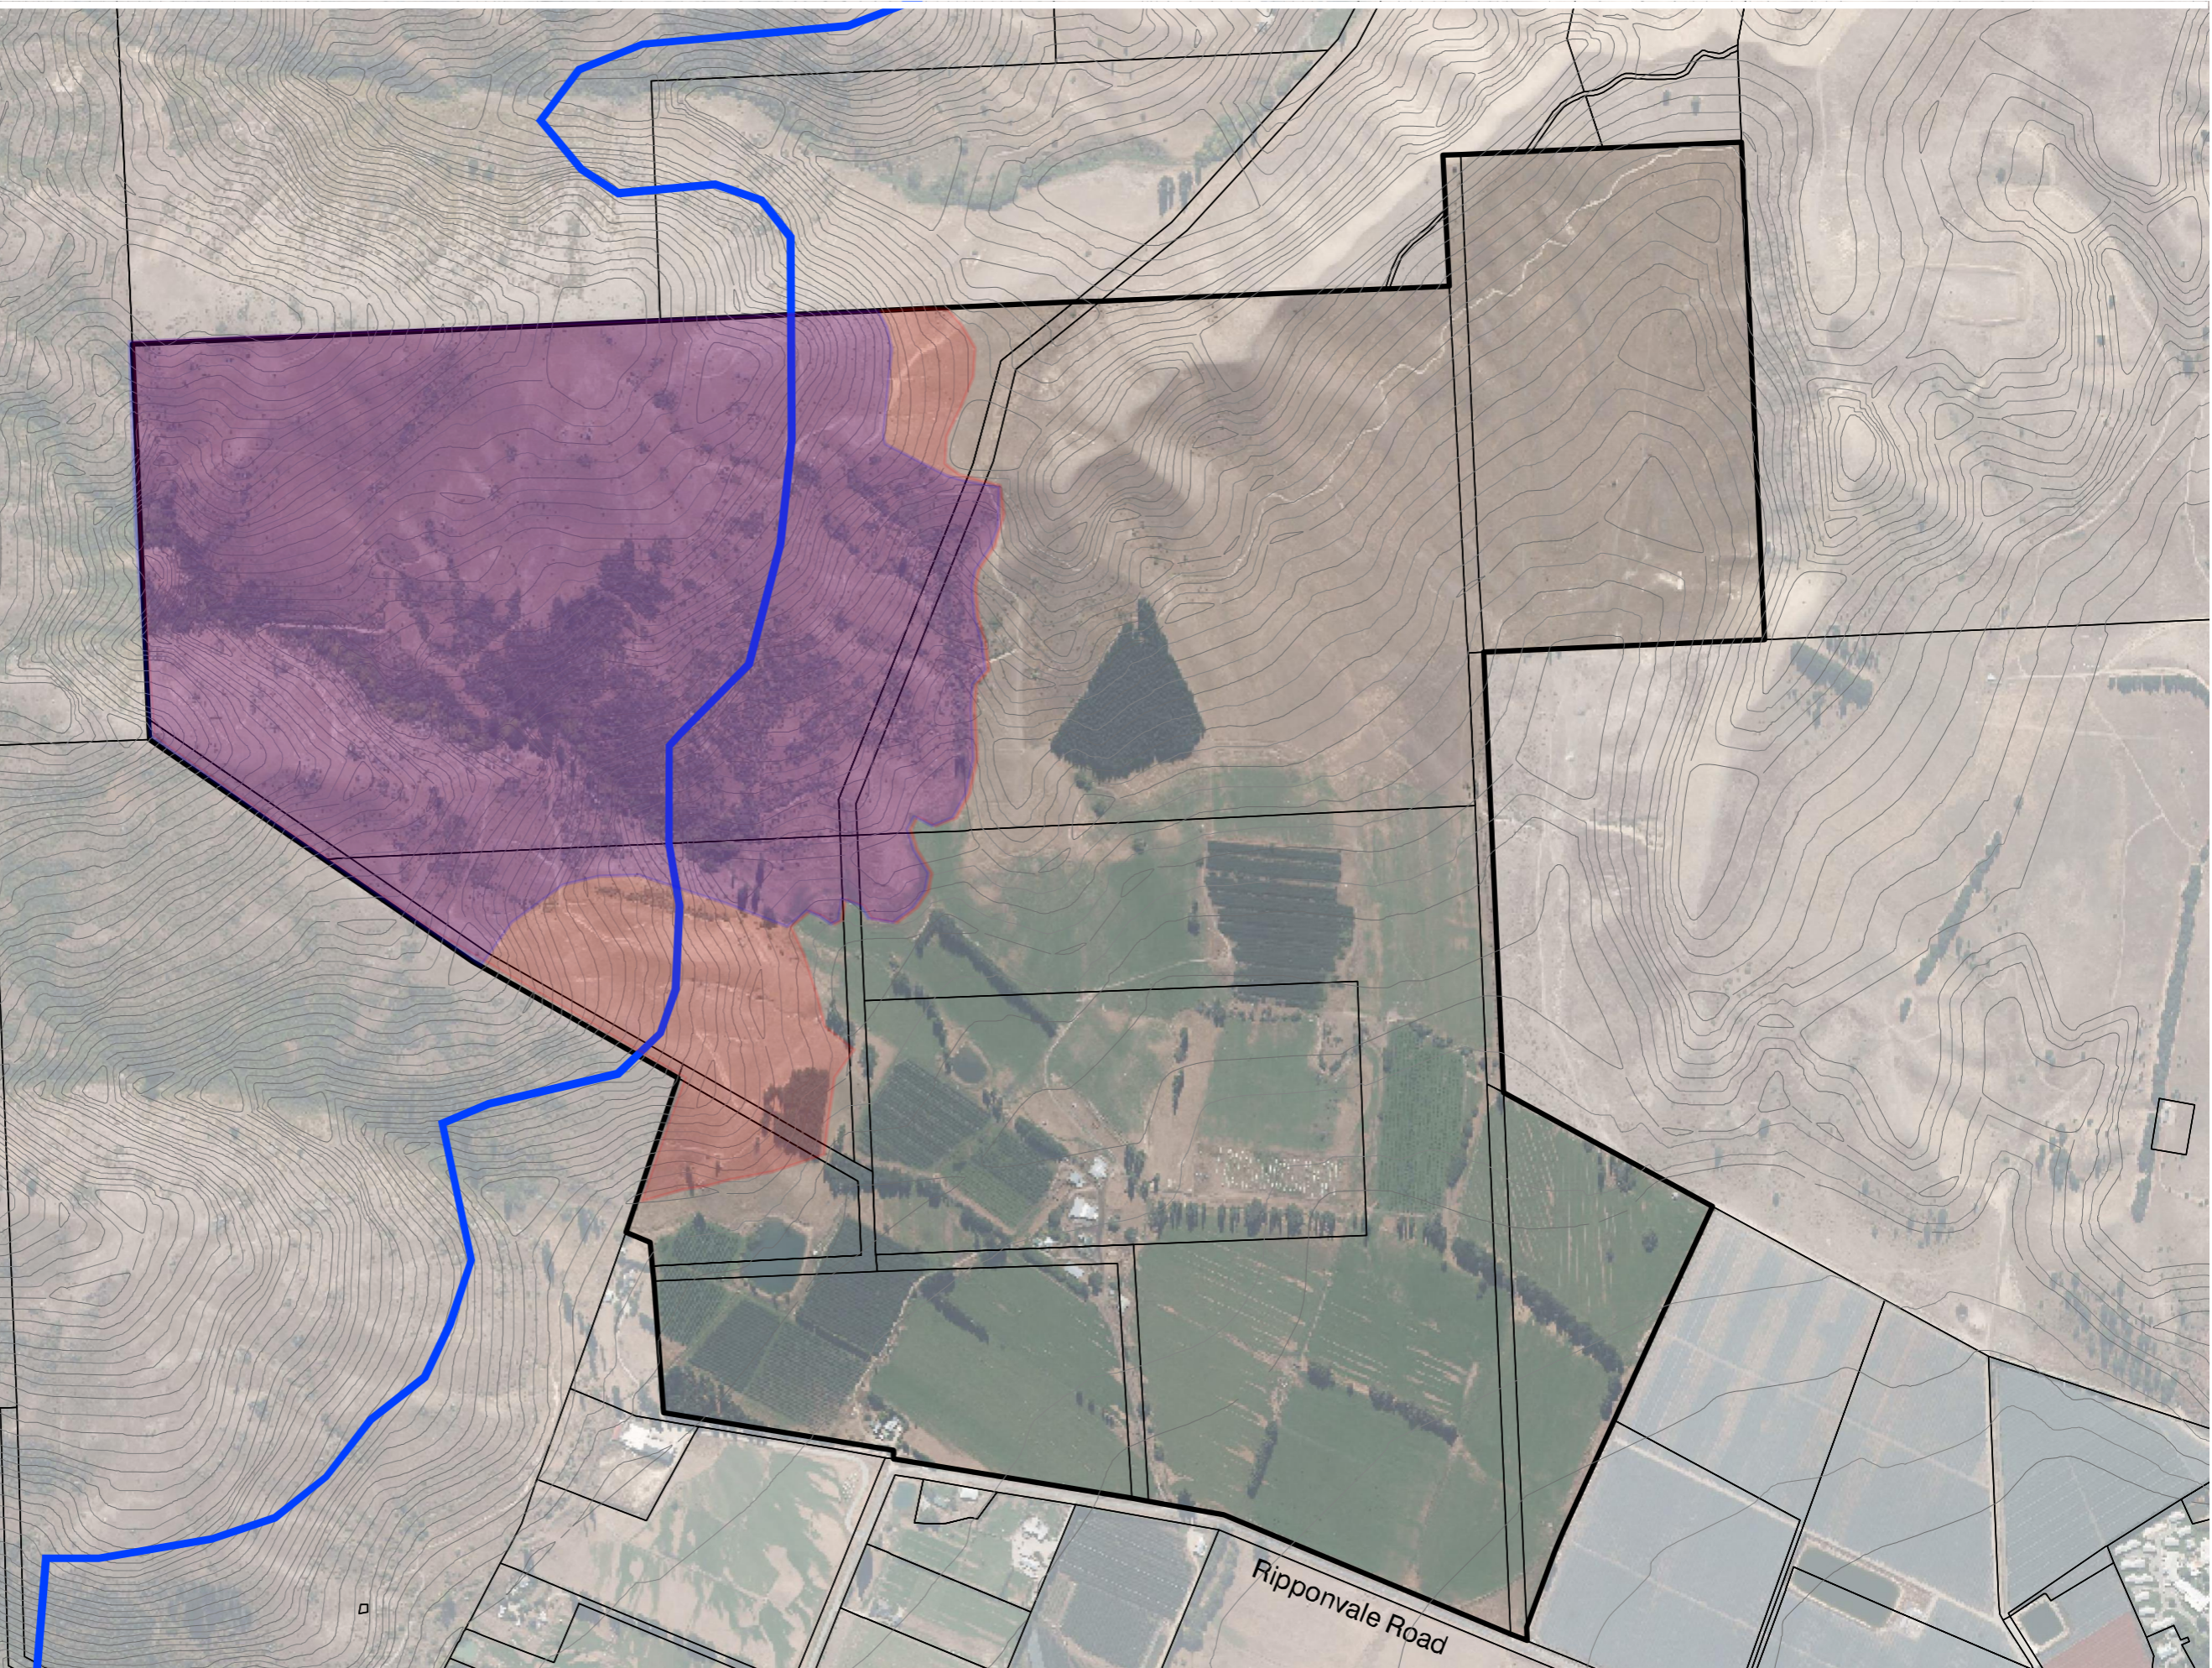
**New Zealand Cherry Corp (Leyser) LP Ltd**  
**Geotechnical Investigation**  
**144 Ripponvale Road, Cromwell**  
**Field Investigations Plan**

Areas with no potential for rural residential built form (i.e building sites) are shaded in purple on Appendix A, Figure 2. All terrain mapped as schist debris landslide in Appendix A, Figure 1 and Figure 2 shaded in red could be developed. An area which will require further clarification is the southwest forestry area which obscures identification of movement and the accurate location of the contact between landslide and alluvial fan as mentioned above.

Development is not considered feasible on the landslides slopes other than those identified with development potential in Appendix A, Figure 2 due to the steeper gradients and evidence of movement. Creep rates of these slopes are likely to be significant (possibly up to 100 mm in prolonged wet periods).

For future building sites which are located on or in close proximity to schist debris landslides mapped in Appendix A, Figure 2, an investigation programme at selected locations with one or more vertical drillholes can be established to establish feasibility and quantify remedial measures.

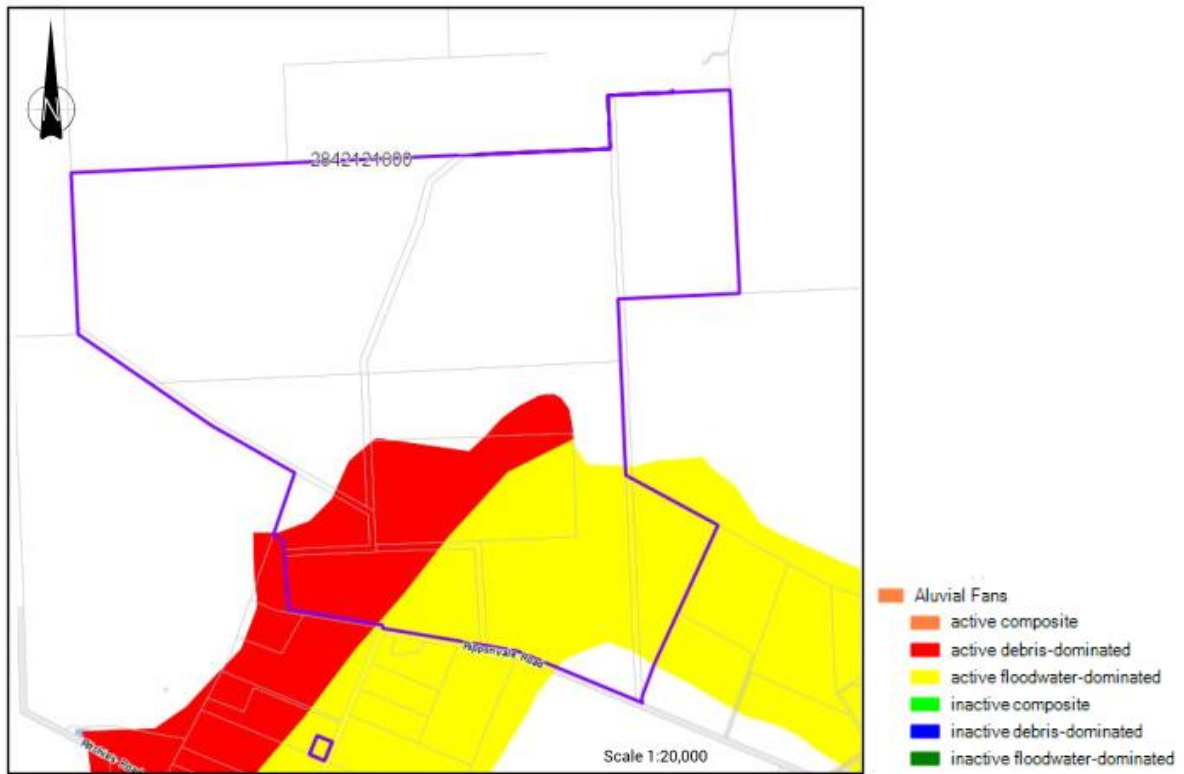
Figure 1 – Regional Alluvial Fan Mapping. Source: <http://hazards.orc.govt.nz>

As indicated in Appendix B, Figure 1, the regional mapping indicates that there are 'active debris-dominated' and 'active floodwater-dominated' alluvial fans within the property bounds. These are confined to the lower section of the property, where slopes are largely sub-horizontal with areas towards the far eastern bounds gently inclined.

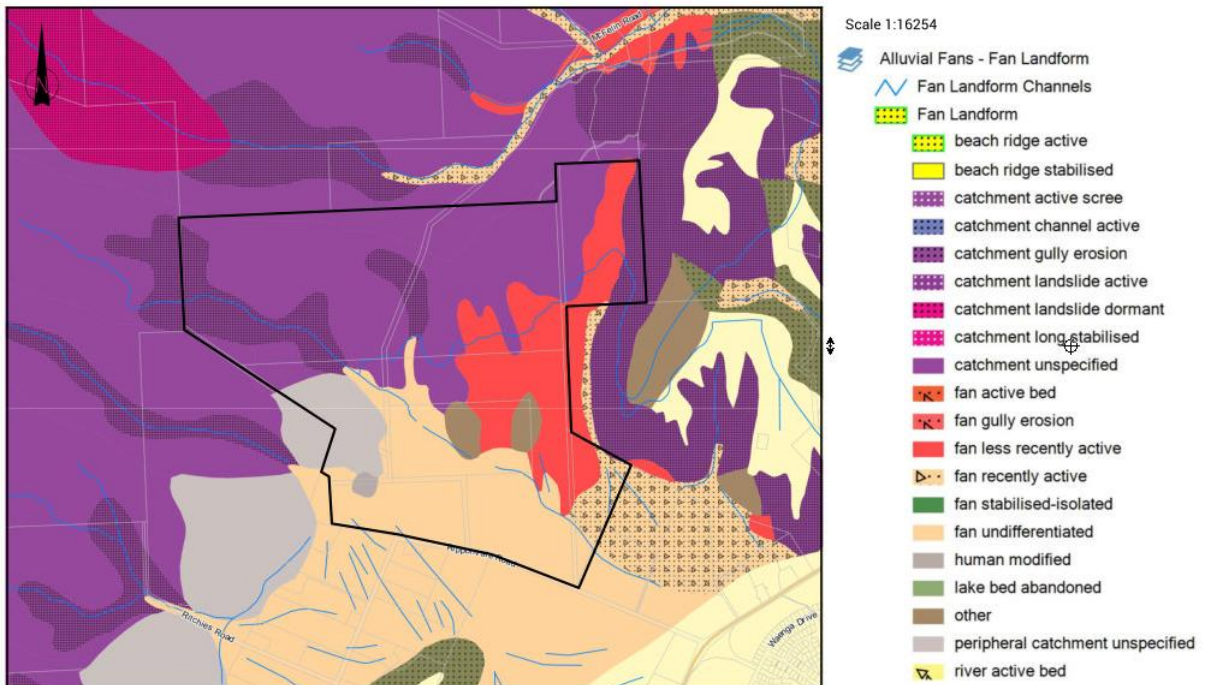
Figure 2 - Alluvial Fan- Fan Landform. Source: <http://hazards.orc.govt.nz>

The existing fan mapping from the ORC database as seen Appendix B, Figure 2, shows several fan landforms within the boundaries of the property. The northern extent is mapped as 'catchment gully erosion' in two gullies, identified in field mapping; with the area surrounding as 'catchment unspecified', a default term for areas not studied in detail. The eastern gully is mapped as a 'fan less recently active' which is described as areas with stream activity >300 years. The southern extent is mapped as 'fan undifferentiated', this refers to areas that were not studied in detail. A small section on the south-eastern boundary is mapped as 'fan recently active' in which there is relatively recent (<300 years) stream activity.

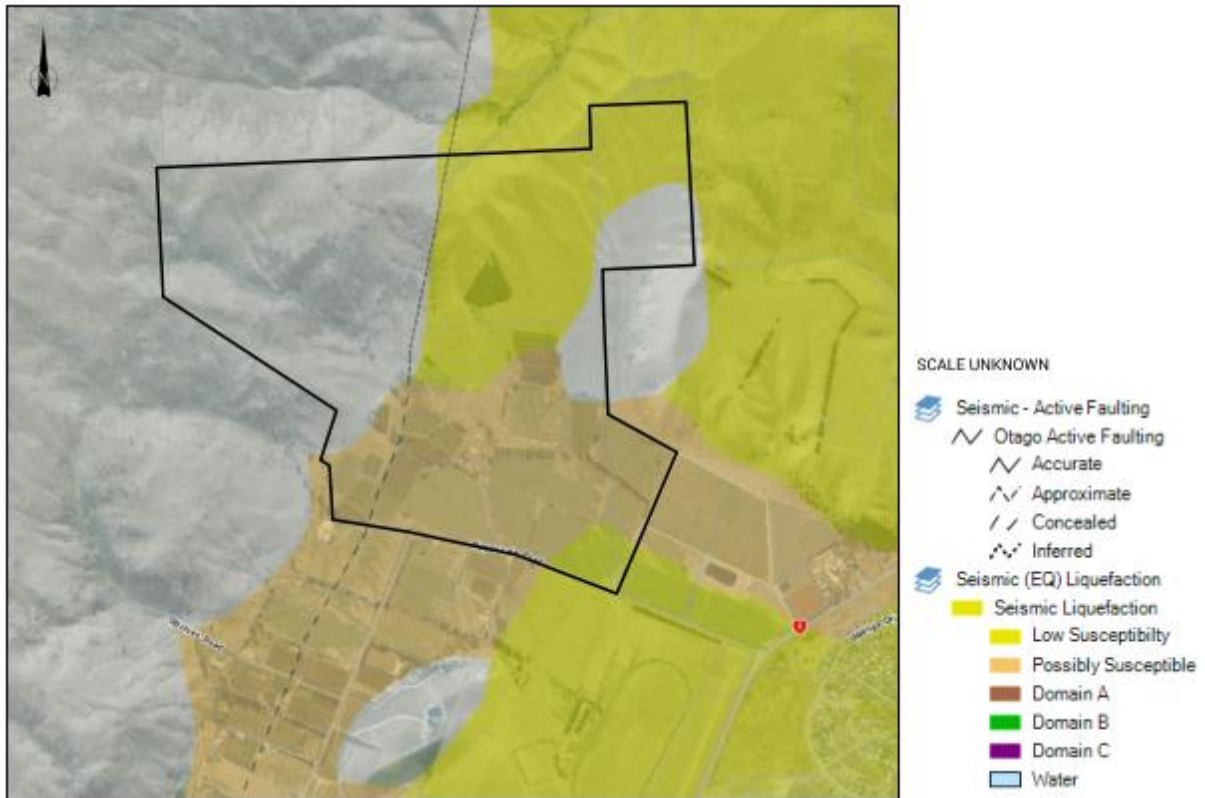
Figure 3 – Seismic and Faulting Mapping. Source: <http://hazards.orc.govt.nz>

The ORC database has marked an inferred location of the Pisa Fault which cuts through the property as seen in Appendix B, Figure 3. The southern area of the property is mapped as 'possibly susceptible' to liquefaction with a large area to the northeast 'low susceptibility'. However, these categories were apparently assigned without reference to watertable depths, which are discussed below.

A review of stereo photography from Wanaka- Cromwell, Run 2692, 1958 showed an active channel in the lower eastern gully, which is mapped in Appendix B, Figure 3 as 'fan recently active'. However, it is evident in the images that the fan is associated with a washout from the Early Settlers water race, where the scarp is still visible today. No other evidence of recent fan or landslide activity is evident in the stereo pairs.
