Project Number 19377.000.001

Geotechnical Investigation

Lot 4 Water Race Hill, Bannockburn,

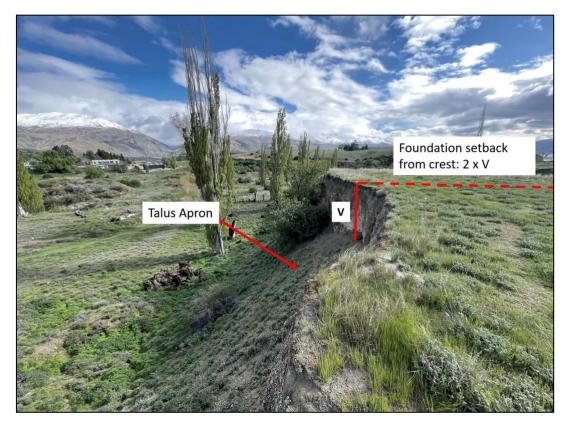
ENGEO recommends that foundation construction in Lot 1 and 9 are setback from the crest at a horizontal distance at least twice the adjacent vertical slope height (V), Photo 5. The vertical slope height may be measured from the top of the talus apron that buttresses the base of the vertical slope. We note that this is steeper than allowed for in Section 3.1.2 of NZS3604, however we consider it to be appropriate for the granular materials encountered in both lots. Setback distances should be further assessed and defined by a surveyor during detailed design works for Lot 1 and 9.

Photo 5: Image showing example setback calculation for Lot 1 & 9.

Based on our site assessment observations, ENGEO recommends setback zones are applied along the western crests of both Lot 1 and 9 to reduce crest loading from nearby structures and promote slope stability of the adjacent banks.

Setback zone dimensions may be optimized if retaining solutions are explored during Building Consent and detailed designed works.

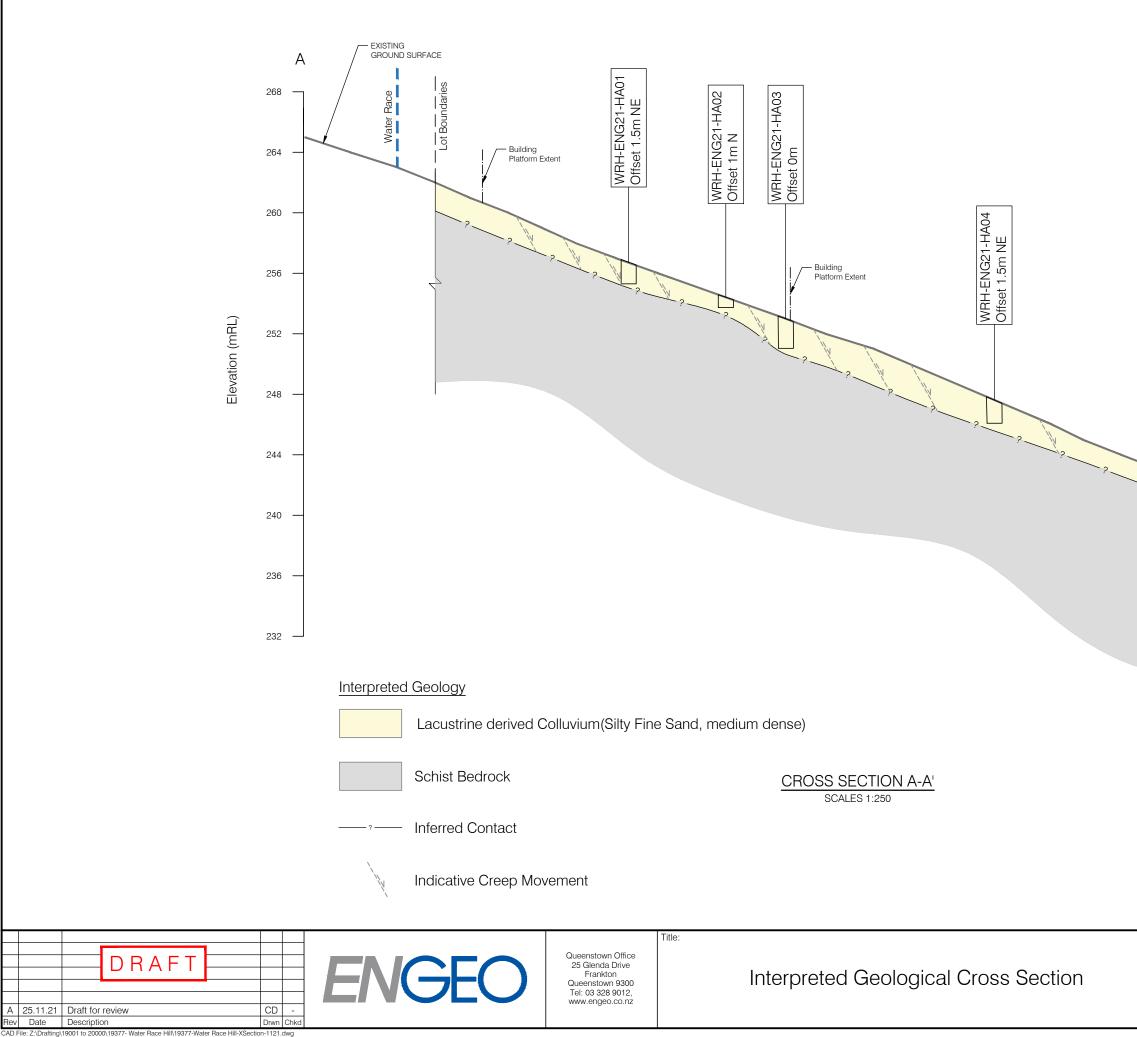
Interpreted Geologic Cross Section

HA and DCP investigation across Lot 18 slope alignment confirmed shallow depth to inferred bedrock, between 0.3 m (where ground cracking was observed) to 1 m. Investigation results returned a lack of evidence in the subsoil to suggest localized slope failure e.g., no changes in moisture, no disturbed or void zones and the density of subsurface material was consistent and generally increased with depth. These findings have been illustrated on the interpreted geologic cross section included in Appendix 3.

As such, it is our opinion that ground cracking has occurred from long term creep of surficial soils over shallow bedrock and not as a result of larger scale landslide failure.

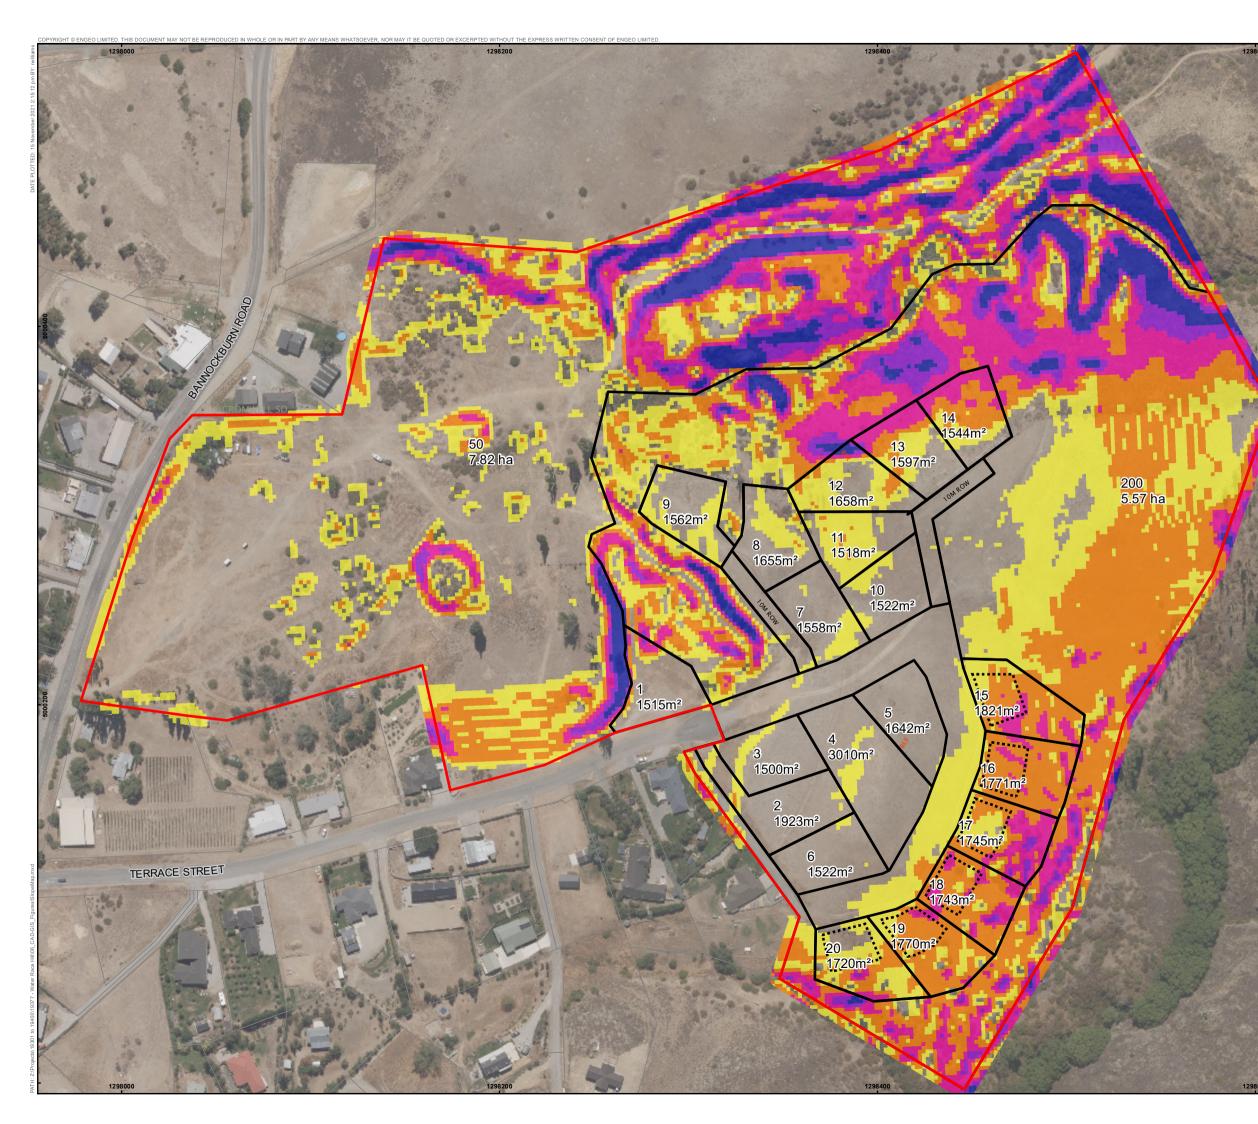
Slope Hazard Assessment

Our resulting slope hazard assessment is presented in Appendix 4. The resultant hazard mapping is limited by resolution of the drone and the vegetation coverage in specific areas that slightly alter the contours.

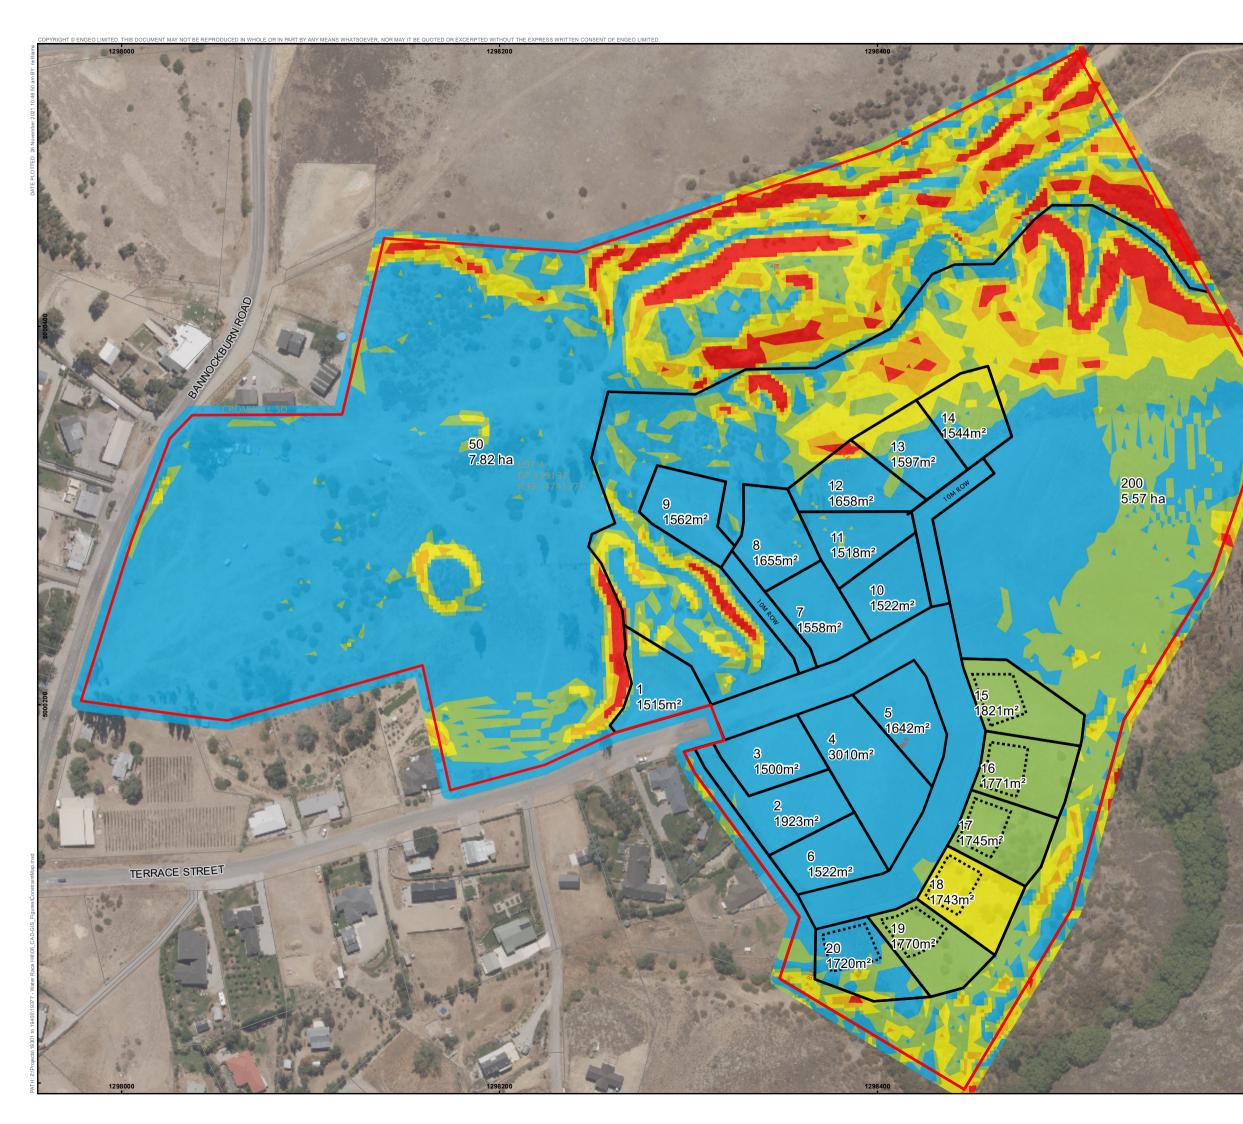
In some areas the map within Appendix 5 indicates higher development risk classes immediately adjacent to a lower risk category. In this instance, we recommend that that the lot specific geotechnical investigation takes into consideration risk posed by the adjacent area such that appropriate mitigation solutions are incorporated into the development works.
