## Geological Review and Natural Hazards Assessment State Highway 8 and Springvale Road, Intersection

**Hartley Road Partnership**  
 Corner of SH8 and Springvale Road, Clyde  
 Geotechnical Assessment  
 Site Plan

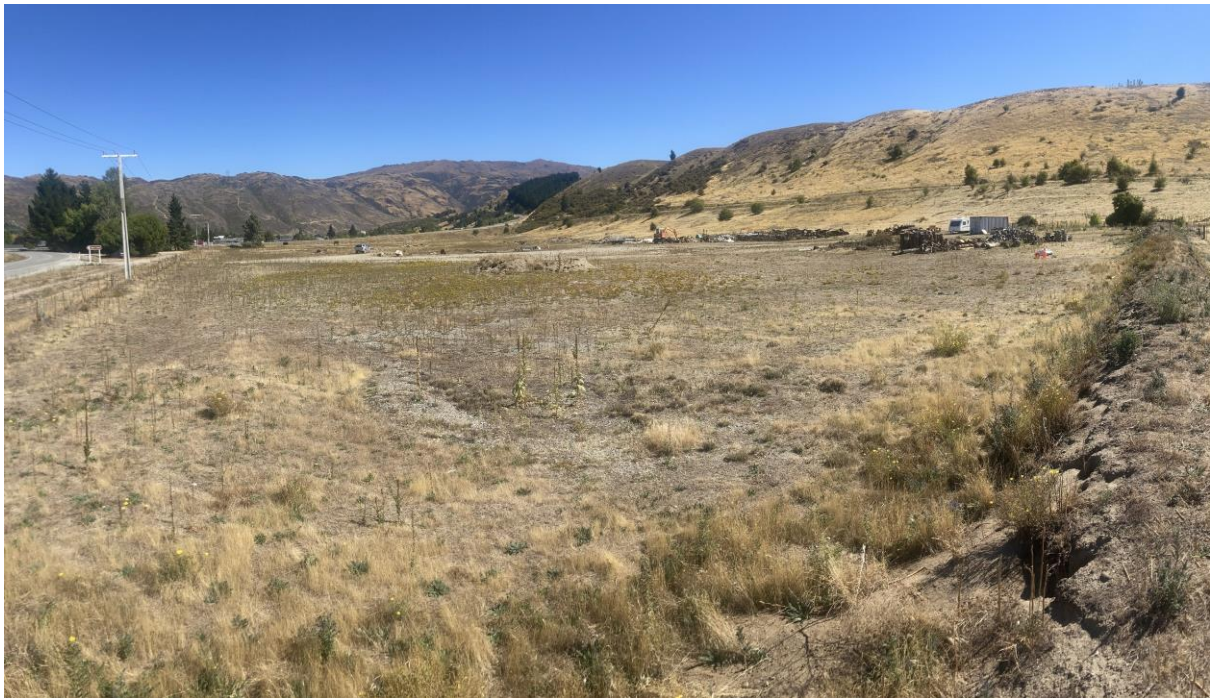
**Photo 1. Panoramic site photo looking northwest across the proposed area for plan change.**

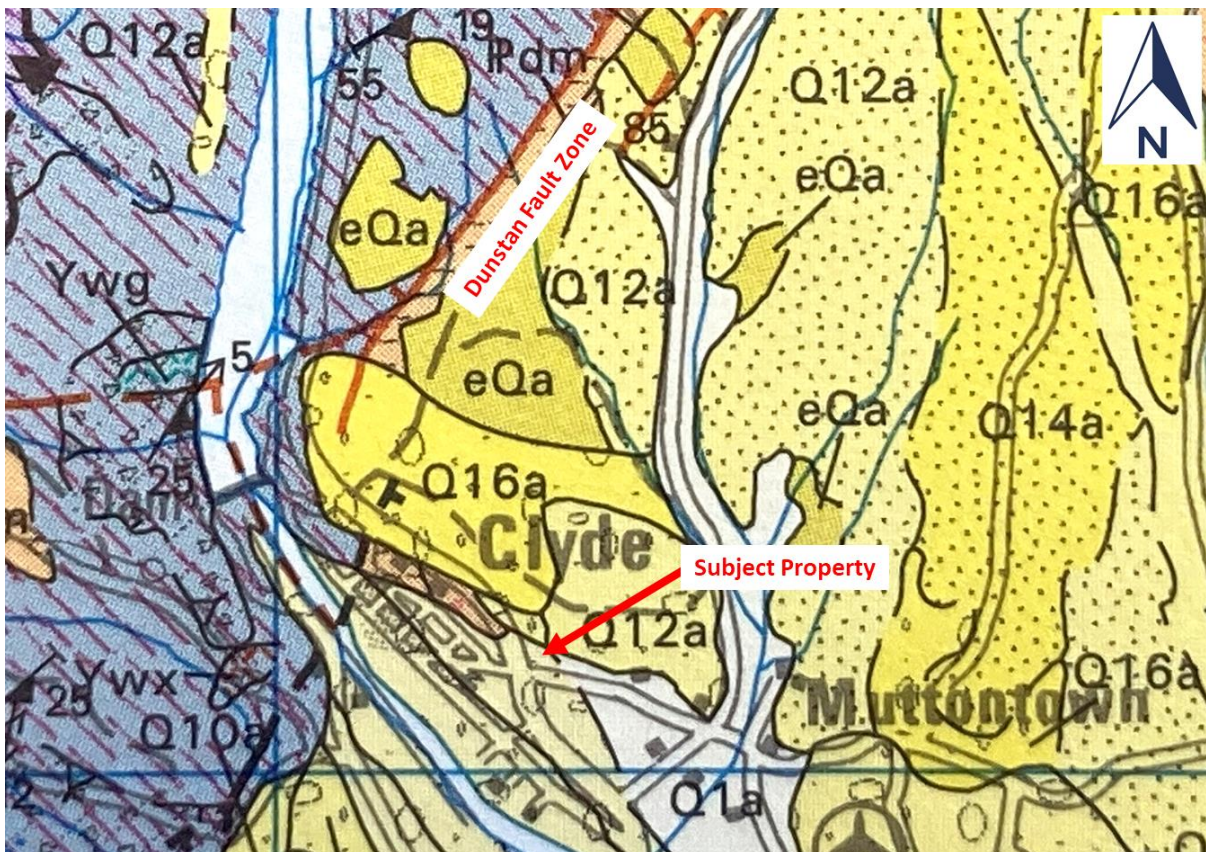
The GNS Science 1:250,000 geological map area of the Wakatipu indicates that the property is underlain by glacial outwash gravels (Q4a and Q12a). These soils are in turn underlain by over-consolidated Bannockburn Formation lake sediment of the Manuherikia Group (mMm) at an unknown depth. Regionally extensive schist bedrock is exposed on the range northwest of Clyde Township and will underlie the site at considerable depths.

Figure 1. Image taken from the GNS Science 1:250,000 geological map of the property and surrounding area.

Active fault traces were not observed onsite although the Dunstan Fault Zone is mapped as a series of active fault structures within 3 km northwest of the property (refer Figure 1 above). However, due to the estimated  $>5,000$  to  $\leq 10,000$  years average return periods for earthquakes on this fault zone, the seismic risk posed by this structure is considered relatively low. Furthermore, the property is situated outside the active fault entity area associated with the Dunstan Fault Zone, an inferred area of land potentially subject to ground surface rupture during fault movements.

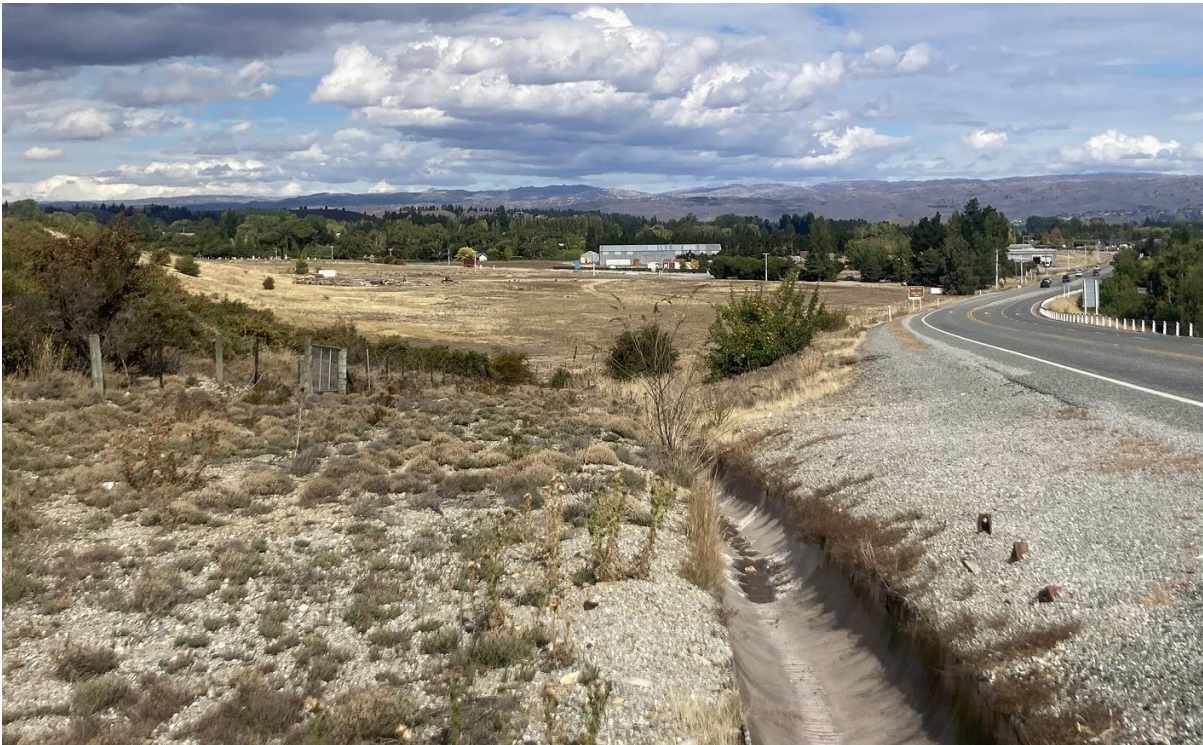
An existing stormwater channel, shown below in Photo 2, runs alongside the state highway and discharges near the northwestern corner of the property along the edge of the fill batter. The channel collects upslope runoff from an even larger ephemeral gully further northwest along the outwash terrace. Stormwater runoff is currently dispersed via an elongated dispersion swale roughly 2000 m<sup>2</sup> in area between the toe of the batter and the western site boundary. We understand that Patersons have considered stormwater runoff and dispersion from the channel outlet as part of their scheme plan development.

**Photo 2. Looking southeast along the stormwater channel towards the development area beyond.**

Future construction will need to consider the effects of surface water run-off and ponding from the upslope terrace riser, ephemeral gullies, and highway stormwater channel. The defunct water race shown on Figure 2 will form an effective cut-off trench to capture and divert upslope run-off away from future development. It is recommended that the defunct water race is assessed to ensure it can take the required overland flow volumes and that it should be upgraded then maintained to serve this purpose. The water race also needs to be checked to confirm any potential for leakage or run-off into the development during flow. Standard floor level elevations and additional cut-off drains can also be utilised to mitigate any residual run-off issue. Additional cut-off drains will need to be incorporated into the stormwater design for the wider development. It's important that design provisions for the highway stormwater channel be considered now as part of the scheme plan. A stormwater runoff assessment is recommended to be undertaken at the resource consent stage to address all the stormwater issues discussed above. Viable options to manage and mitigate site runoff issues are available.

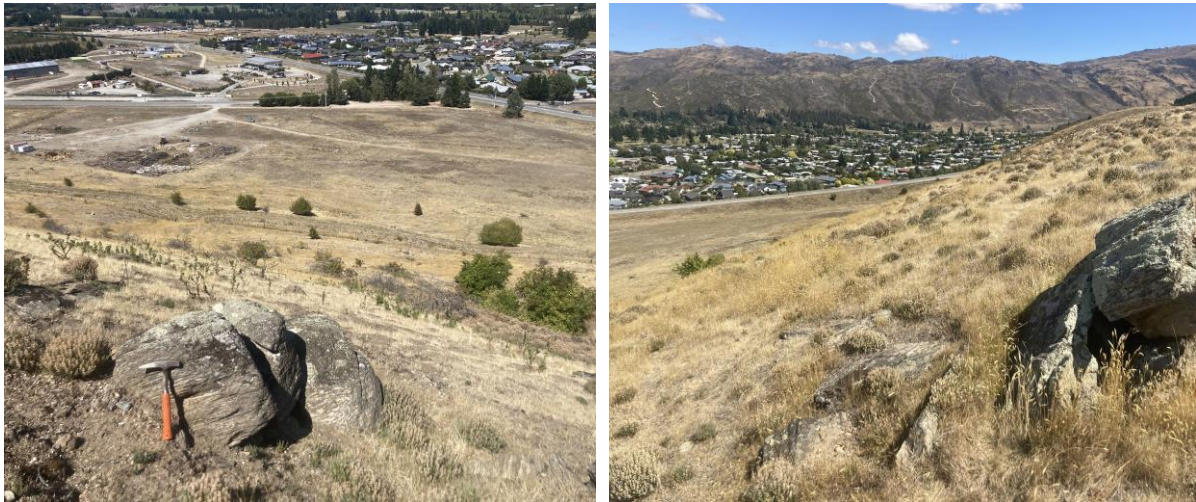
Albeit relatively isolated, there is some potential for localised rock-roll into the development area originating from the upslope terrace riser. Several outwash boulders of variable size and embedment have become exposed by erosion and in some instances could be re-mobilised via seismic shaking or gradual weathering. The two example boulders shown below in Photos 3 & 4 have the most potential to be dislodged from the slope. However, this issue is straightforward to remediate using an excavator or hand tools to pluck the boulders from the slope well in advance of future development. Boulders which are partially embedded within the slope, preventing rock-roll, should be left untouched to avoid undue slope disturbance.

**Photos 3 & 4. Example boulders with the most potential to become dislodged from the terrace slope. Geological hammer for scale.**

Problematic boulders on the terrace riser above the development should be plucked/ removed from the slope in advance of future development. However, boulders with partial embedment should be left untouched to prevent undue slope disturbance. Removal of problematic boulders should be confirmed by a geotechnical practitioner at a later stage once the plan change application has been granted. We assume the removal of problematic boulders can be readily facilitated given their location within the town belt (refer Figure 2).

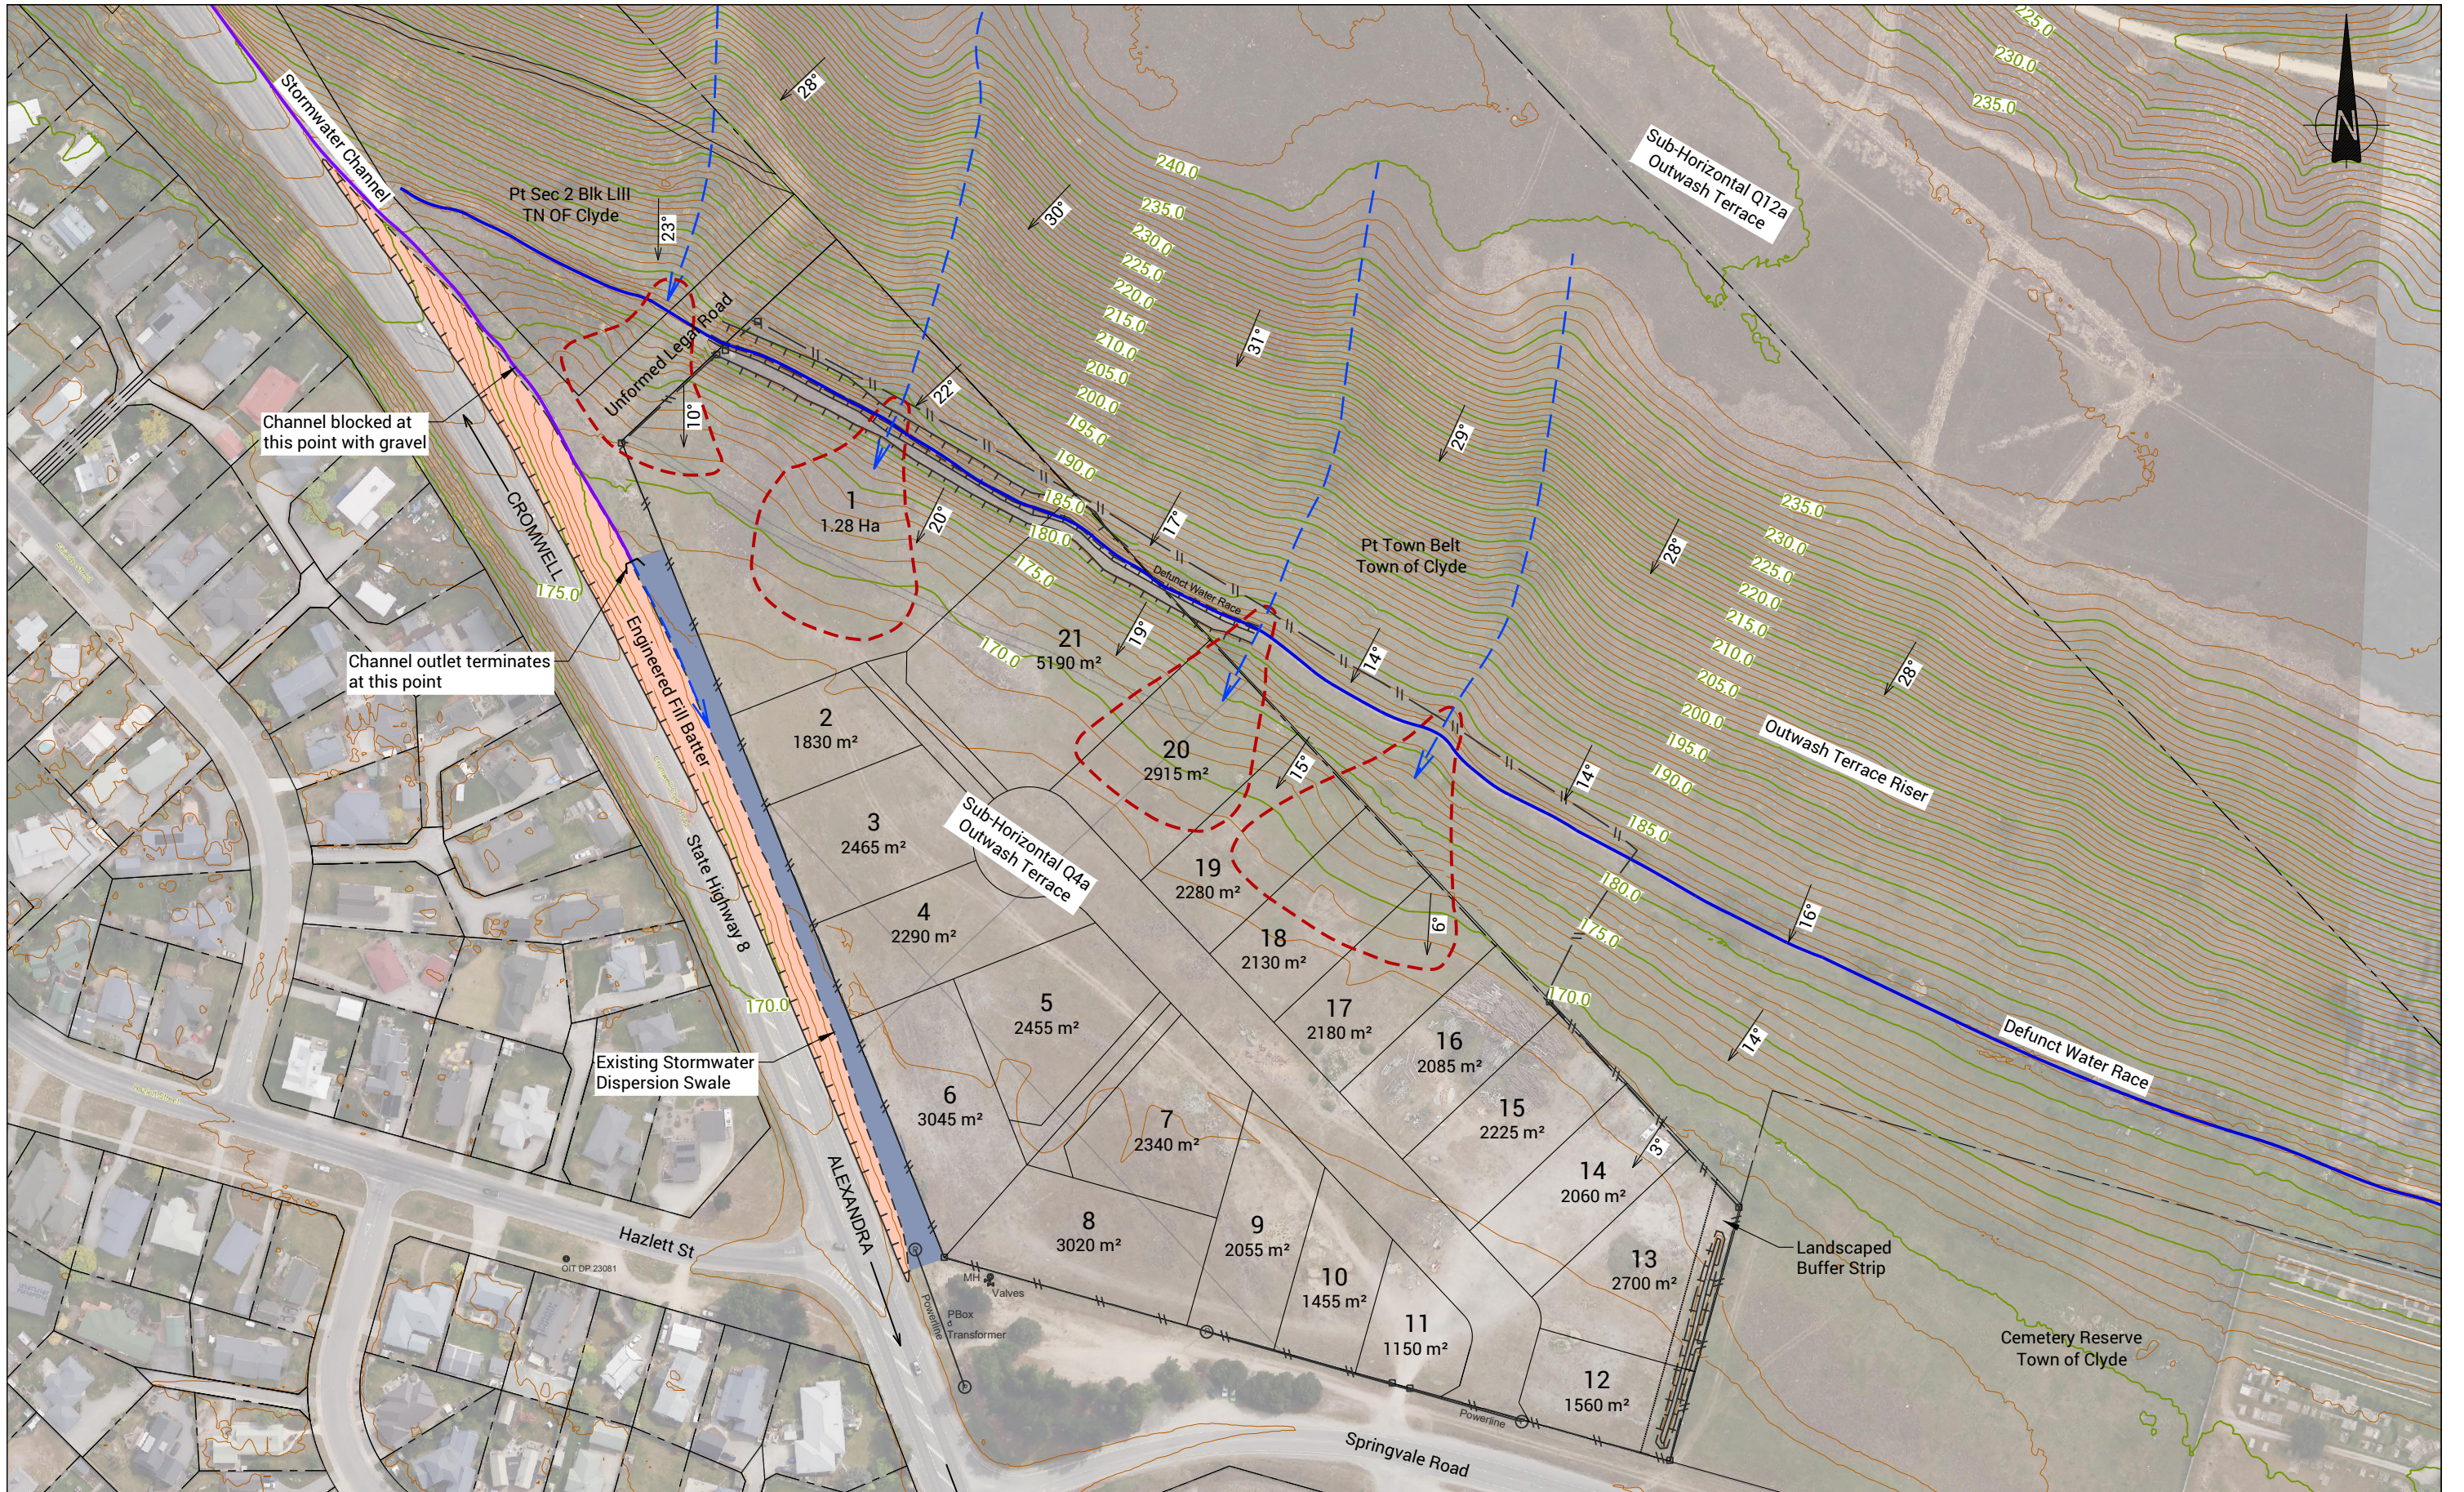
FIG No: Figure 2

Four relatively small alluvial fans terminate within the boundaries of the property. The fans have formed via localised runoff from the upper outwash surface and overlie the lower degraded terrace. Subdued ephemeral gullies dissect the face of the terrace riser above the fans. No evidence of recent sedimentation was observed, and the fans are currently inactive, although this doesn't suggest renewed activity in the future isn't possible. However, given the limited upslope catchment area it's likely the fans have formed due to extreme rainfall (i.e. >500-year return period), alternatively they could be geologically very old having formed immediately post glaciation.

Either way the defunct water race shown on Figure 2 cuts through the head of the fans and forms an effective cut-off trench to capture and divert upslope run-off away from future development. The water race trench ranges around 0.8-1 m deep and is now no longer used. Localised surface run-off from the ephemeral gullies and terrace slope during heavy rainfall is expected to be the primary issue rather than sedimentation.

The location of the stormwater channel and dispersion swale alongside the highway are also shown on Figure 2.
