In the matter of Plan Change 19 to the Central Otago District Plan - Hearings
Panel Minute 1 – 69 Hall Road site

Statement of evidence of Dr Reece Hill on behalf of Steve Davies

16 May 2023

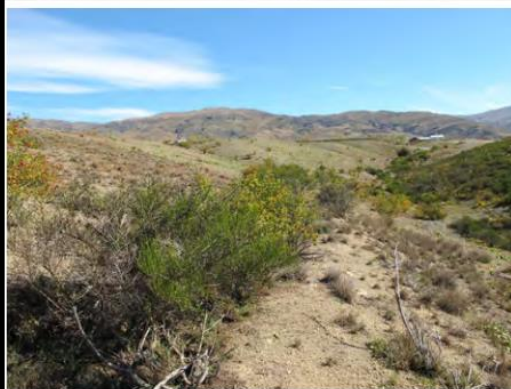
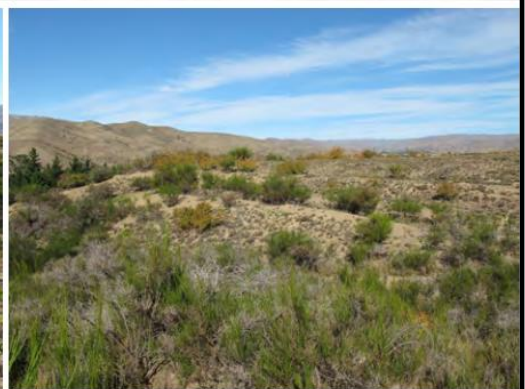
Appendix 3: Site images from archaeological reports.

- 54 The historic aerial photography (from 2012 to 2022) and images from the archaeological reports for the Site (see Appendix 2 and Appendix 3) indicate that the soil has been extensively modified by the placement of tracks, earthworks, the placement of fill and historic soil disturbance such as the excavation of water races and sluicing tunnels for mining operations.

Images showing historic mining earthworks (top), and modified soil associated with water races (bottom).

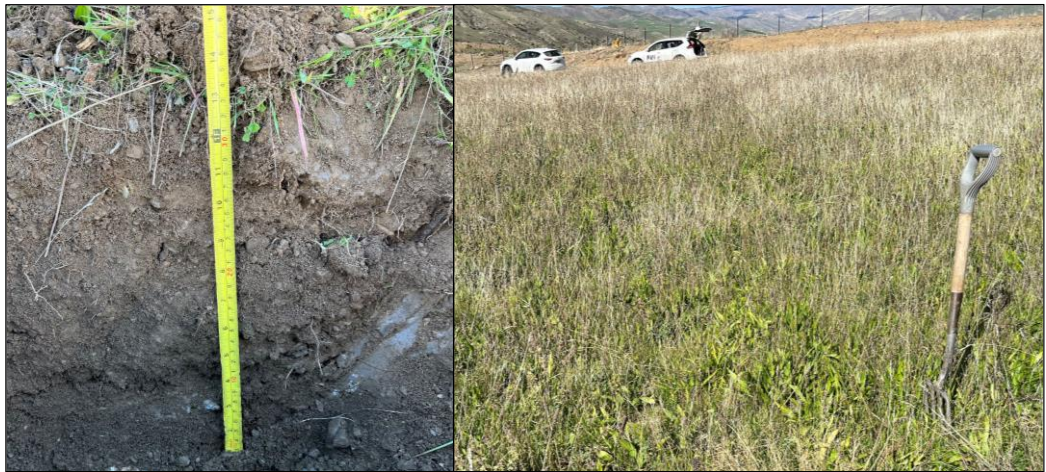
- 58 The soil observation photos at locations 1, 2 and 3 (refer Appendix 5 and 7) show the soil profile formed in the reinstated soil following gravel extraction. The soil profiles are characterised by a compact mixed gravelly fine textured poorly defined/developed A horizon of 20-30 cm depth, over a compact truncated surface of gravels and stones.

1. Reinstated soil - shallow stony soil with compact mixed topsoil over compact gravel surface.

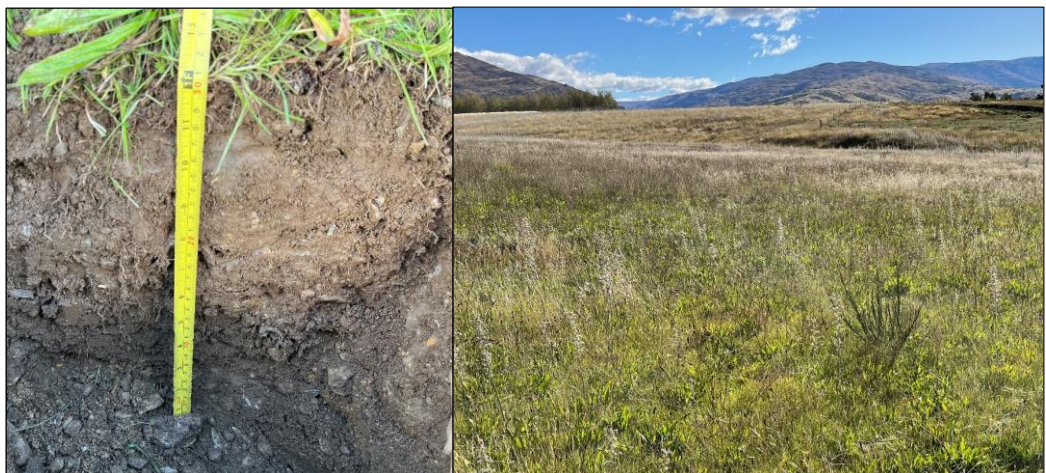
2. Very shallow stony soil with disturbed A horizon.

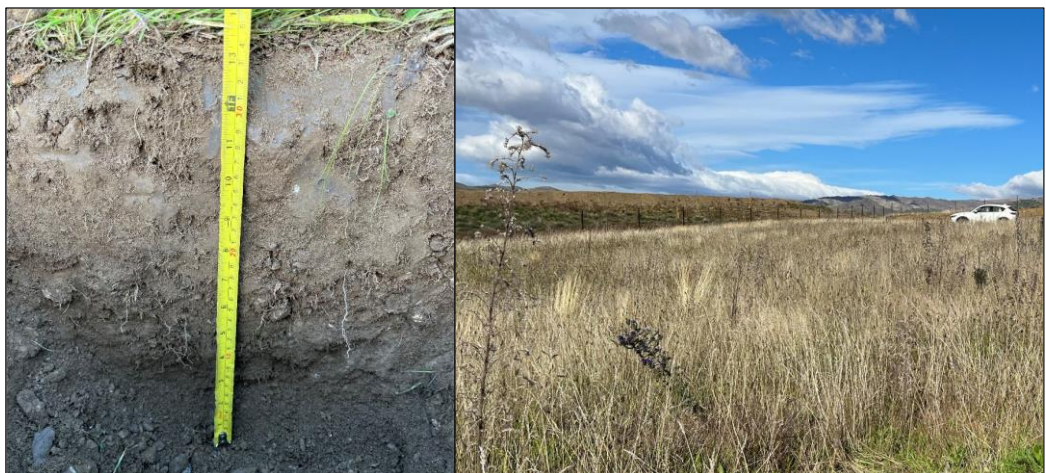
3. Reinstated soil - shallow stony soil with compact mixed topsoil over compact gravel surface.

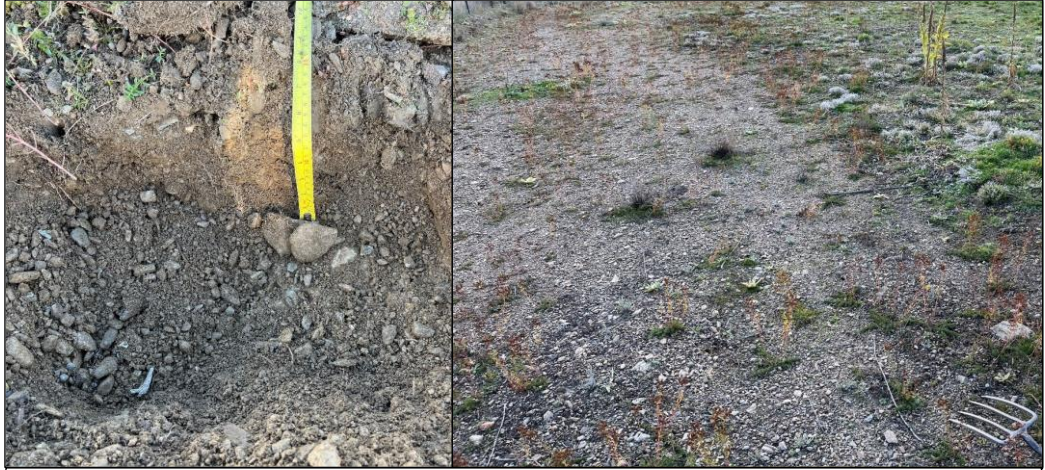
- 65 Based on the slope measurements for this area (see Appendix 6), the soils are on rolling slopes (C slope class).
- 66 The soil observation at location 4, provides an example where no soil is present. This is an example of non-productive land on the site.

4. No soil present – Non-productive land.

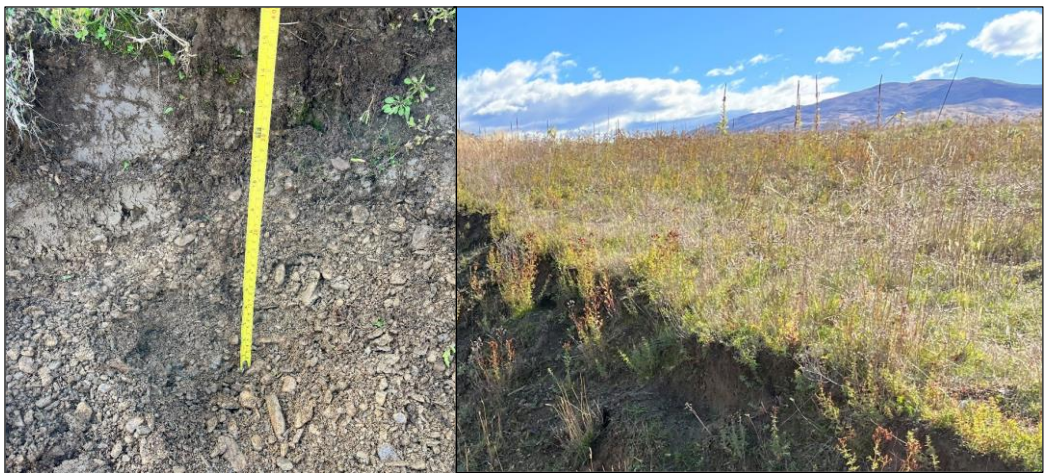
- 64 The soil observation photos at locations 5, 6, 7 and 8 show a soil profile with a mixed poorly defined gravelly fine textured A horizon (topsoil) over gravels. These soils are not characteristic of the Becks soils indicated by the NZLRI but do resemble the very stony loamy sand soils on tailings. Surface gravels are common (see Photo 7 in Appendix 7).

5. Very shallow stony soil with disturbed A horizon.

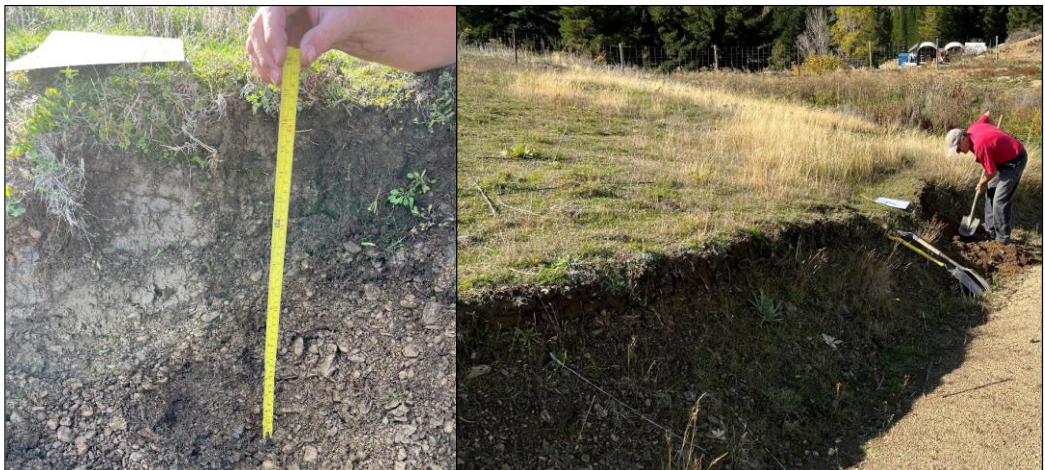
6. Very shallow stony soil with disturbed A horizon.

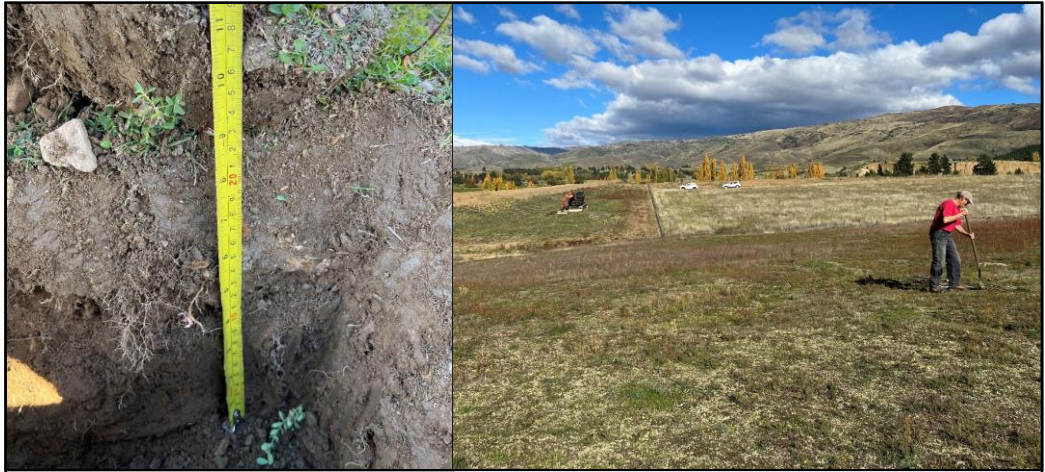
7. Very shallow stony soil.

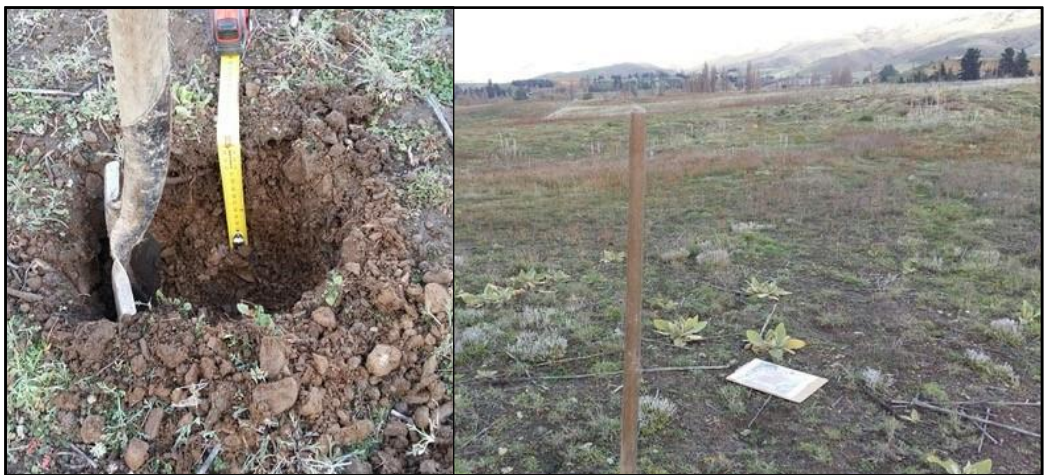
8. Very shallow stony soil.

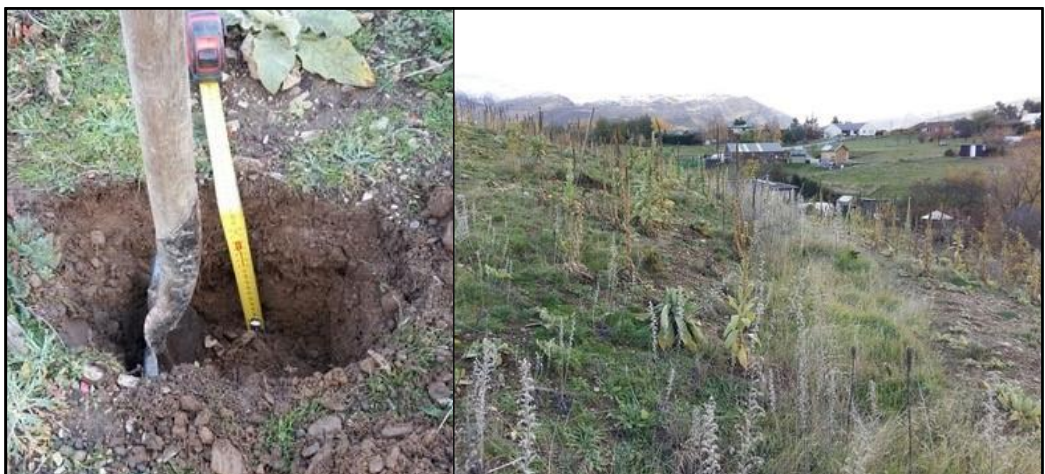
- 61 The soil observation photos at locations 9, 10 and 11 show a soil profile with a very shallow (<5 cm) poorly defined gravelly fine textured A horizon (topsoil) over gravels with sparse vegetative cover. Surface gravels are common (see Photo 8 in Appendix 7).

9. Very shallow stony soil.

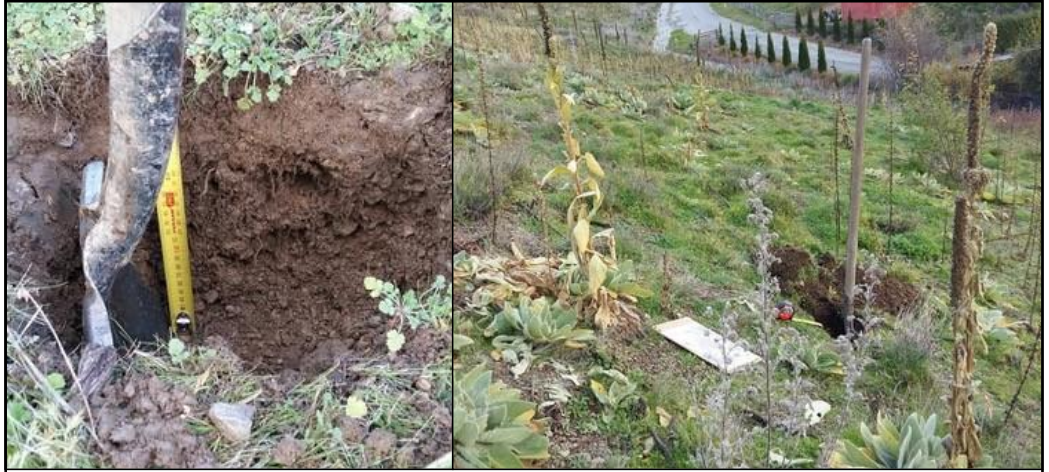
10. Very shallow stony soil.

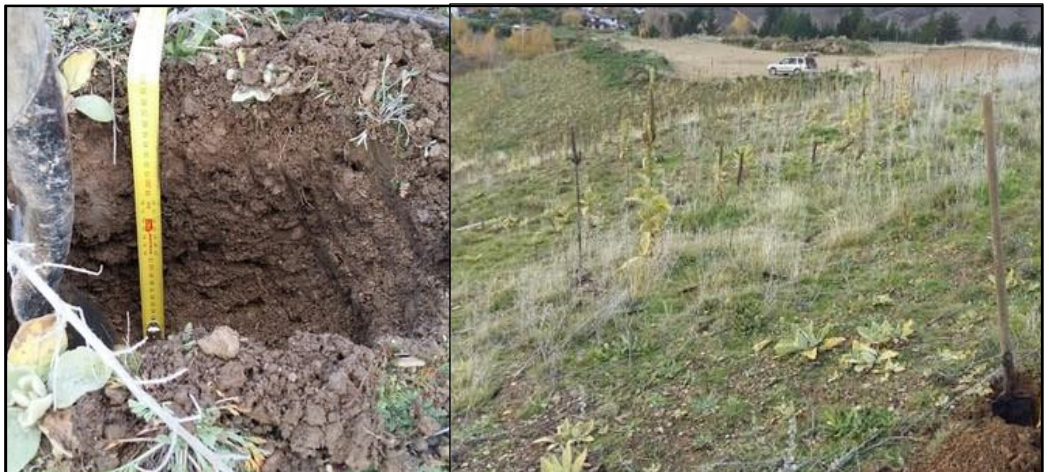
11. Very shallow stony soil.

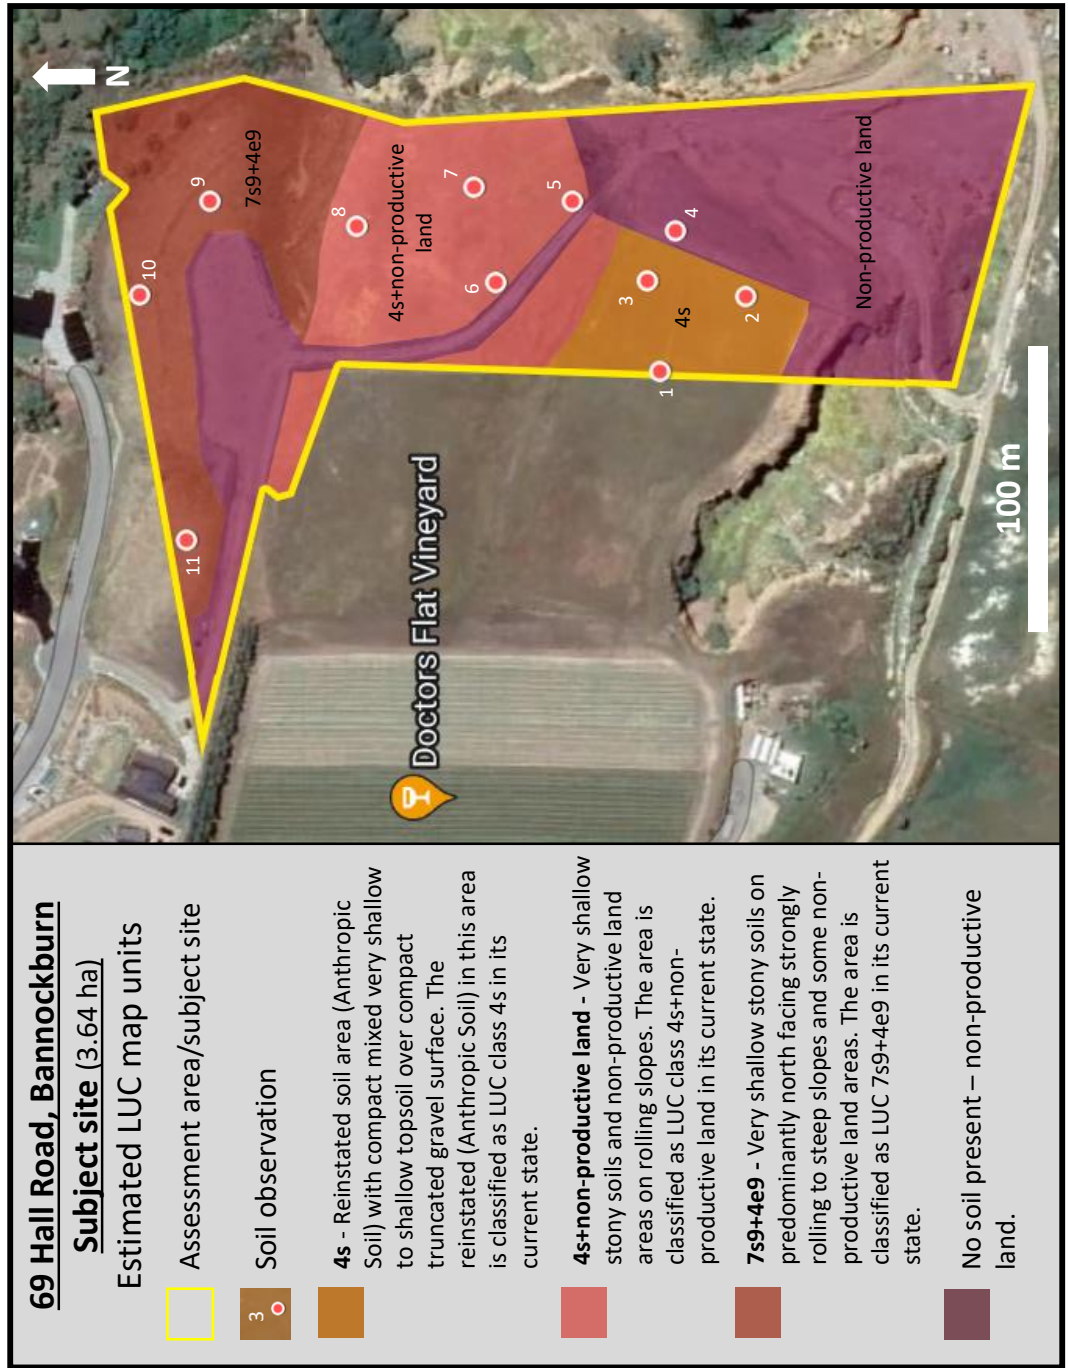
Appendix 8: Revised LUC classification map.

- 67 Based on the on-site soil observations in combination with historic images showing soil modification across the Site and the slope measurements, a revised map of LUC units for the Site in its current state is provided (Appendix 8).

- 68 The map shows the distribution of three LUC map units identified for the Site, the balance of the site is considered non-productive land.
- 69 In the revised map provided, the area covering the NZLRI LUC 7s9+4e9 unit is classified as LUC 7s9+4e9 on the strongly rolling to steep slopes and LUC class 4s+non-productive land on the rolling slopes. This map unit extends slightly south of the NZLRI LUC 7s9+4e9 area.

- 70 The NZLRI LUC 3s6+4e9 area in the north of the Site (excluding the non-productive land area is classified as LUC 7s9+4e9 on the strongly rolling to steep slopes.
- 71 The remediated soil area within the NZLRI LUC 3s6+4e9 unit is classified as LUC class 4s.
