**Pearson Road, Cromwell  
Preliminary Site  
Investigation**

**River Terrace  
Developments Ltd**

*September 2017*

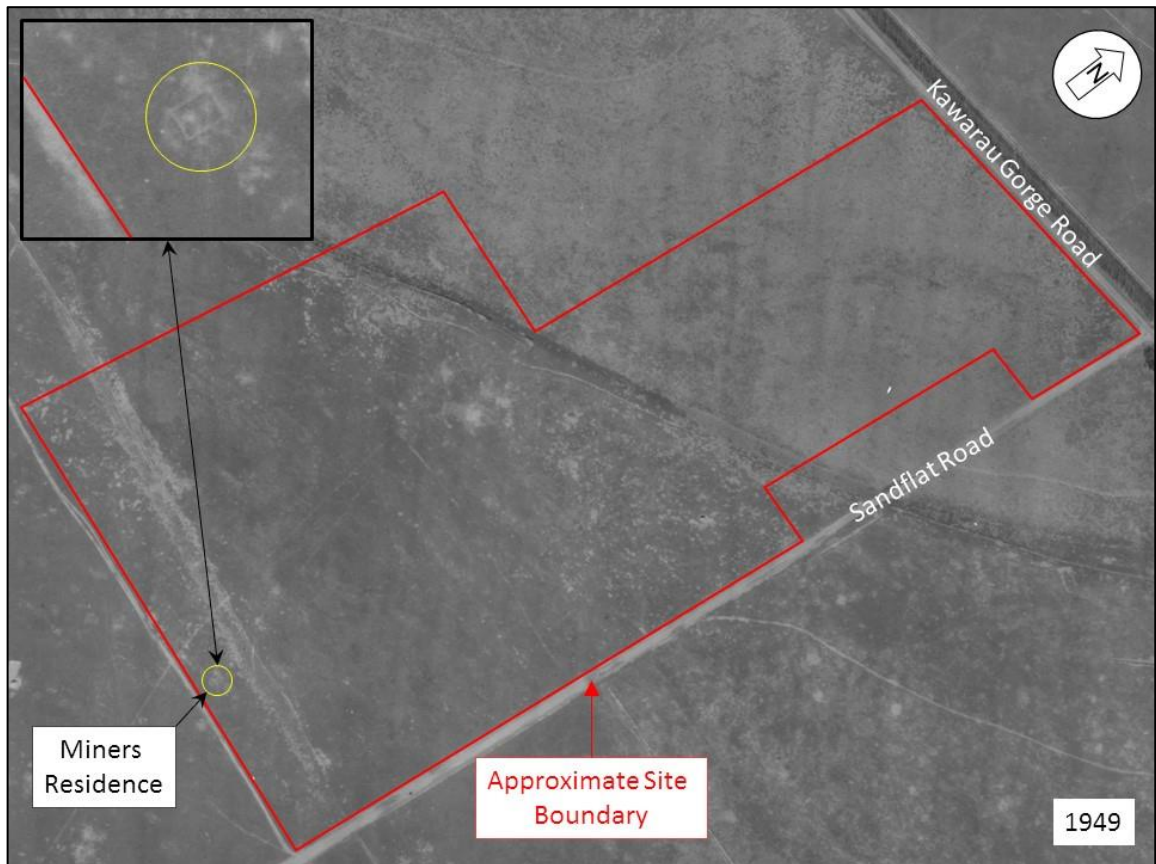
**Plate 1: 1949 Historic Aerial**

1949- The site appears to be covered in pasture and the only visible feature is the miners residence foundation. The neighbouring orchard was not established at this time.

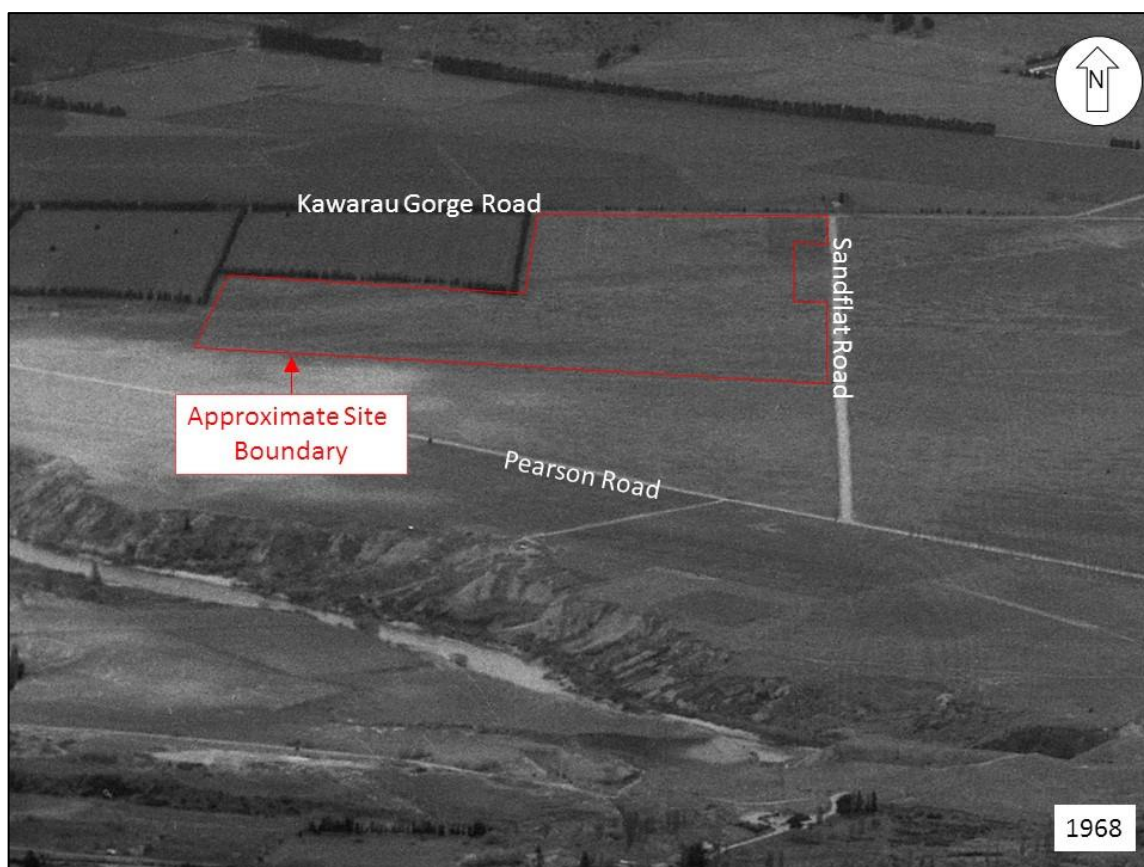
**Plate 2: 1968 Historic Aerial**

1968- The site appears to be vacant or in an extensive pastoral farming landuse. The neighbouring orchard to the west has been established and shelter belt trees have been planted.

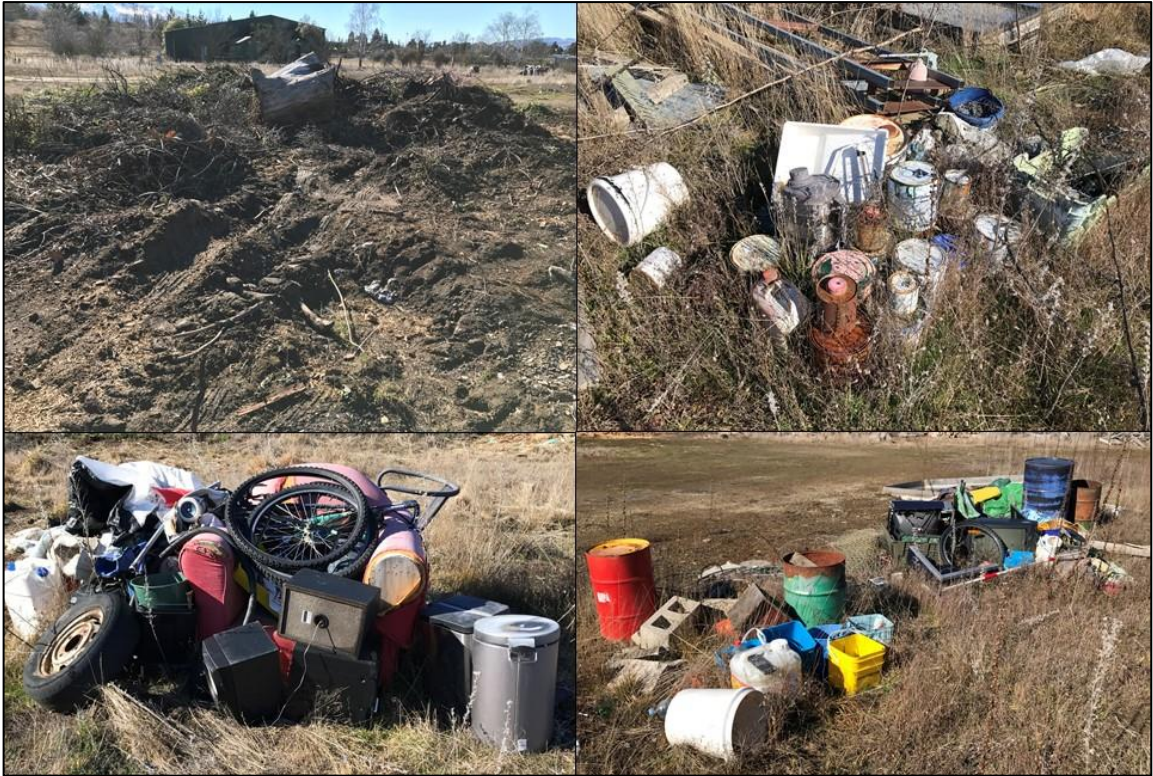
**Plate 3: Contents found on firewood yard 1 and burning pile**

wire, plastic netting, sheet plastic, cloth, electrical cord, empty aerosol cans, old furniture, stereo speakers, vehicle tyres and plastic buckets. The yard included stacks of wood awaiting processing and a burning pile which mostly contained organics however there was evidence of non-organic material being burnt and present was a slight burnt plastic odour.

A warning sign was attached to the entrance of the site stating that the poison Pindone will be present on the site from 11/06/2017. The MSDS for Pindone describes the persistence and degradability as 'the product is biologically degradable and will not accumulate in soil or water' and as being 'soluble in water'. The Pindone MSDS can be viewed in Appendix D. Photos of the yard are provided in Plate 3.

The firewood yards have potential to impact the sites soils through the storage of waste (namely areas of burning waste material and the storage of paint tins and household waste). Contaminants associated with this activity include a range of heavy metals and organic contaminants such as petroleum hydrocarbons and are likely to be detected as hotspots across the yards.

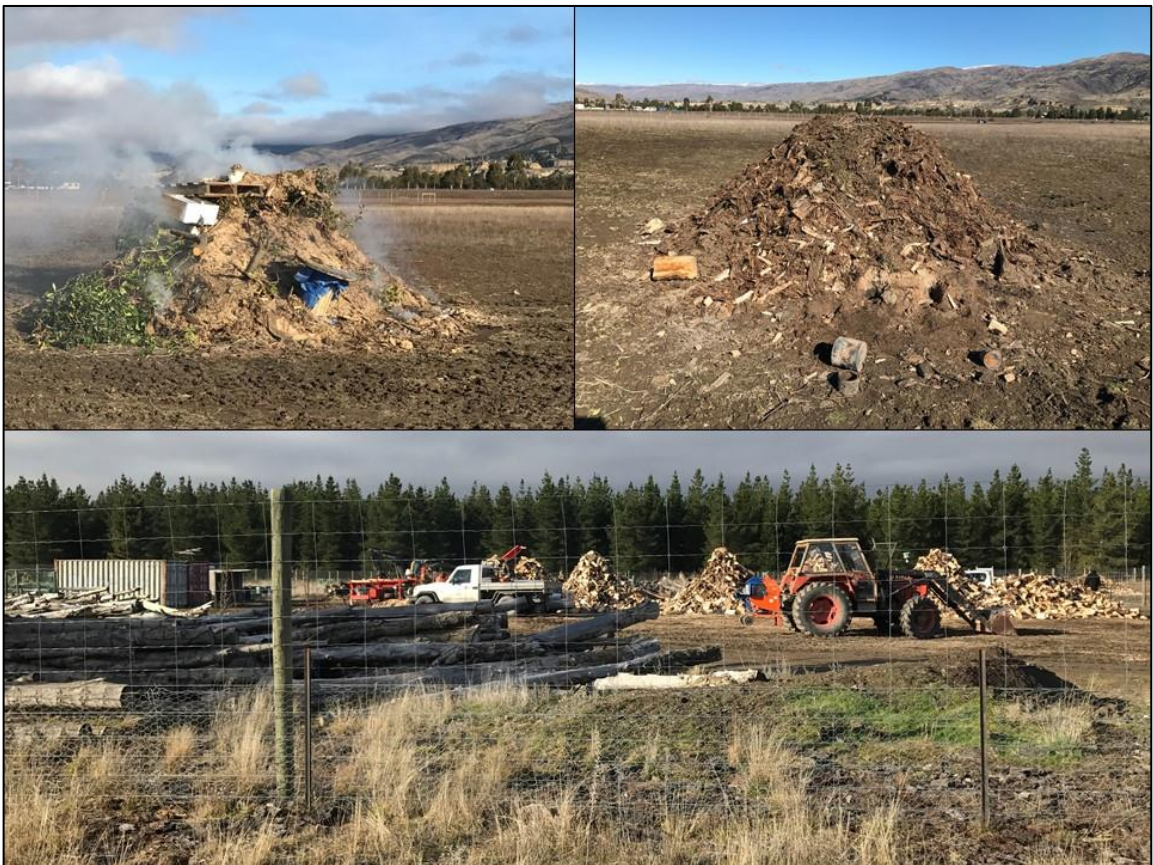
**Plate 4: Firewood Yard 2 and burning pile**

Firewood yard 2 included the storage of empty 50 gallon drums, cut firewood and wood to be processed, a tractor, an excavator, a shipping container and a chicken coop. A burning pile located 20 metres west of the yard included organic waste, wooden pellets, a wooden cable drum with plastic and tin paint cans. A site walkover of the operation was completed, and no visible contamination was found. The lease holder informed e3s staff that he tries to minimise the amount of fuel he has on site at one time and typically only has enough to keep his small digger operating. The lease holder has been operating on this site for approximately 9 years. Photos of the yard are provided in Plate 4.

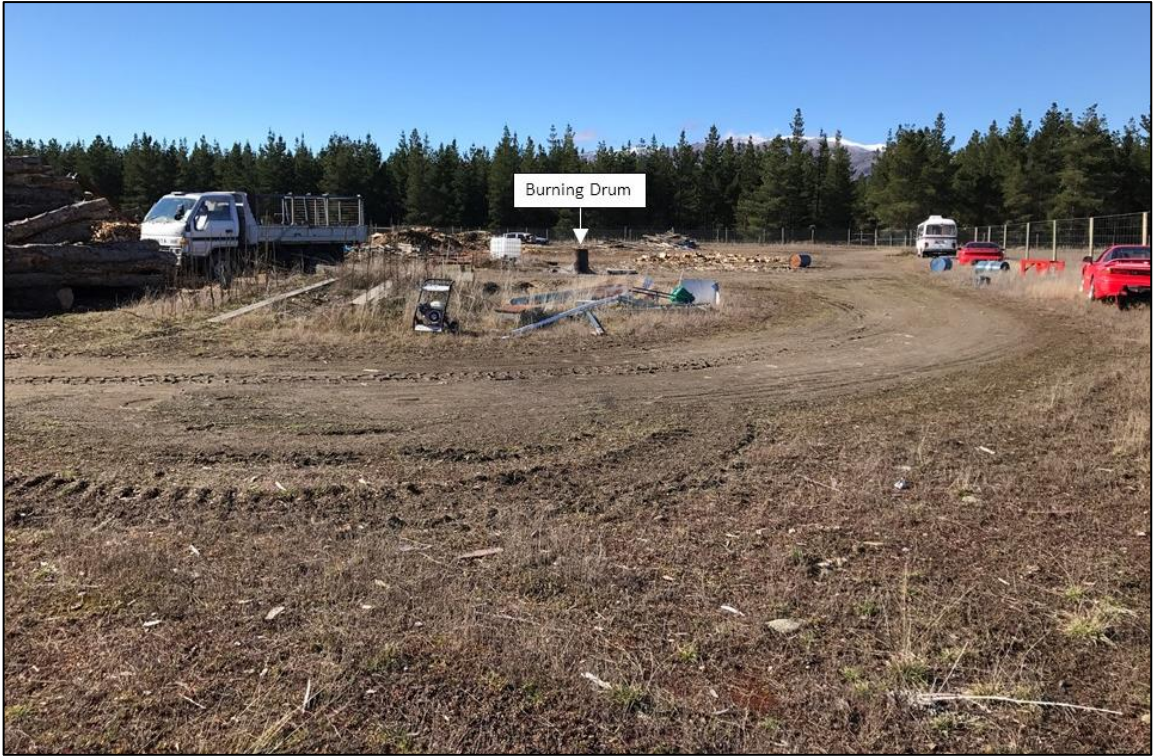
**Plate 5: Firewood Yard 3**

Firewood yard 3 includes mostly wood awaiting processing and some scrap metal (including empty 50-gallon drums). A camper bus and two cars were also present at the time of the site inspection. The yard also includes a drum for burning material. A photo of the yard is provided in Plate 5.

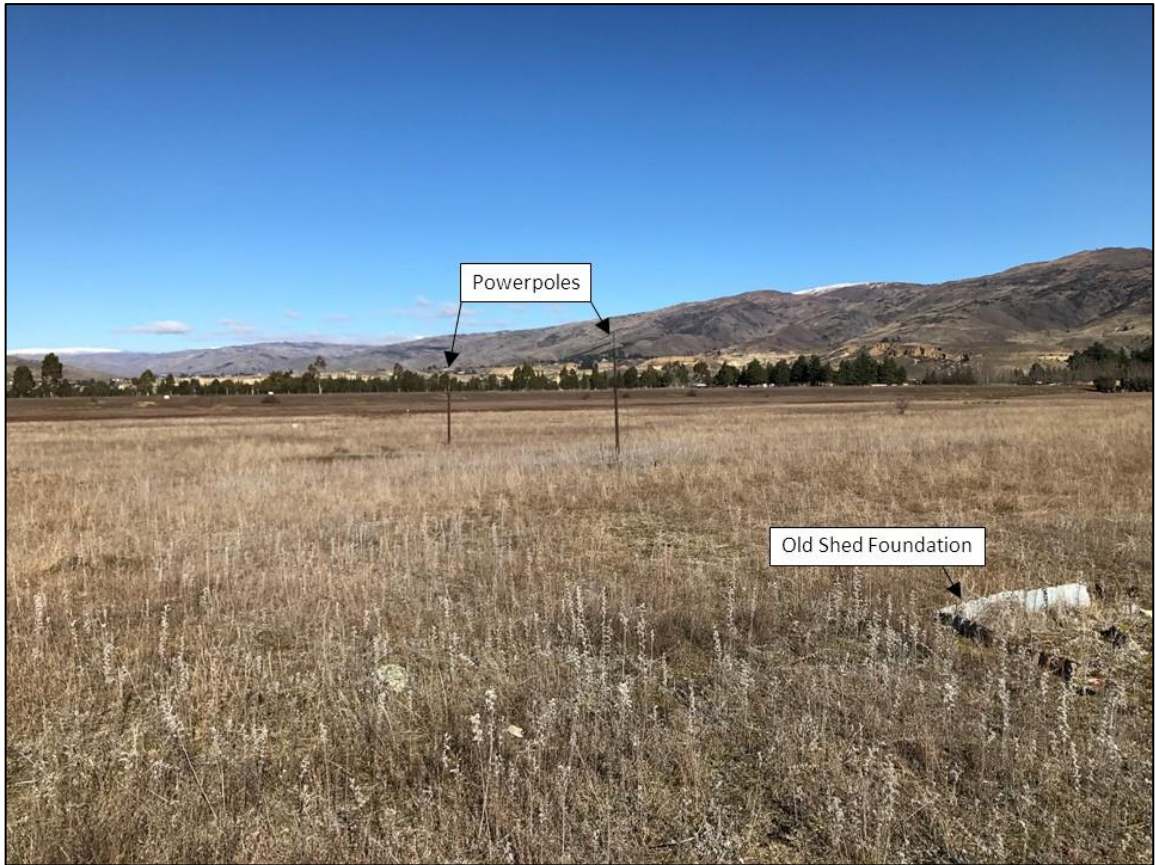
**Plate 7: Old shed foundation and possible Powerline**

The foundations of a historic dairy shed and what appears to be an old storage shed, possibly an old pump shed, are found to the south of the centre of the site. The dairy shed consists of a concrete pad with a drain for effluent. The adjacent shed includes a concrete foundation and remnants of corrugated iron. In between the two features is some schist masonry. Just south of the foundations were two poles which appear to have a wire attached to them suggesting it was once a powerline (see Plate 7).

Soils adjacent to other historical buildings on the site were also found to contain elevated heavy metal levels but at much lower concentrations.

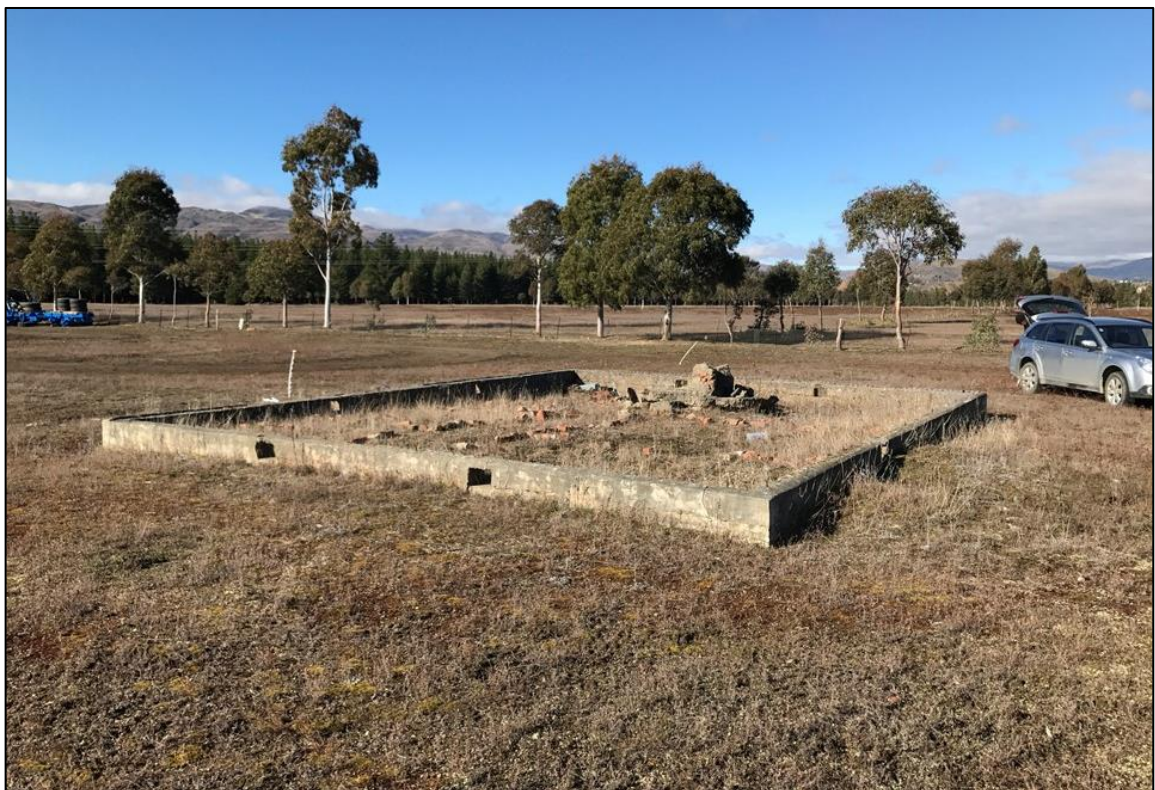
**Plate 8: Former miner's residence**

Next to the southern site boundary is the foundation of a former miner's residence which age is probably circa 1920. Houses of this time were often built using lead pipes and fittings as well as being painted with lead paint. The foundation is approximately 9 by 9 meters in size. See Plate 8 for a photo of the foundation.

- Firewood yards including burning piles for heavy metal and hydrocarbon concentrations; and,
- Historic Building sites for heavy metal concentrations, namely lead and zinc.

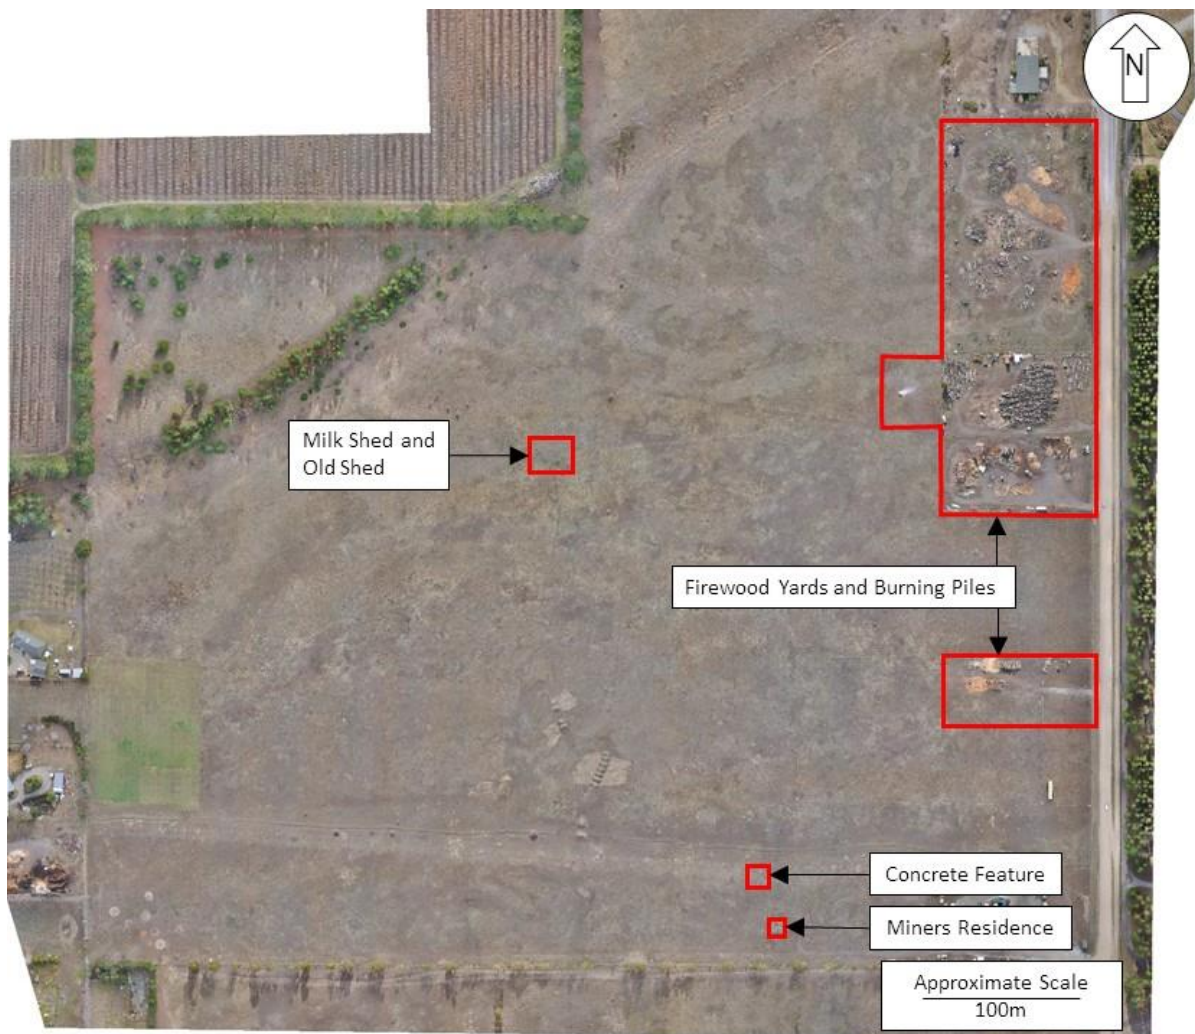
**Figure 3: Areas Requiring a Detailed Site Investigation**

Figure 3 presents the above locations on the site.
