# SANDFLAT ROAD, CROMWELL

Archaeological Assessment  
February 2018

# Archaeological Assessment for Sandflat Road, Cromwell

Archaeological Sites: F41/808, F41/809

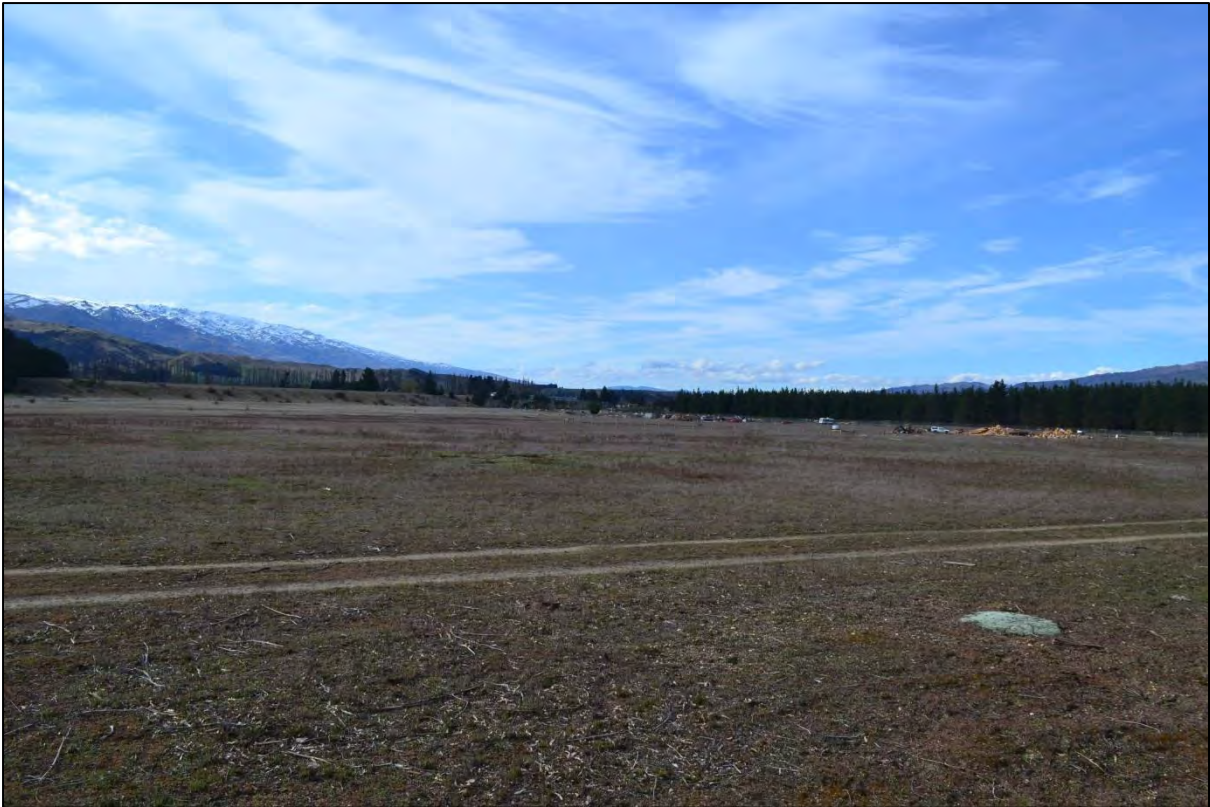
The site is defined by a low covering of pasture grass stretching over most of the site, which is ringed by a fence (Figure 6). There are two natural terraces, the higher one forming the northern part of the site, and it slopes down to the lower terrace which comprises the rest. A site walkover was undertaken from south to north, and any visible features were noted and their location recorded with a GPS (Figure 5). The features appear to be a mix of different ages and forms, mostly dating from the late 19<sup>th</sup> to the early 20<sup>th</sup> century.

*Figure 6. View looking north over the site from the southern boundary.*

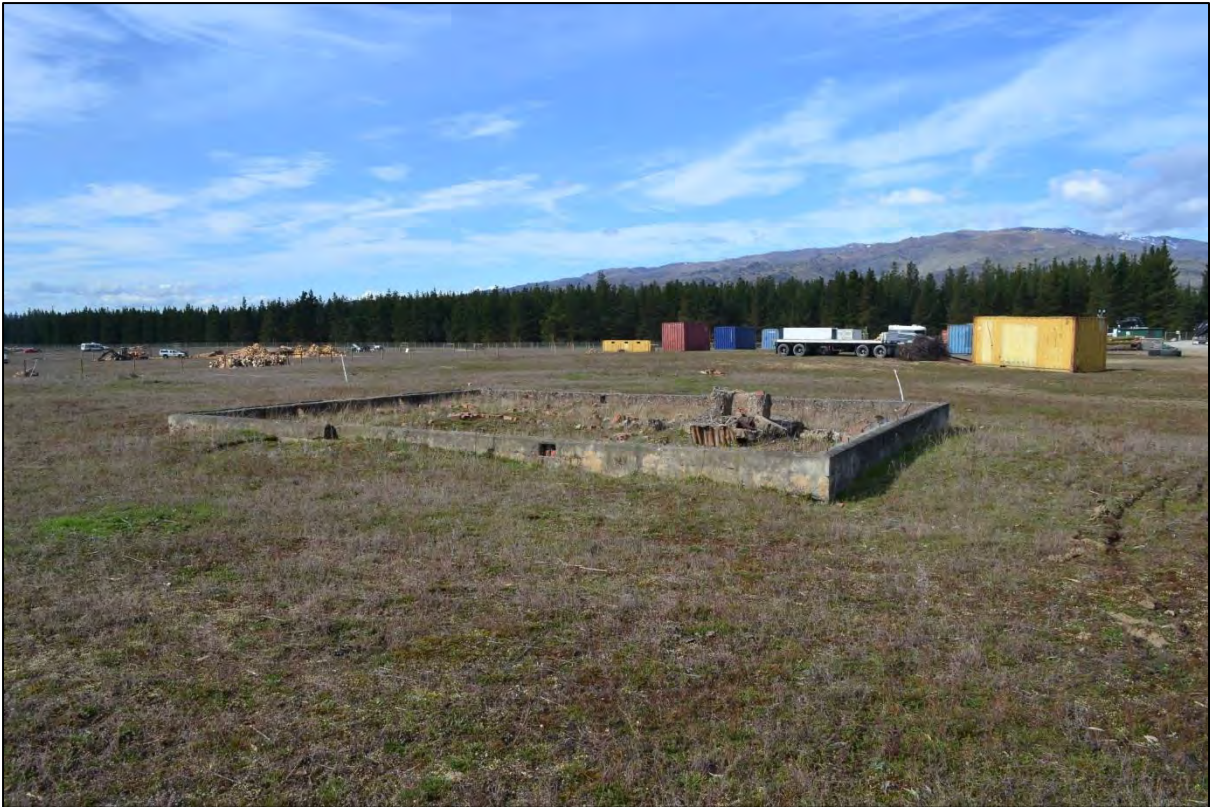
Near the southern boundary of the site are the remains of a concrete foundation for a small building (Figure 7). This appears to have originally been a house clad with corrugate iron, and likely timber framed (Figure 8). Everything except the foundation and remains of the subfloor and chimney appear to have been removed off site. The internal wall divisions of the building are indicated by the placement of brick, which presumably supported a timber floor (Figure 9). This theory is reinforced by the presence of holes in the cement foundation which would have originally contained ventilation grills. The age of this building is uncertain, as there is no clear artefactual evidence indicating its use. However, the concrete foundation and presence of well-fired brick suggests this building was constructed sometime in the first half of the 20<sup>th</sup> century.

*Figure 7. Concrete house foundation located near the southern boundary (see Figure 5).*

- Due to the uncertain nature of the possible house site and linear stone feature, test pitting should be undertaken by an archaeologist in an attempt to determine if these features have archaeological values. A small amount of test pitting may provide sufficient information to determine if they are archaeological sites. In the event that they are found to be archaeological features and will be damaged or destroyed by proposed works, this will require an archaeological authority. A condition of any such

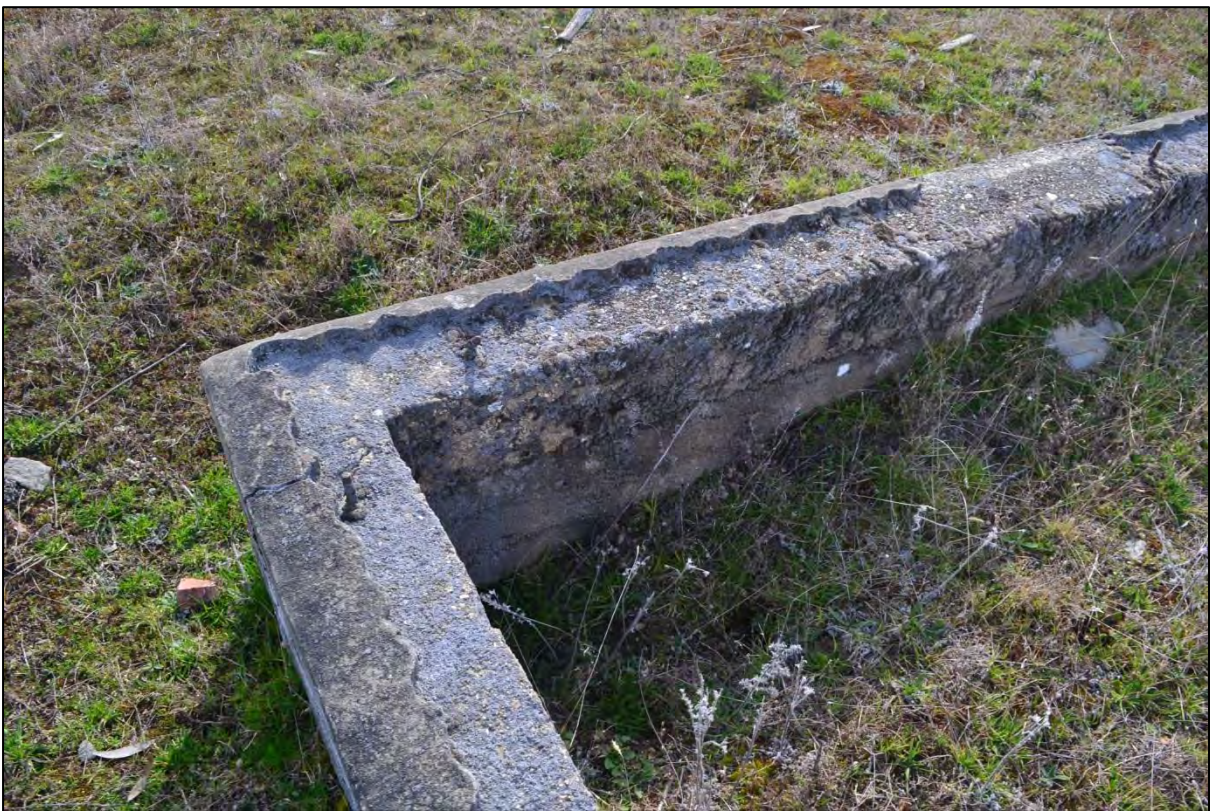
*Figure 8. Detailing of concrete house foundation showing steel bolts and remains of cast plaster on exterior edge, indications the original cladding was corrugate iron.*

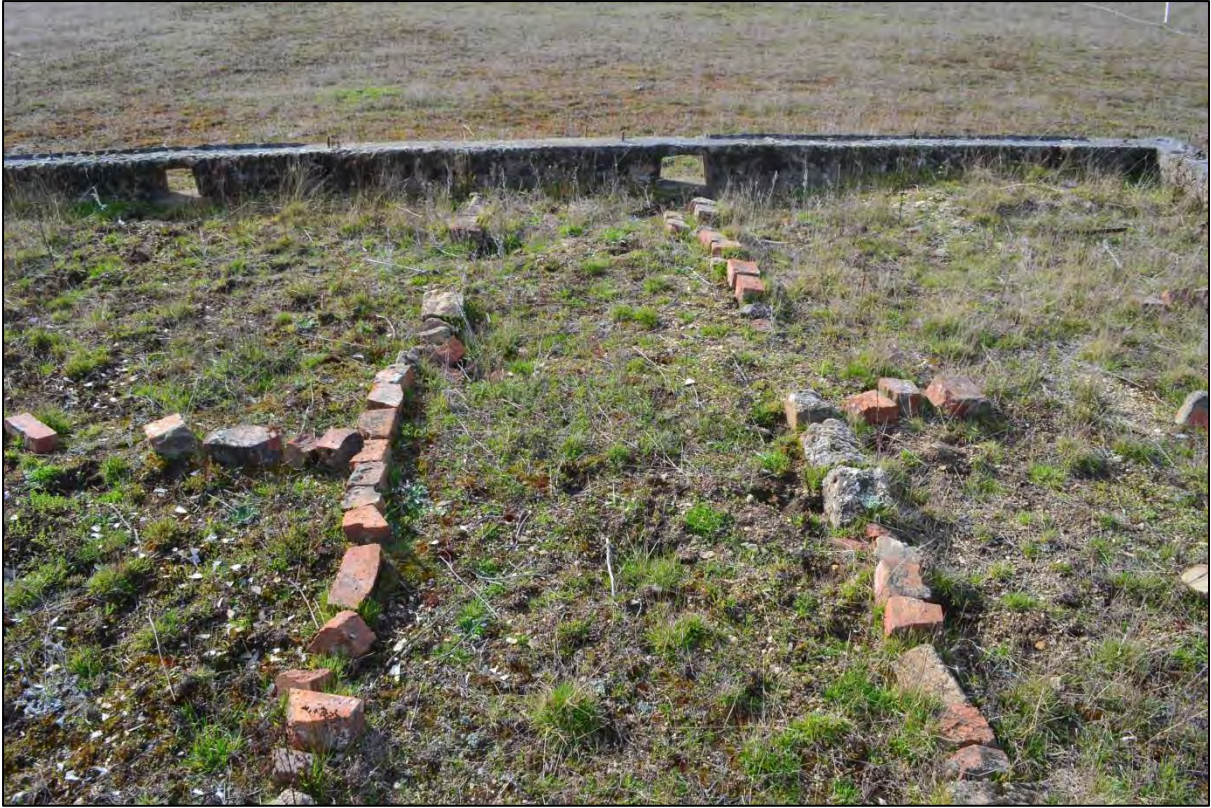
*Figure 9. Remains of house sub-floor showing the use of brick to presumably support a suspended timber floor.*

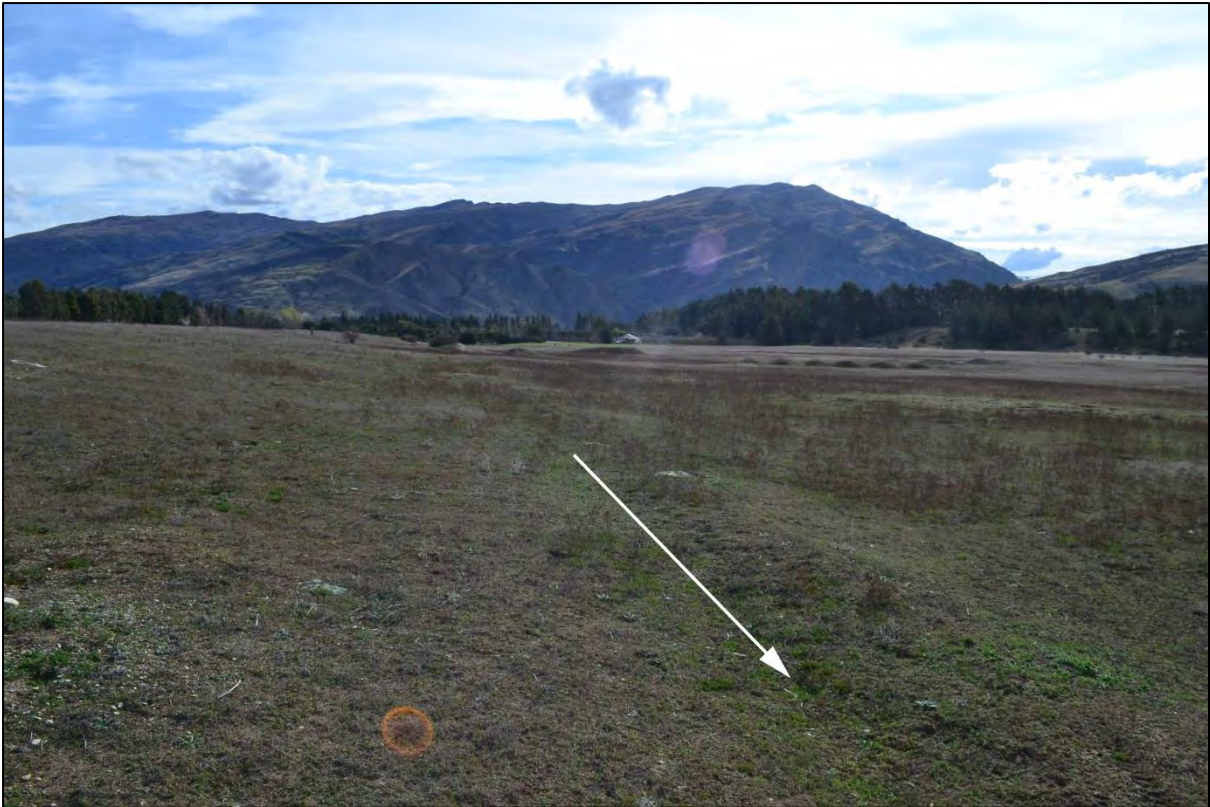
Immediately to the north of the concrete foundation is a visible water race running approximately east-west across the site (Figure 10). This race runs along the base of a small slope, and is clearly visible. It has been partly infilled over time by natural soil accumulation.

*Figure 10. Remains of southern water race.*

- Consideration should be given to preserving the water races during the development of the site. Races in other parts of the region have been retained as landscape features, and are a naturally suitable place to put plants as they catch additional moisture.

- Any works that will modify or destroy part of either water race will require an archaeological authority under Section 44 of the Heritage New Zealand Pouhere Taonga Act (2014). Water races provide only minimal information through excavation. In the event that the races will be damaged or destroyed, sections should be excavated by the archaeologist in select places to provide a topographical record of the races. This information should be added to the site record form held on ArchSite.

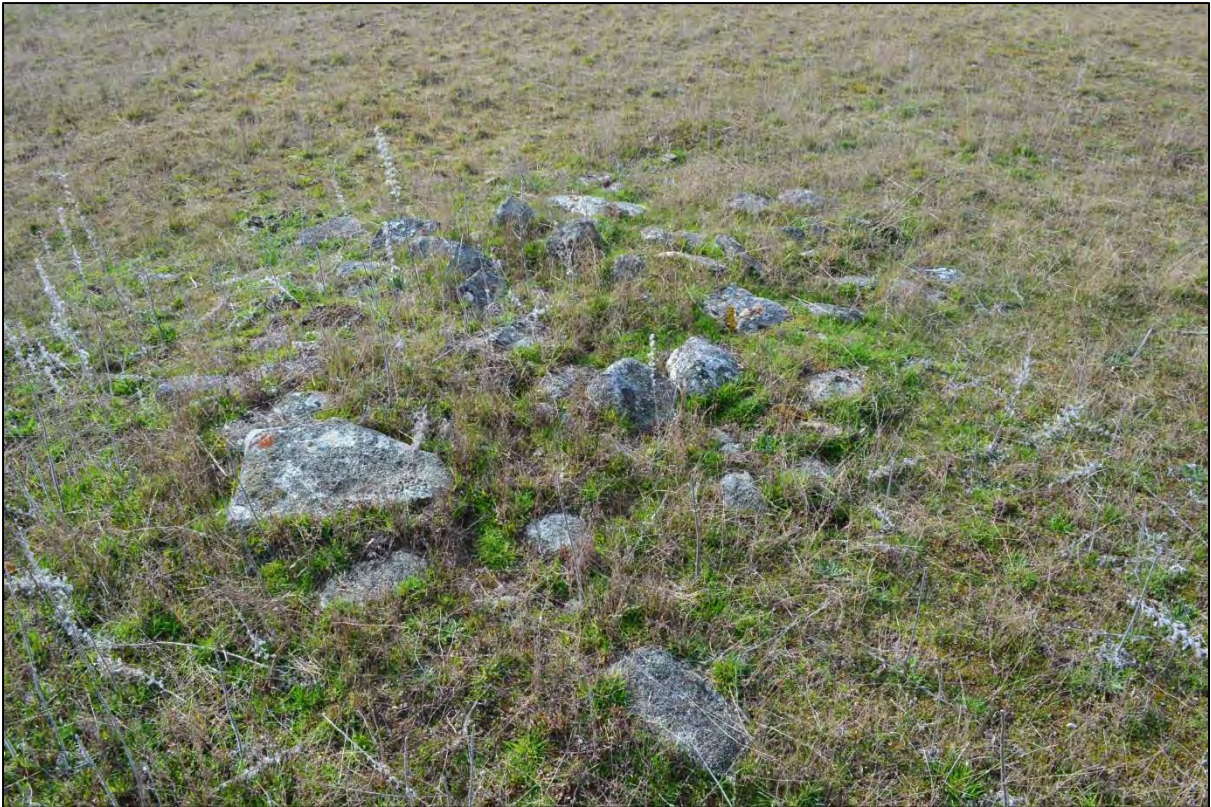
In the approximate centre of the site are a collection of features. The first one is a pile of stones with no clear delineation (Figure 11). They may have been stacked originally to prevent them being hit during ploughing. However, they are in close proximity to two other features, adding the possibility they originally had some defined purpose. To the north of this pile is a concrete pad and drain (Figure 12). The current owner of the property believes this was originally used to milk cows, with the drain allowing the concrete pad to be cleaned. Its date of construction is uncertain. Immediately to the north of this concrete are the remains of what appears to be another house site (Figure 13-Figure 14). This feature includes a pile of stacked stone, which may have been a chimney, and pieces of corrugated iron used as cladding. Examination of the area revealed glass and iron artefacts. The glass was identified as part of a ring seal bottle, which is commonly found on sites in Central Otago with occupation dating from the 1880s through into the early 20<sup>th</sup> century. It is possible that this area originally contained a small residence site built in the late 19<sup>th</sup> or early 20<sup>th</sup> century.

*Figure 11. Stone pile located towards the centre of the site.*

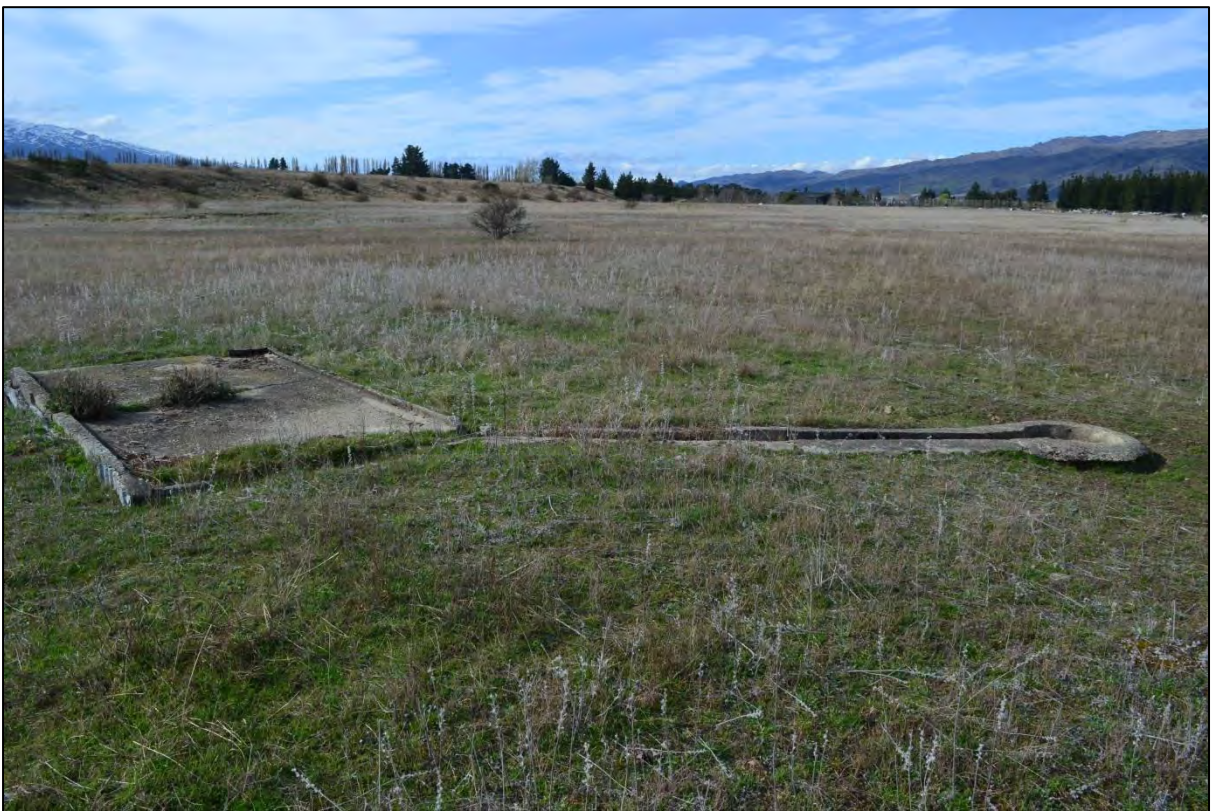
*Figure 12. Concrete pad with associated drain.*

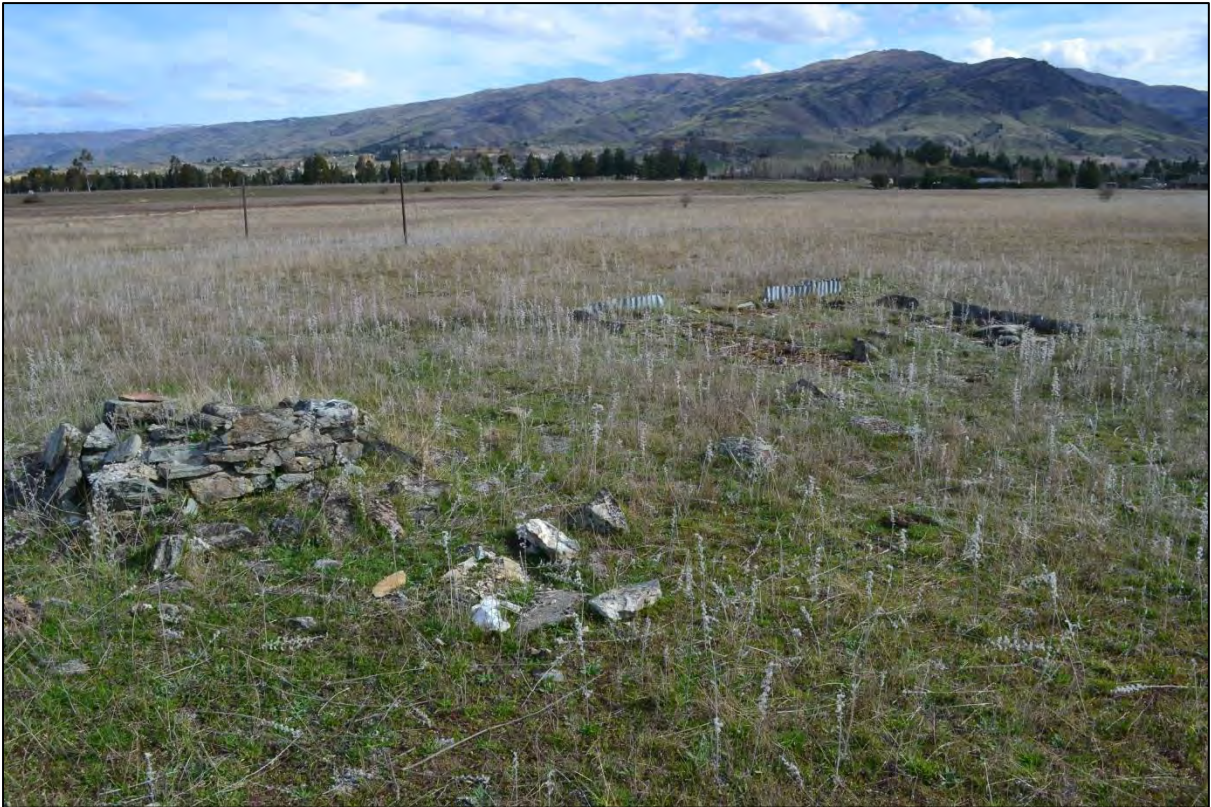
Figure 13. Remains of what appears to be a house site. Stacked stone on left is indicative of the remains of a chimney.

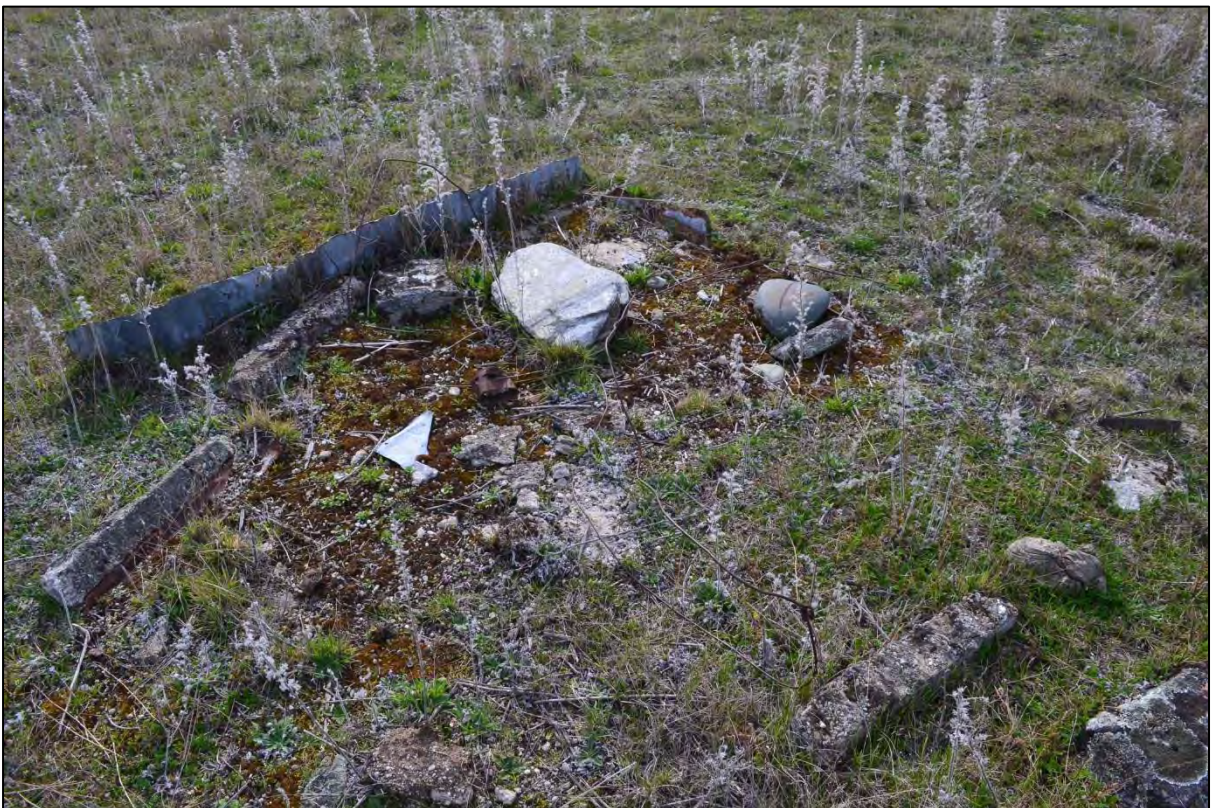
Figure 14. Concrete and corrugated iron remains in association with the stacked stone feature.

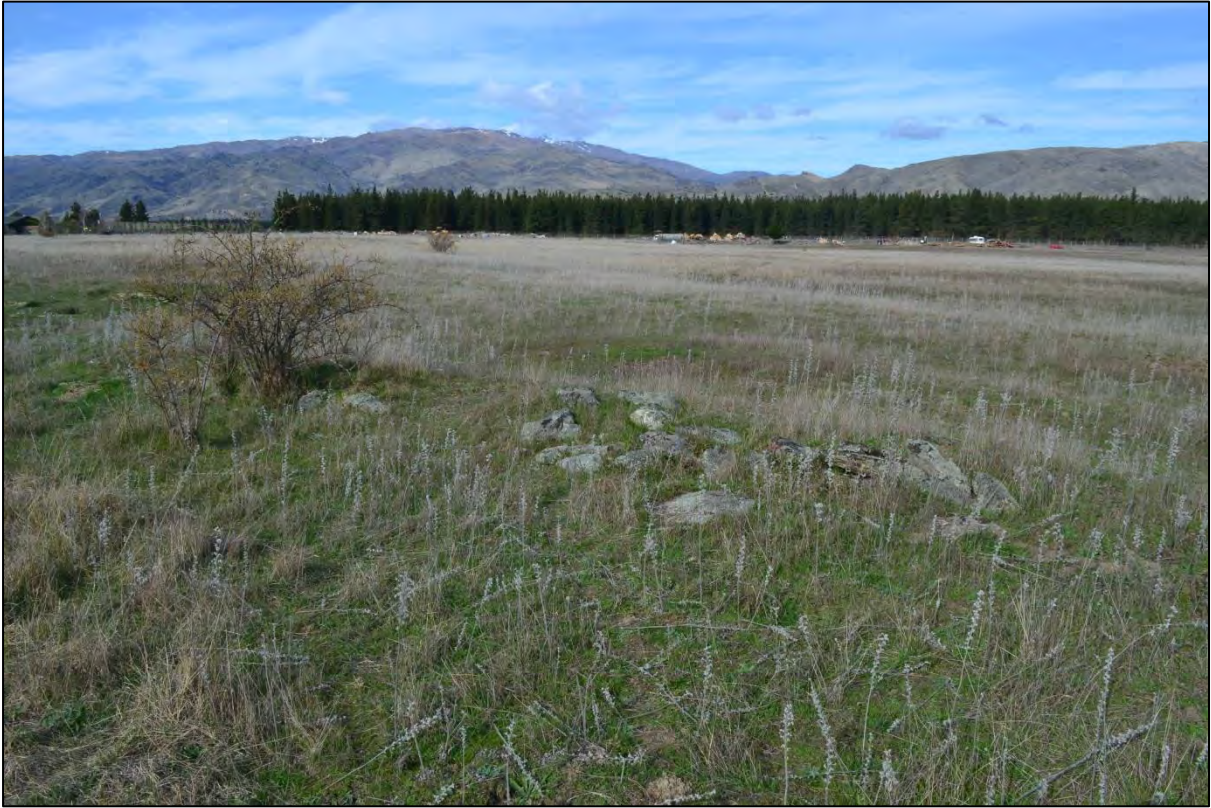
Further to the north, another collection of stones were identified on site, with these ones placed in a linear alignment (Figure 15-Figure 16). The purpose of this feature is unknown, but the line of stones suggests some form of building or raised platform may have been constructed in this part of the site. Its age of construction is uncertain.

*Figure 15. Raised Stone Feature, located towards northern edge of terrace.*

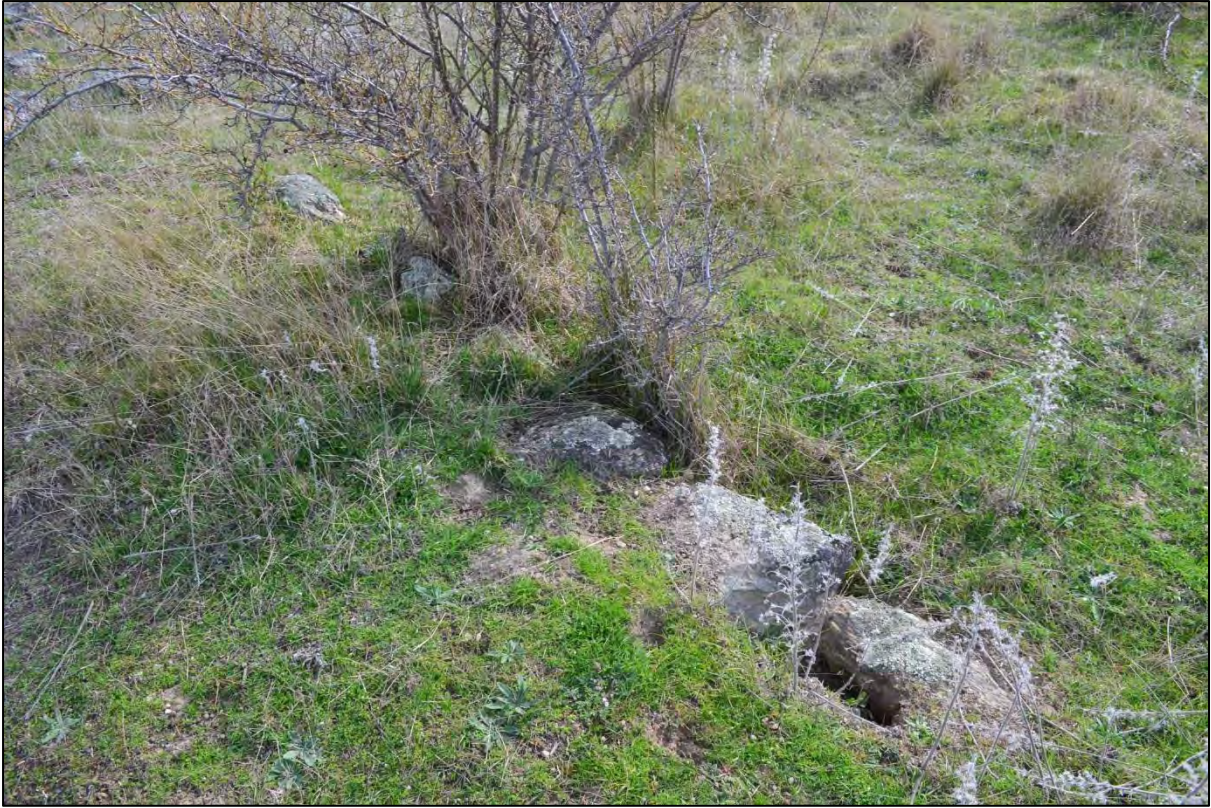
*Figure 16. Detail of linear stone, part of the Stone Feature.*

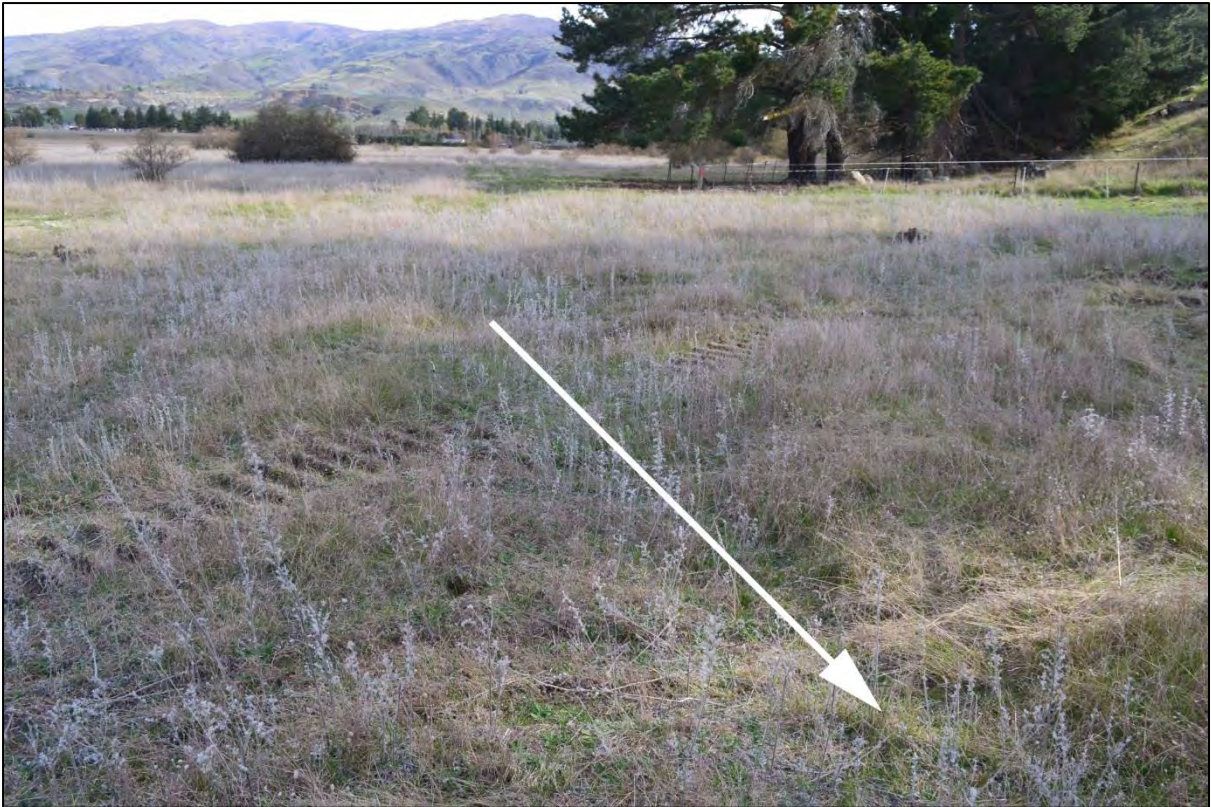
Running southwest-northeast across the centre of the site is the remains of the northern water race (Figure 17- Figure 18). This race is clearly visible on the ground, and follows the contour of the lower terrace slope. It is mostly intact across the site, with some minor disturbance near the property corner halfway along the feature. As with the southern race, it has been partly filled in by natural accumulation of soil.

Figure 17. Remains of northern water race following contoured edge of terrace.

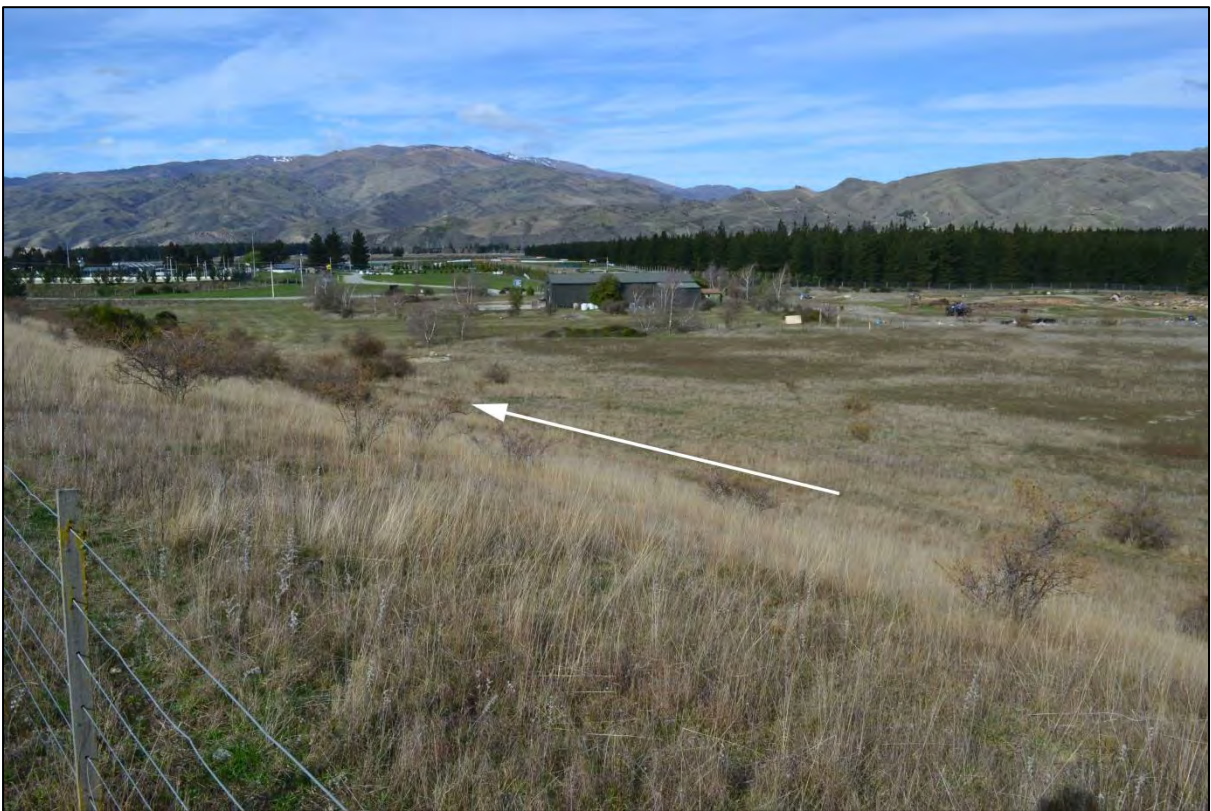
Figure 18. View looking southeast from edge of top terrace down towards lower terrace. The northern water race is shown with an arrow.

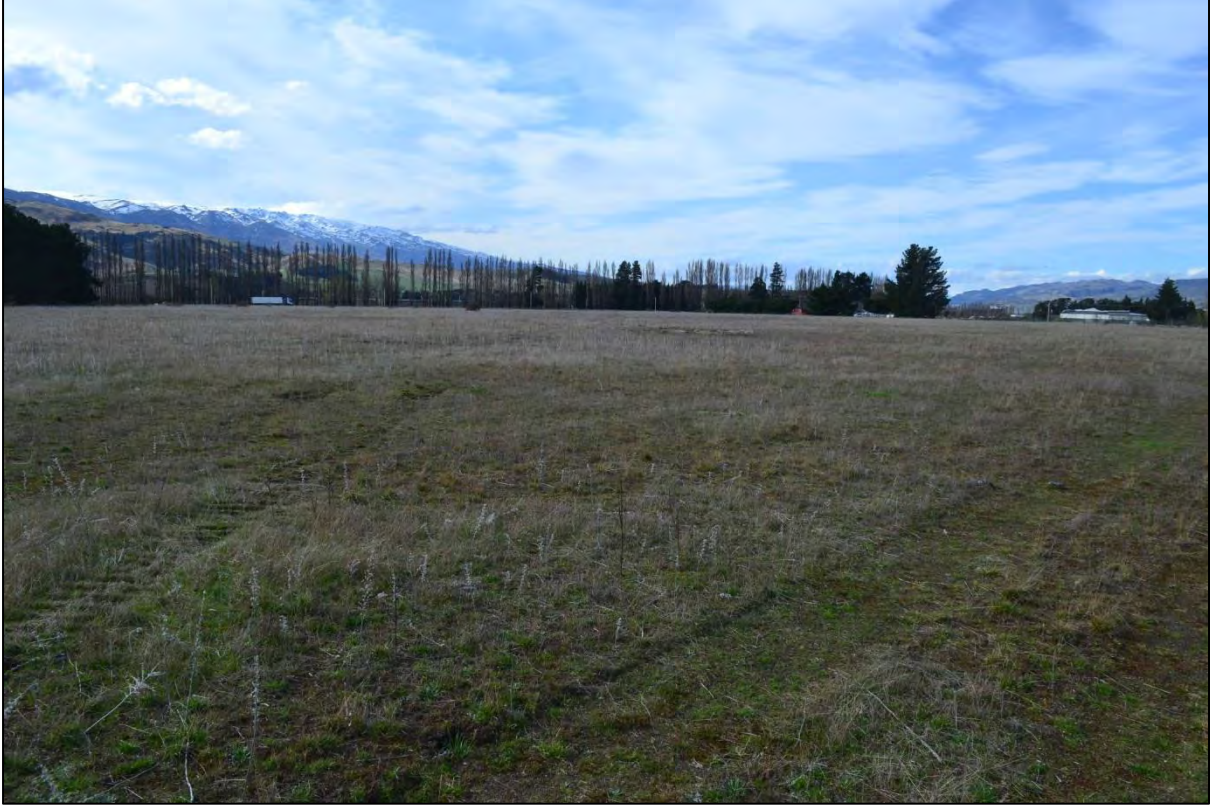
Above the water race, the northern corner of the site is defined as a part of a natural terrace, which is elevated above the rest of the site (Figure 19-Figure 20). This part of the site is very flat, and contains no visible surface features. Its eastern boundary borders a small area of modern development and the sites northern edge abuts the Kawarau Gorge Road.

*Figure 19. View along top terrace looking north towards the Kawarau Gorge Road.*

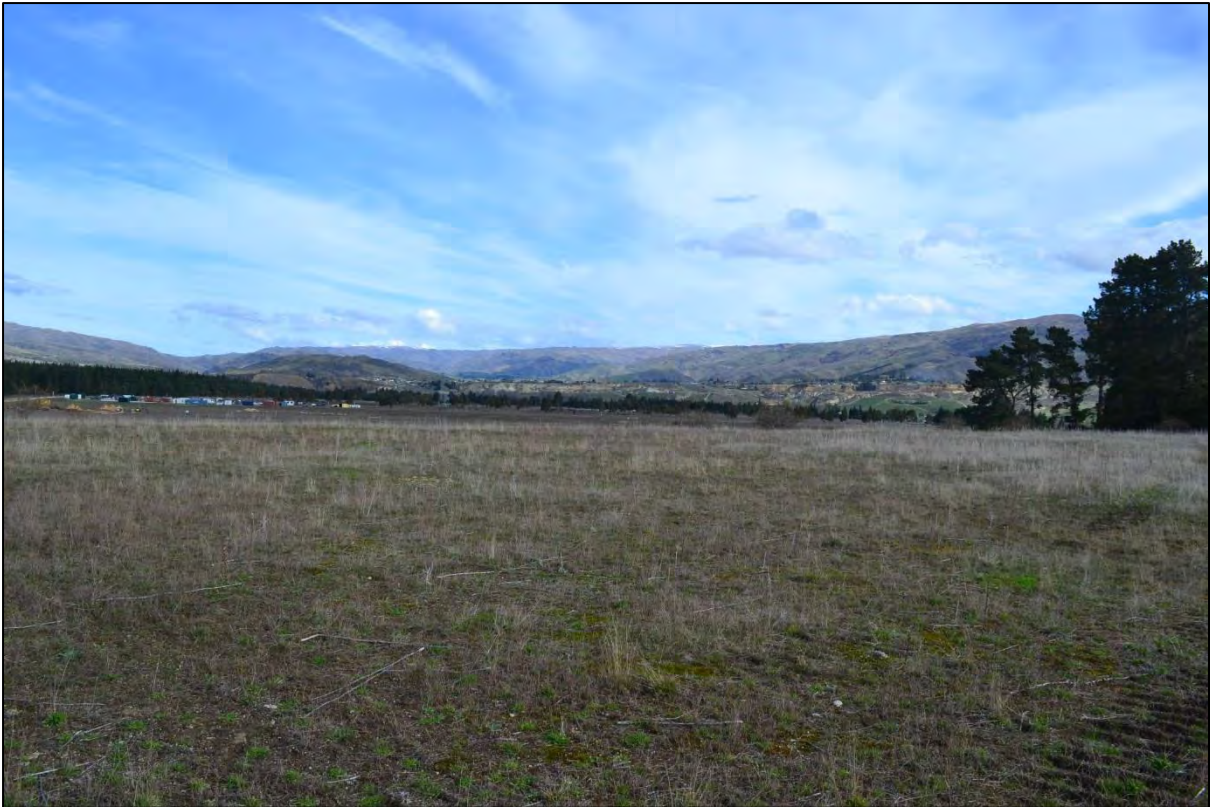
*Figure 20. View looking south along top terrace.*

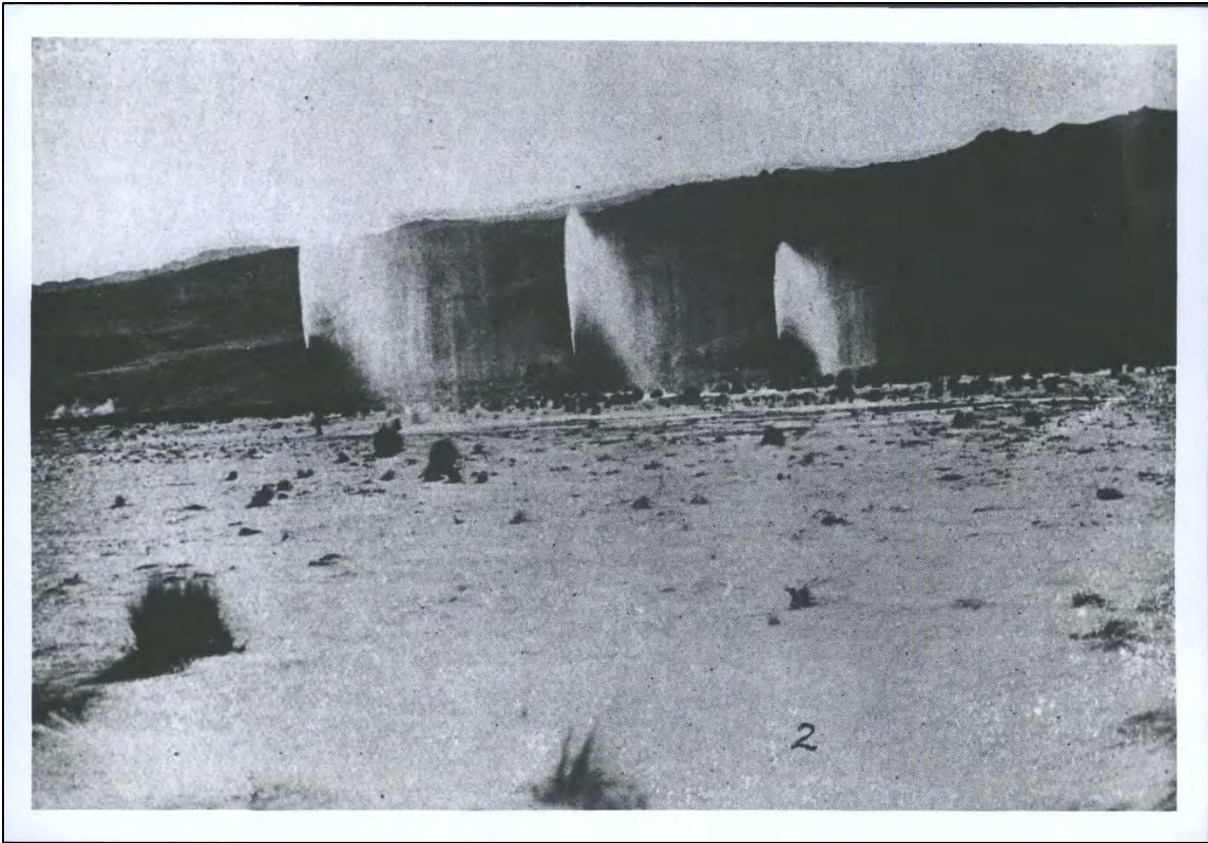
In 1883 Bennett sold his store and the rest of his holdings to James Horn (Cromwell Argus, 1883a). Horn was born in Inverkeithney, Banffshire, Scotland in 1855. He arrived in New Zealand in 1875, initially residing in Port Chalmers, and then moved on to Stirling. He shifted to the area in 1883 following the purchase from Bennett, and ran the business in partnership with Mr J. C. Anderson, before the partnership dissolved and he took full ownership. He was a well-known resident of Central Otago, and became the representative for the Wakatipu District in 1919. He was credited with the establishment of new irrigation schemes (Cromwell Argus, 1932). In the 1890s, there was a notable increase in water being provided to Cromwell Flat for irrigation purposes, presumably as alluvial mining became a less viable industry (Mataura Ensign, 1890)(Figure 23).

Figure 23. Historic photograph of irrigation on Cromwell Flat (Hocken Snapshot).

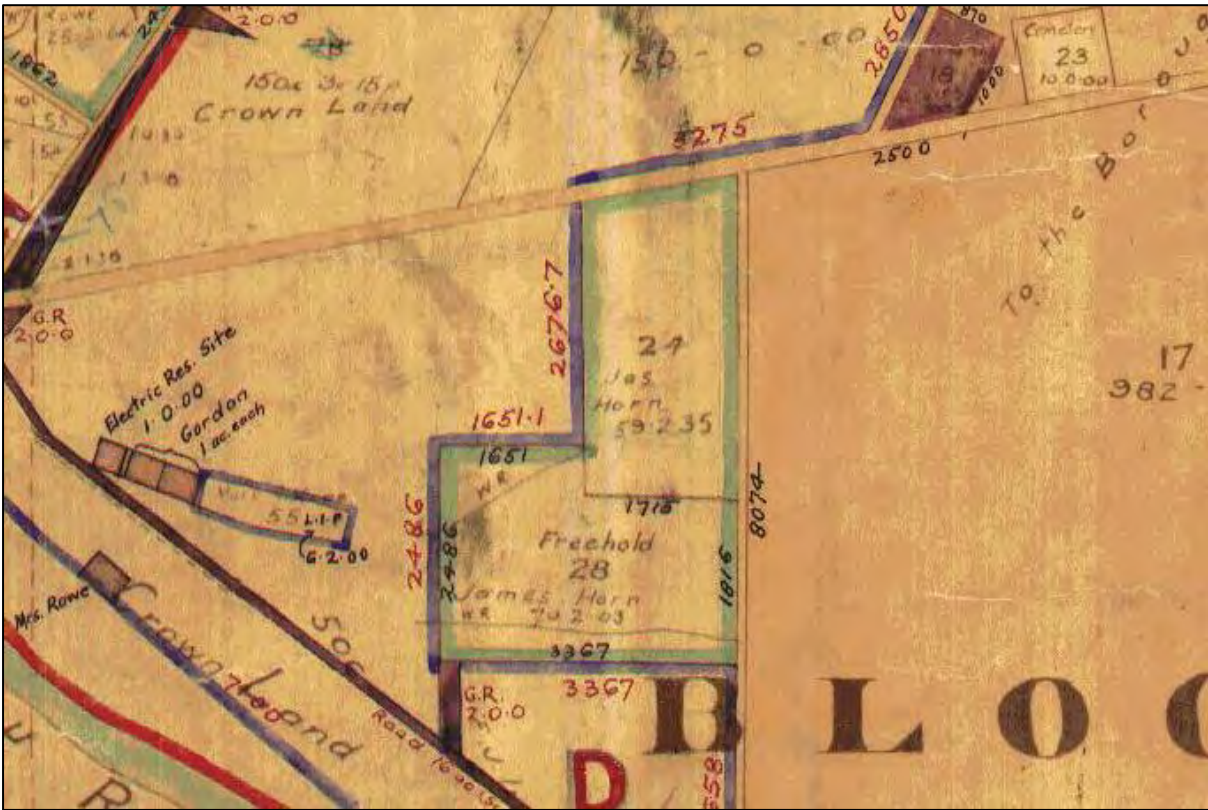
Another, larger, survey map (SO369) shows both sections as being held by James Horn in freehold. The date of this map is uncertain, but likely annotated in the early 20th century. The two water races are shown in pencil crossing the lower block. Horn purchased Section 24 in 1897 (OT125/196), and subsequently purchased Section 28 in 1907 (OT160/271). Both titles clearly show the water races running across the sections. In 1916, the newspaper refers to Horn relocating a residence from Bannockburn to Cromwell Flat (Otago Witness, 1916). This was likely undertaken because Horn now owned the land rather than leasing it.

Figure 24. SO 369 showing the two sections owned by James Horn in the early 20<sup>th</sup> century (QuickMaps).

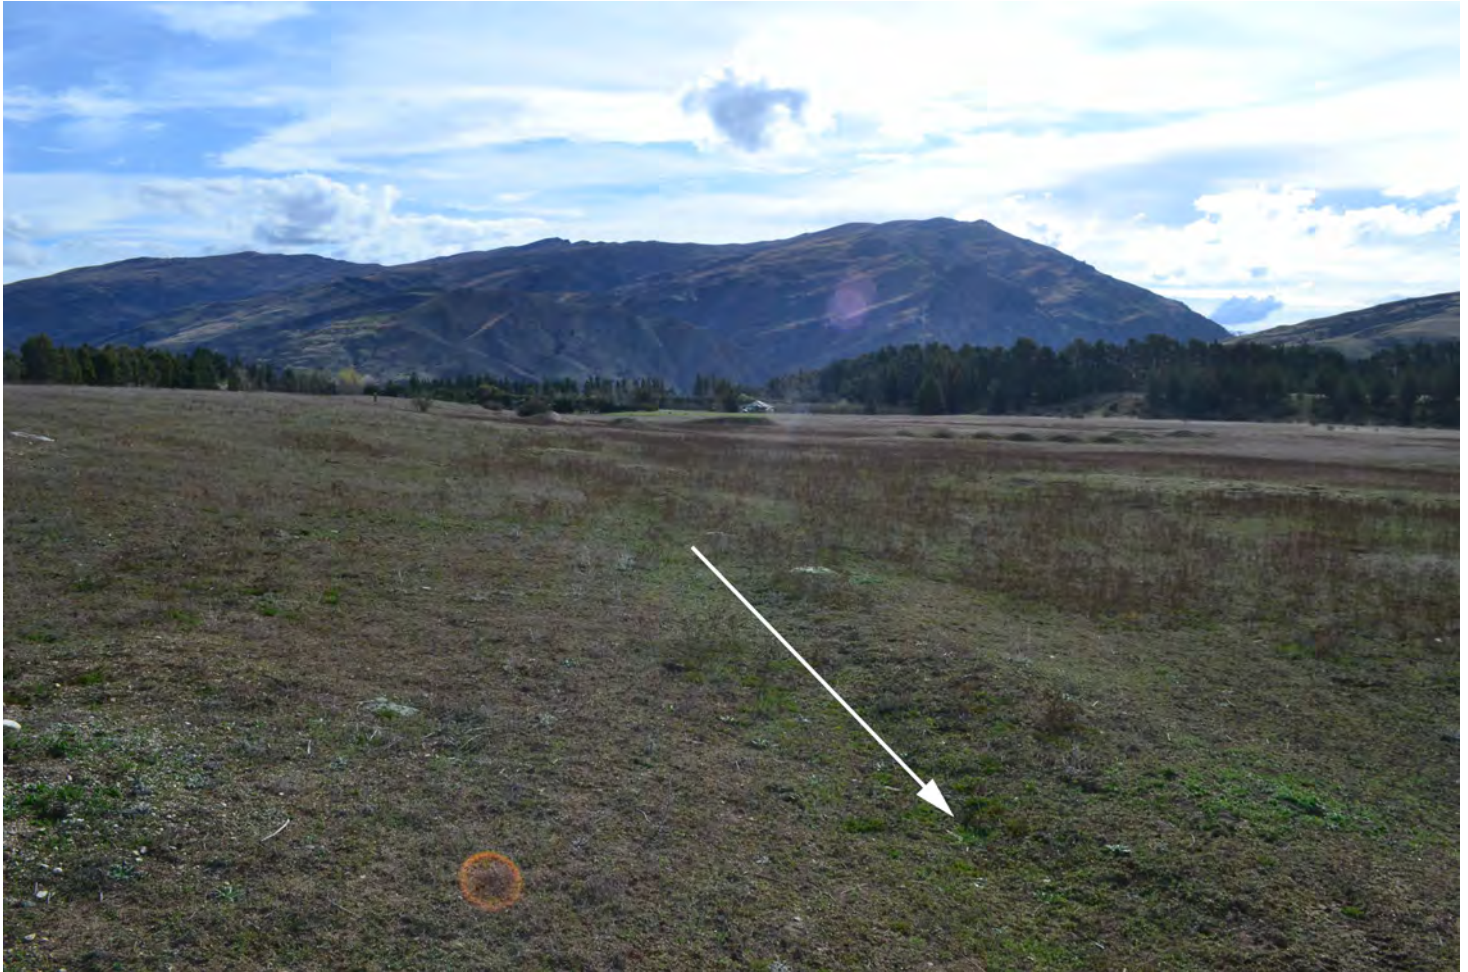
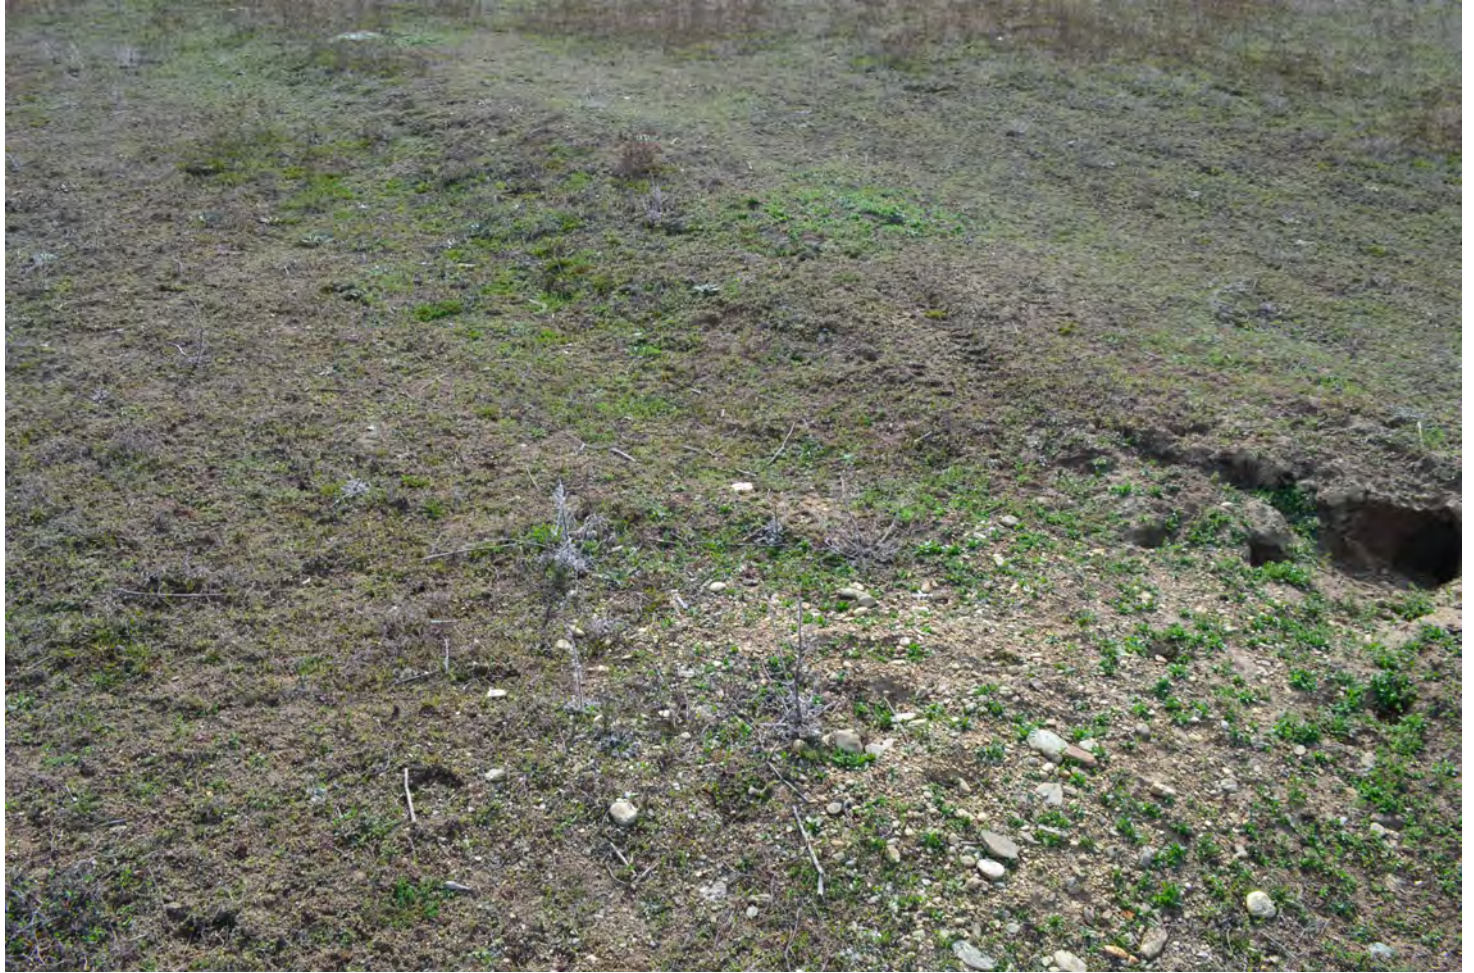
View of race looking west. Teele, B. 22/09/2017
