# SANDFLAT ROAD, CROMWELL

Archaeological Assessment  
February 2018

# Archaeological Assessment for Sandflat Road, Cromwell

Archaeological Sites: F41/808, F41/809

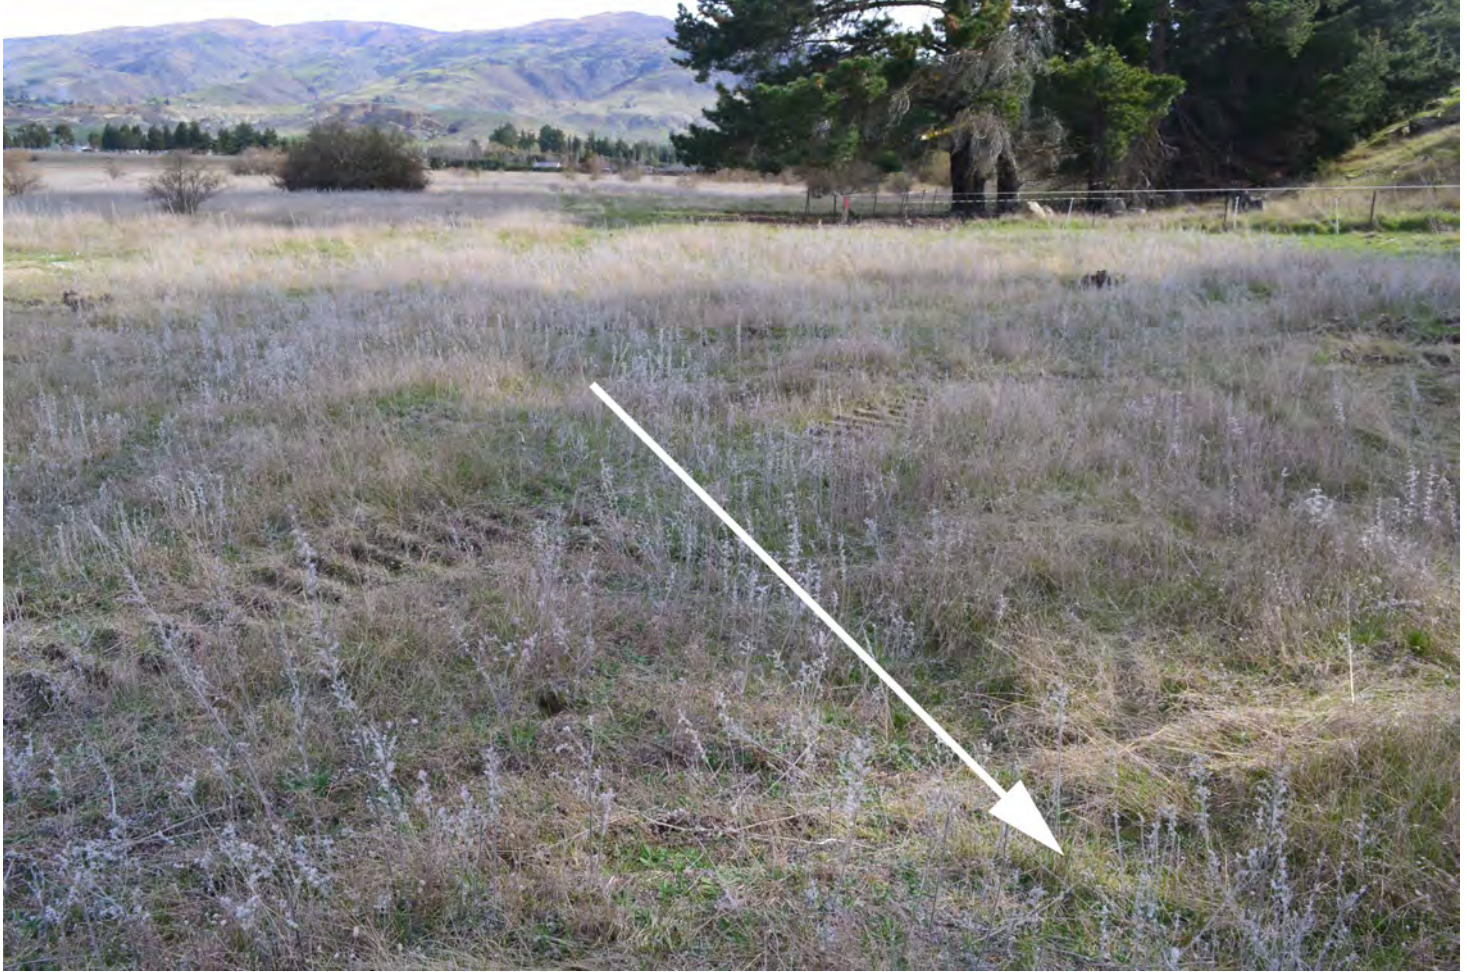
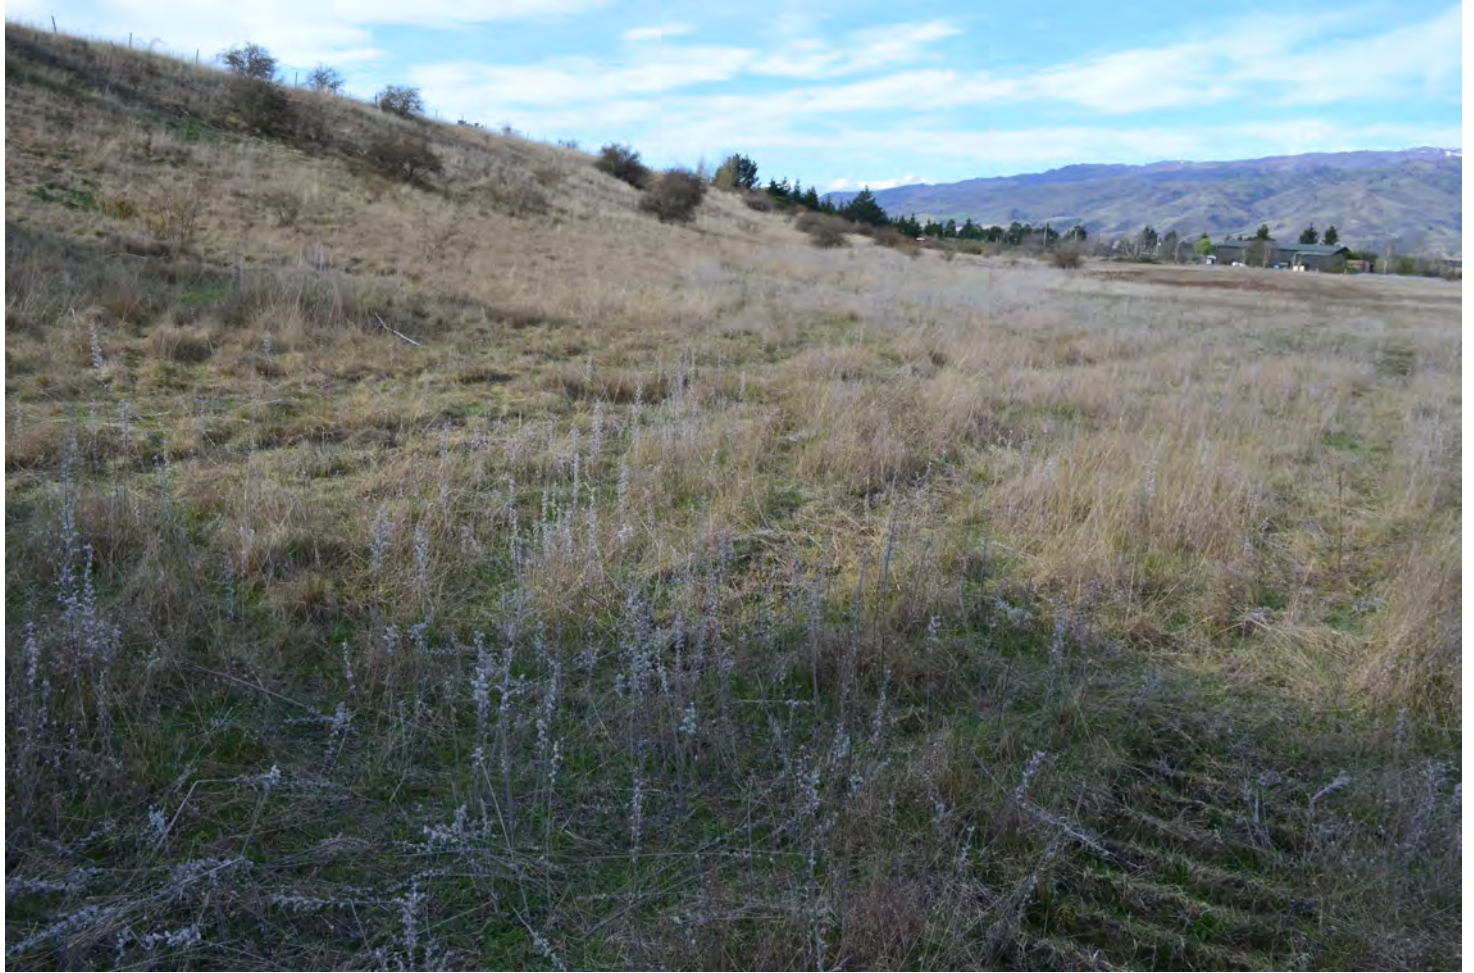
View of race at base of terrace slope looking west. Teele, B. 22/09/2017
