2 March 2020

Detailed Environmental Site Investigation for Private Plan Change at 74 Mutton Town Road, Clyde

Our Reference: 19057_1

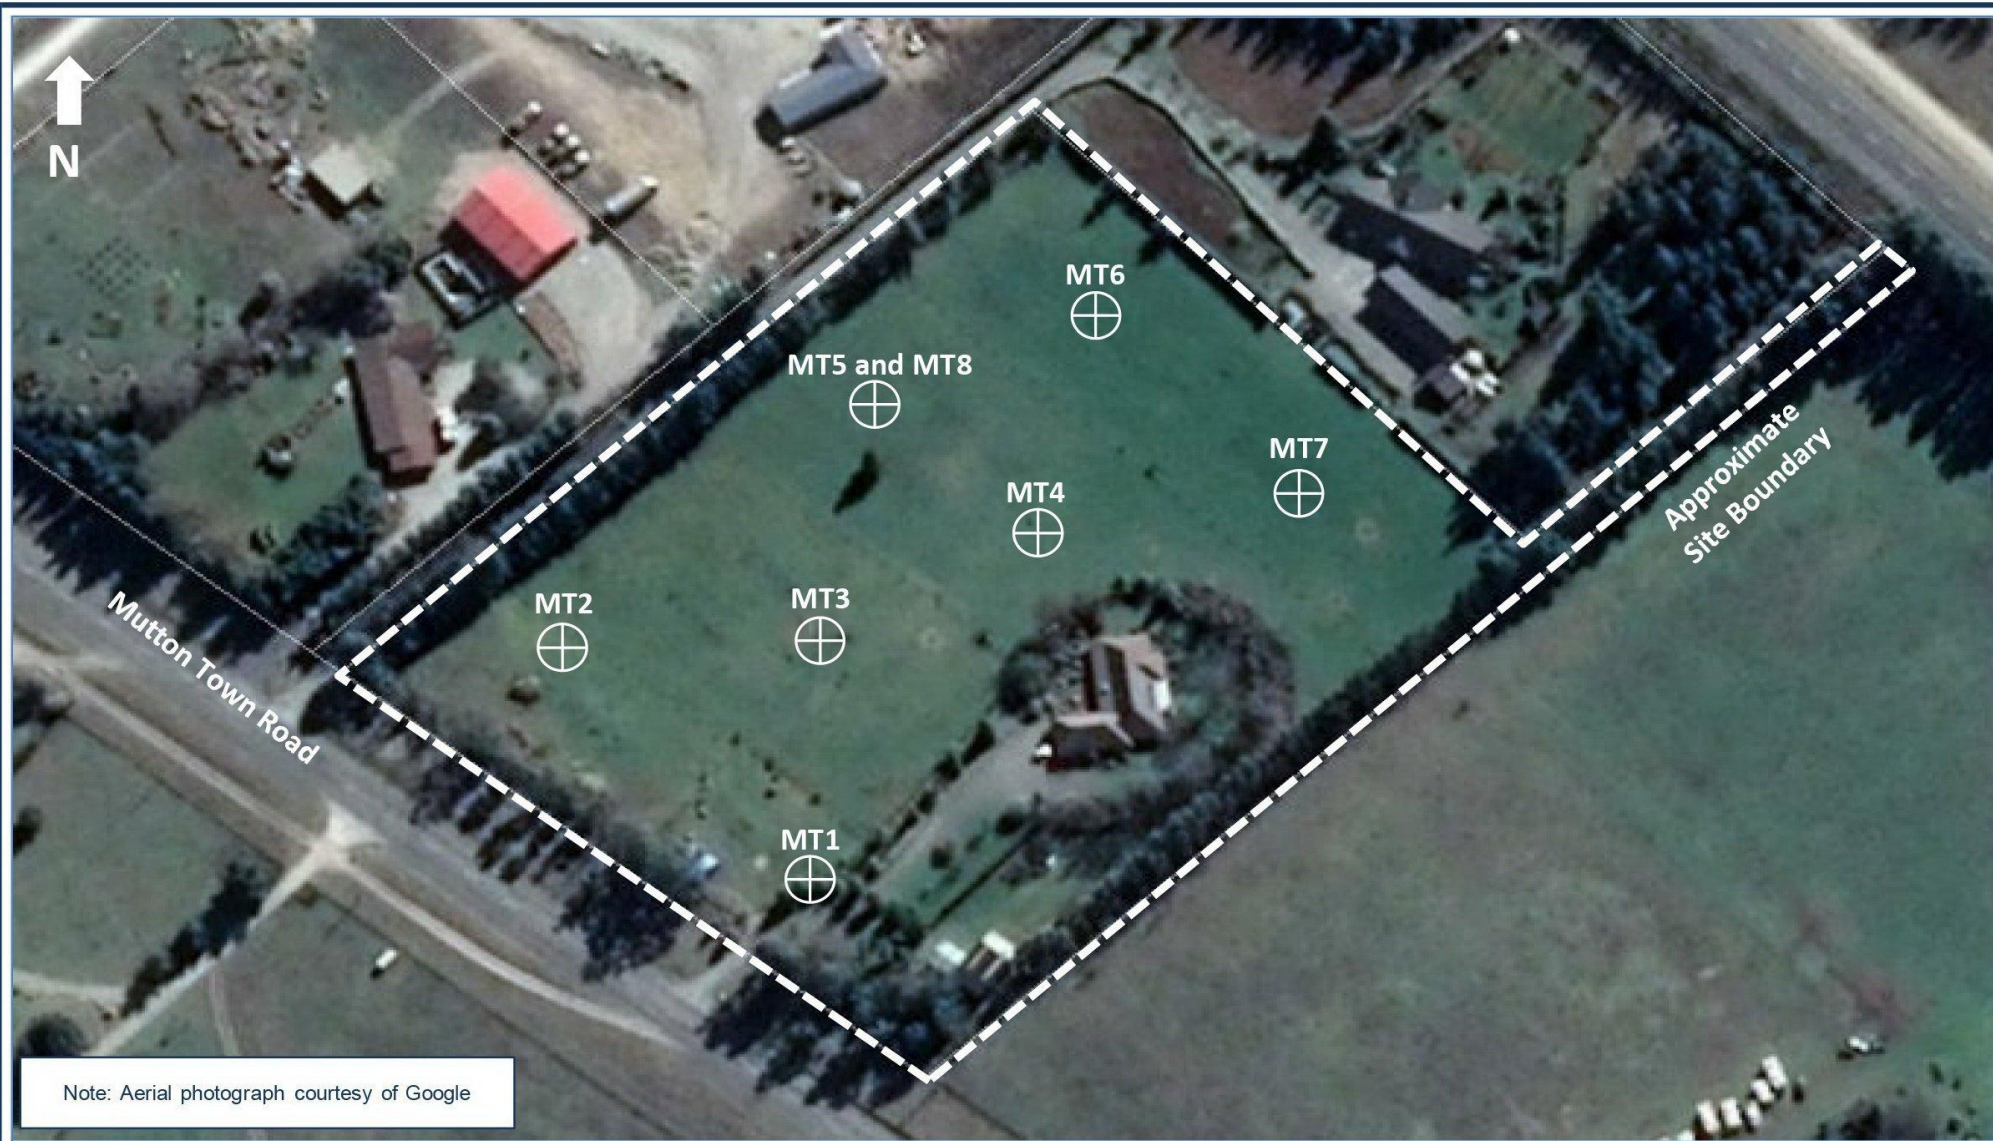
Description	Sample Location Plan	Figure Number	2

- Obtain seven (7) soil samples from 7 locations across the site where potential for contamination impacts had been identified;
- Obtain one (1) duplicate soil sample for QA / QC purposes;
- Visual and olfactory inspection of soil samples in the field;
- Submit eight (8) soil samples to Hill Laboratories for analysis of a suite of common heavy metals and organochlorine pesticides;
- Assess laboratory results for the soil samples against the adopted human health criteria for residential land use and maintenance / excavation activities; and
- Present a DSI report outlining our findings, the suitability of the site for residential development / use and recommendations to manage impacted areas (if any).

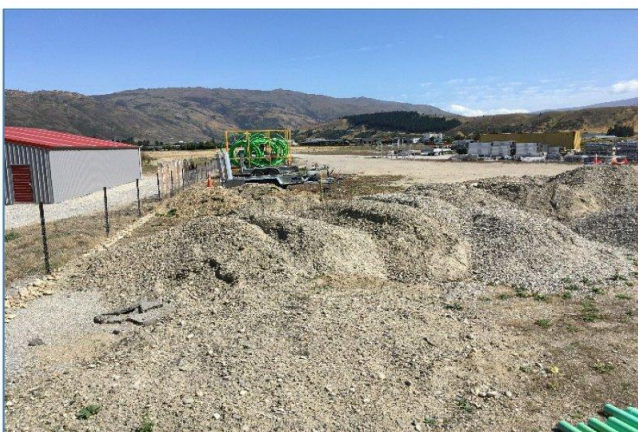
Photo 4: Miscellaneous stockpiles of gravel and asphalt south west of the Downer shed.

property was used to recondition commercial coffee making equipment, but is now used as office space for Downer who store miscellaneous equipment in the gravel-paved yard surrounding the shed. Although small amounts of asphalt were observed in a few small gravel stockpiles in that area, the materials are considered to be relatively inert and are unlikely to result in significant contamination impacts in that part of the site. A recently constructed vehicle workshop building and an above-ground fuel storage tank on the southern central property showed no evidence of contamination impacts.

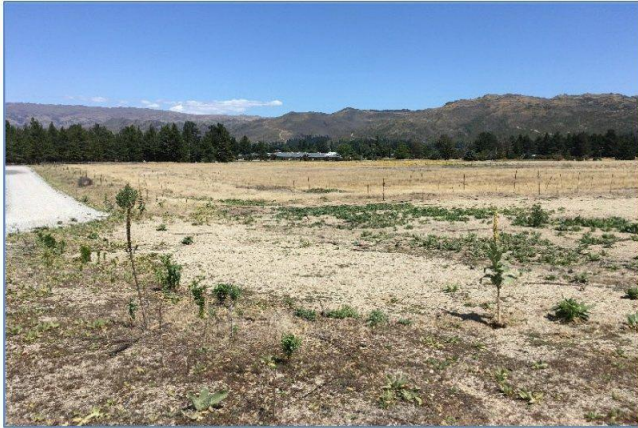
Photo 7: Former waste pit / incineration area near to the centre of the site.

- A waste incineration pit, used to burn green waste and minor amounts of other domestic waste, had been located near to the boundary between the northern and central properties. The waste was excavated by Ray Harvey of Clyde Cartage and Excavation Limited in 2018. Mr Clarke was not aware of the location where the waste had then been disposed of, but the pit was backfilled with uncompacted soil that had been excavated from the building footprint of the shed at the time of its extension.

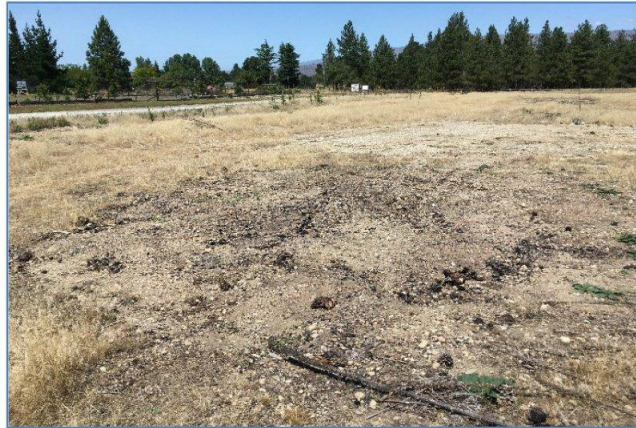
Photo 8: Small amounts of residual charcoal in former green waste incineration areas.

Visible signs of contamination	Remnants of burned tree stumps, in the form of small amounts of charcoal, were observed in several locations along the north western site boundary and along the boundary between the northern and central properties. A small stockpile of treated timber fence posts was observed adjacent to the driveway on the southern property. Stockpiles of imported gravel, containing a few asphalt pieces, were observed in the Downer yard on the northern central property. No other indicators of contamination were evident within the site boundaries.
Surface water appearance	No surface water was present at the time of the site walkover inspection.
Current surrounding land use	Mixed rural residential, standard residential, horticultural and commercial land surrounds the property.
Local sensitive environments	No sensitive environments are located within 200 m of the site.
Visible signs of plant stress	Apart from evidence of dry, summer conditions, no visible signs of plant stress were noted.

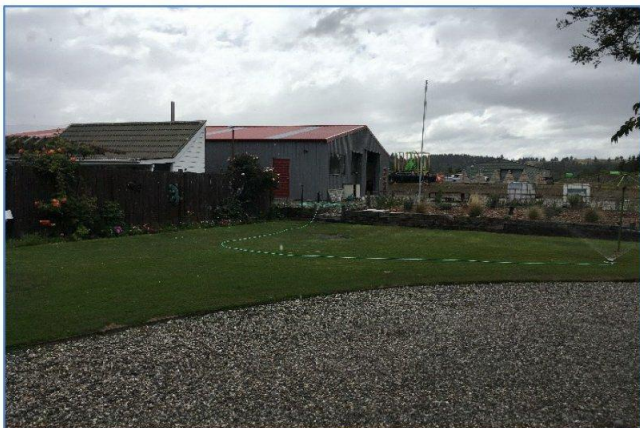
Photo 13: Vehicle workshop building on the southern central property.

- Mr Clarke had used fencing to control rabbits, but has more recently switched to using Pindone as recommended by ORC.
- Mr Clarke works on antique cars in the workshop that he constructed adjacent to his dwelling. Waste engine oil is collected and disposed of off-site.

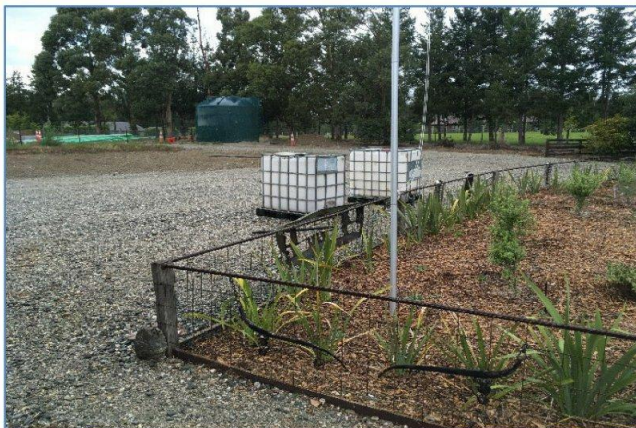
Photo 14: Waste oil containers on the southern central property.

Additional Observations	An above-ground fuel storage tank, waste engine oil containers, an antique car and an antique pesticide sprayer were observed on the southern central property.

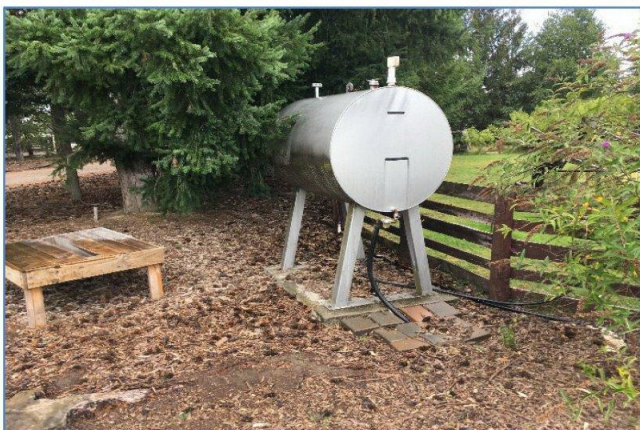
Photo 16: Above-ground fuel storage tank on the southern central property.

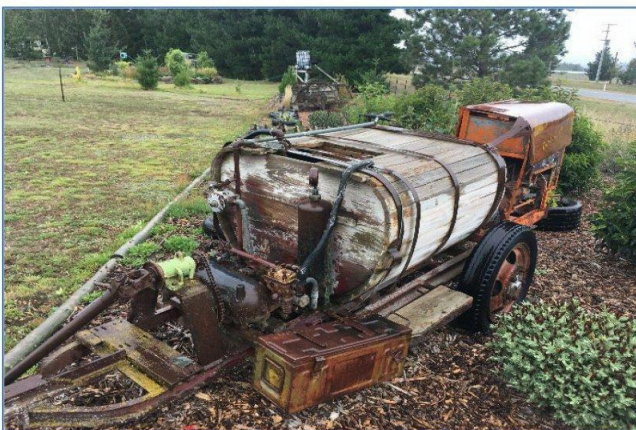
Photo 17: Antique pesticide sprayer on the southern central property.

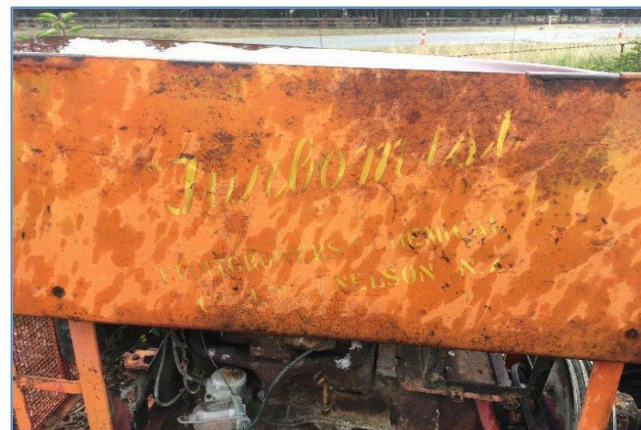
Photo 18: Signwriting on the antique pesticide sprayer reading "Turbo-Mist" and "Fruitgrowers Chemical Co Ltd Nelson N.Z.".

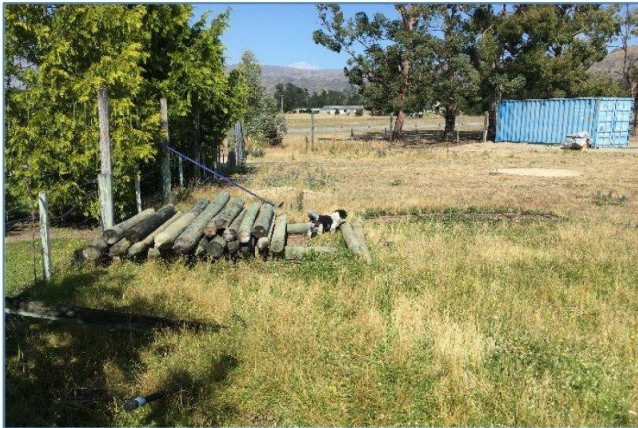
Photo 22: Stockpile of treated timber fence posts adjacent to the driveway on the southern property.

Visible signs of contamination	A small stockpile of treated timber fence posts was observed adjacent to the driveway on the site.
Surface water appearance	No surface water was present at the time of the site walkover inspection.
Current surrounding land use	Mixed rural residential, horticultural and commercial land surrounds the property.
Local sensitive environments	No sensitive environments are located within 200 m of the site.
Visible signs of plant stress	Apart from evidence of dry, summer conditions, no visible signs of plant stress were noted.
Additional Observations	None noted.
