Soil Contamination Assessment

269 Dunstan Road, Alexandra

Detailed Site Investigation Report Molyneux Lifestyle Village Ltd

11 December 2020

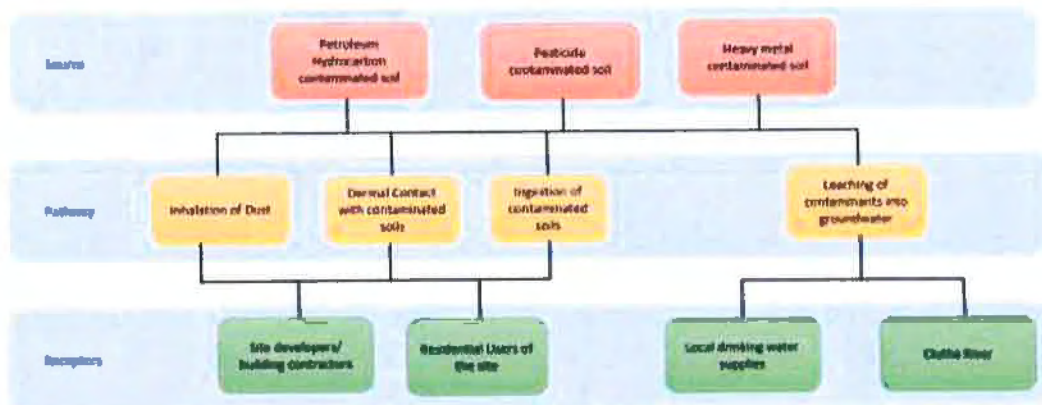
Figure 5: Conceptual Site Model

Using the data obtained from this report a preliminary Conceptual Site Model has been derived for the site and is presented in Figure 5.

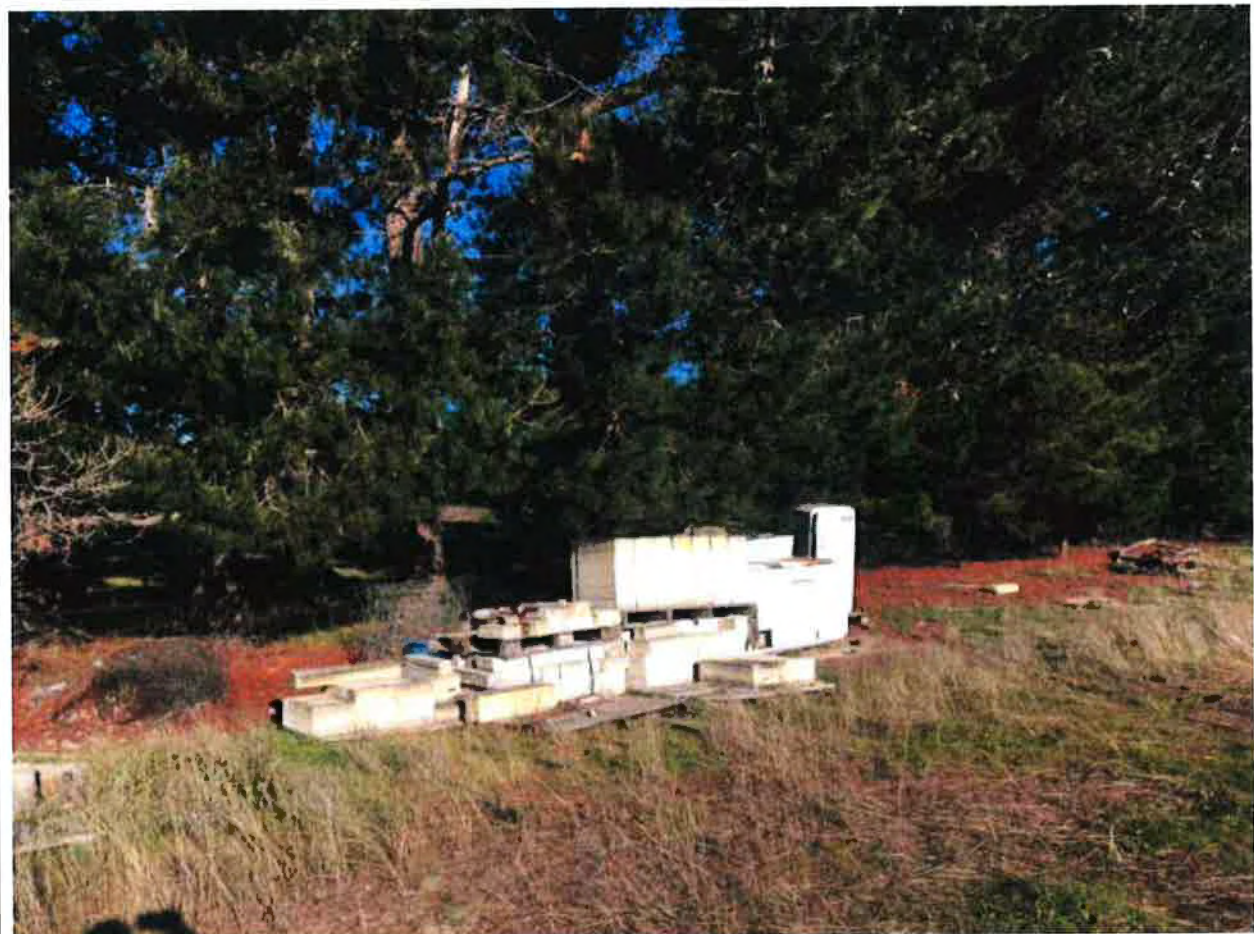
Fly tipping on southern side of site.

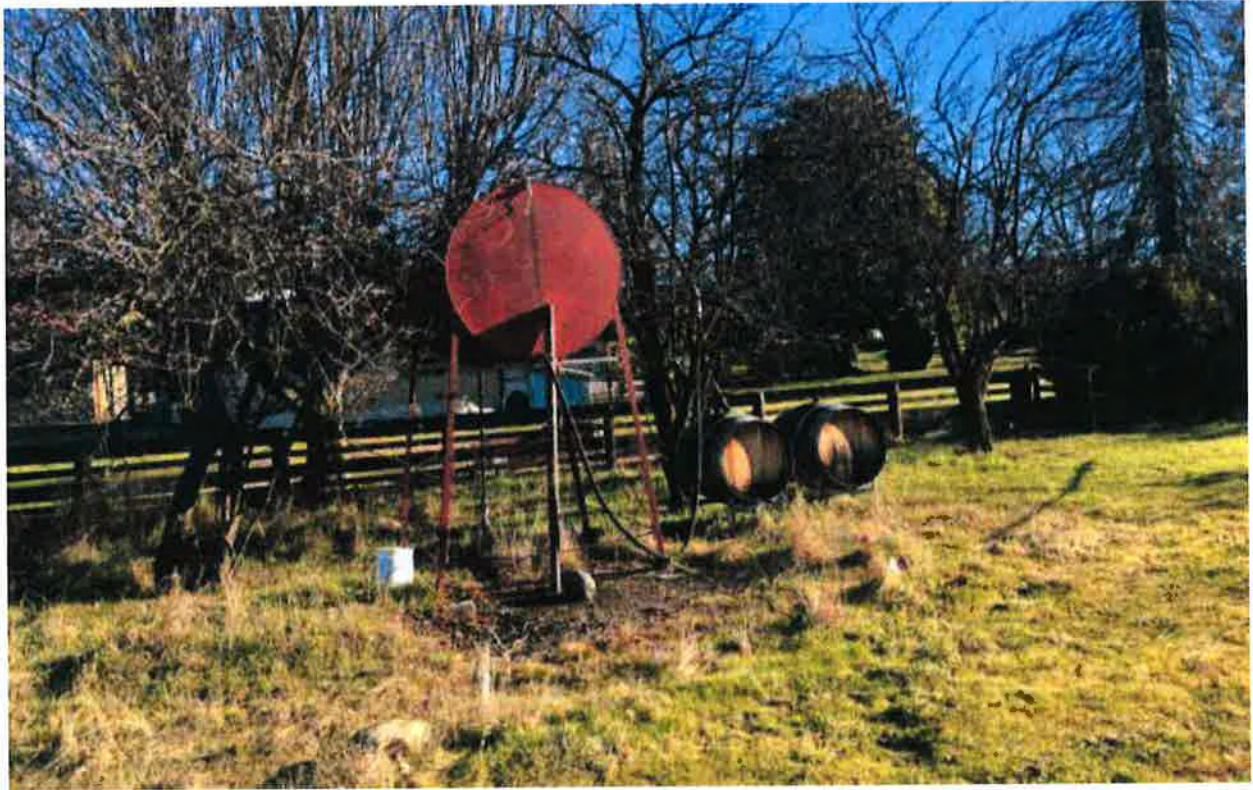
A single C10 – C14 concentration in excess of the SGV was recorded at a specific location on the site (S19). However it should be noted that this result was not unexpected as soil was collected at 0.20m bgl in an area situated directly below the above ground fuel tank located on the site. As such the TPH exceedance located below the above ground fuel tank does pose a direct exposure risk however this risk is limited to the immediate vicinity of the fuel tank.

Above ground fuel storage tank.

The above ground fuel tank and surrounding near surface are considered to be a 'piece of land' with respect to the NES and cannot be deemed suitable for the proposed end-use due to an elevated C10-C14 concentration. If that area of the site is to be developed then some form of remedial measures would need to be undertaken on this area in order to create suitable ground conditions.

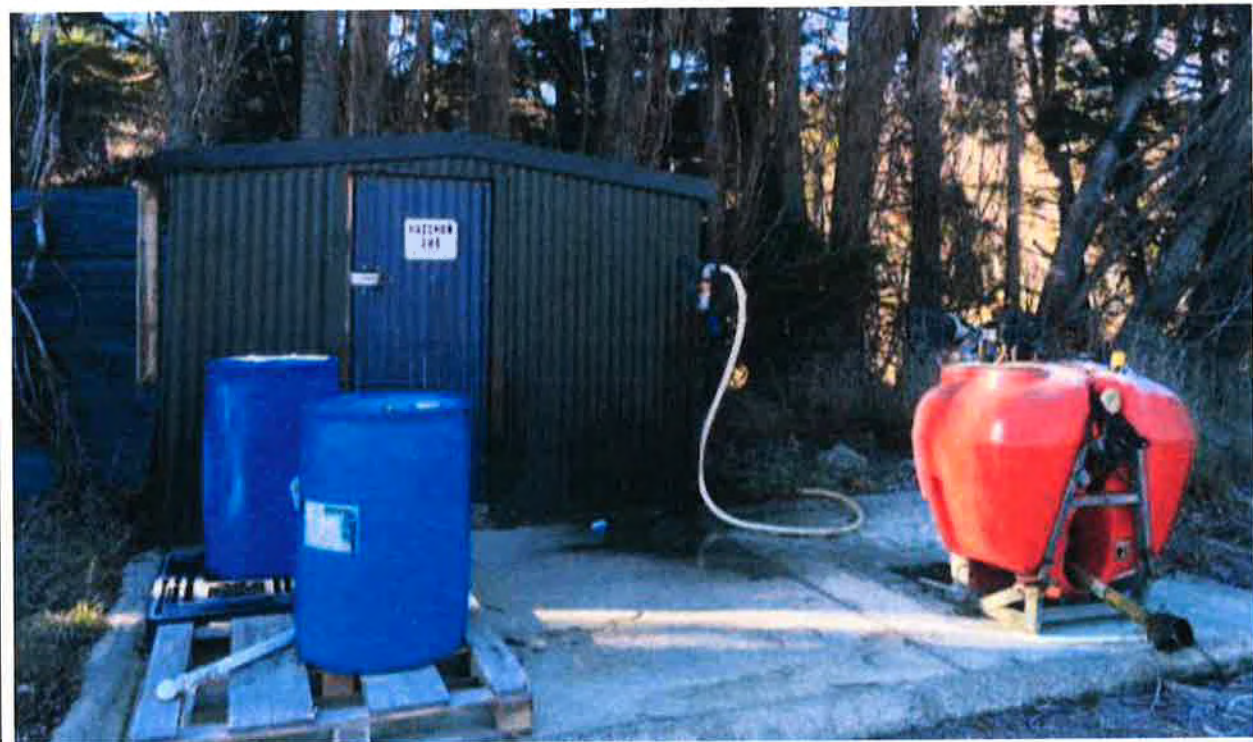
Pesticide storage and mixing shed located on eastern boundary.

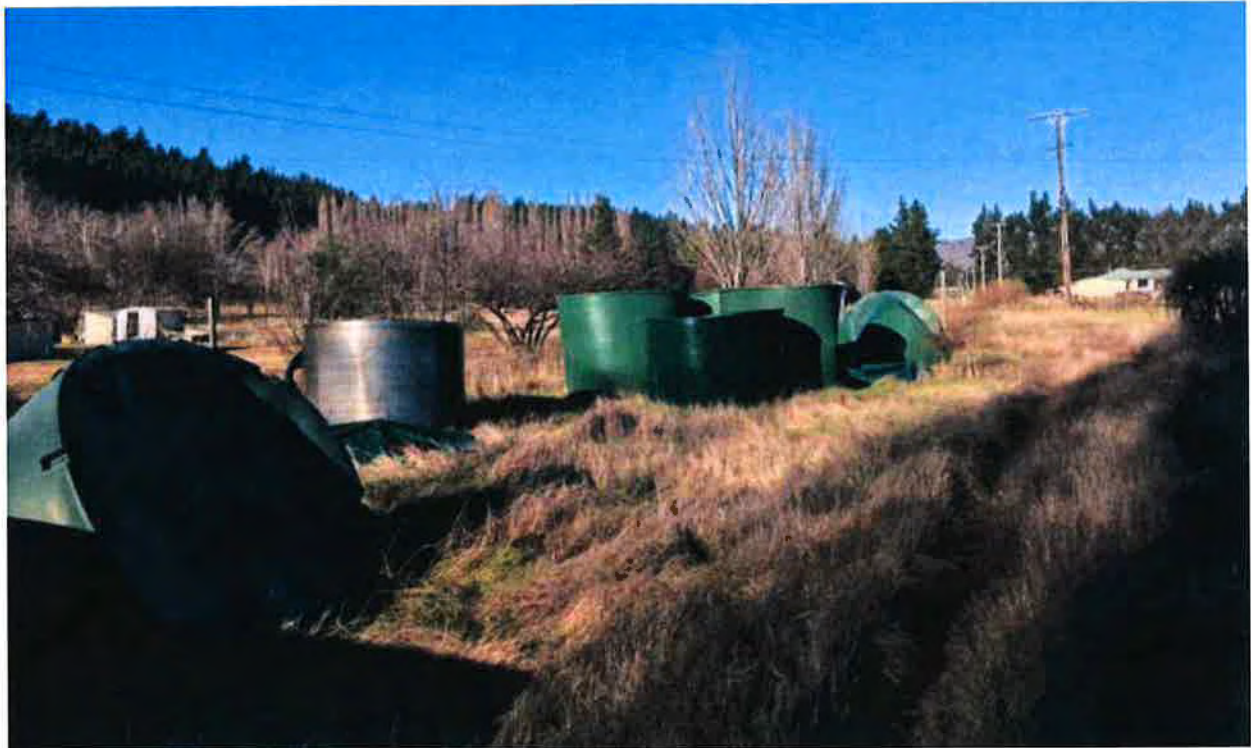
Plastic storage drums located on the eastern site boundary just south of the pesticide mixing shed.

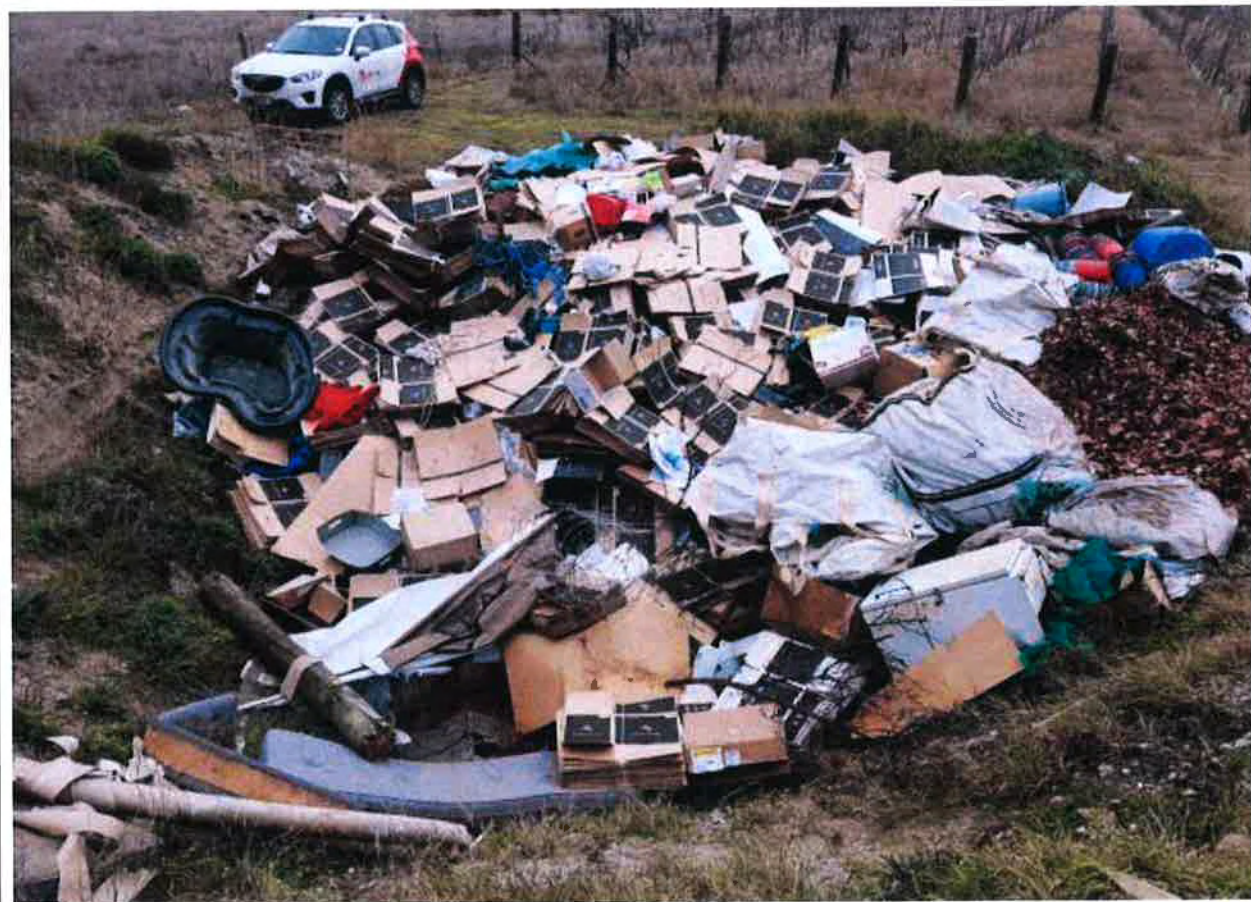
Pit containing miscellaneous rubbish close to the southern site boundary taken on the 9th July 2017.

- Should development be proposed within the vicinity of the waste pit on site, remedial measures will be required in order to remove residual waste along with burnt materials from the area. Infilling of the pit in its present form is not considered appropriate remediation should residential development of the area be proposed.

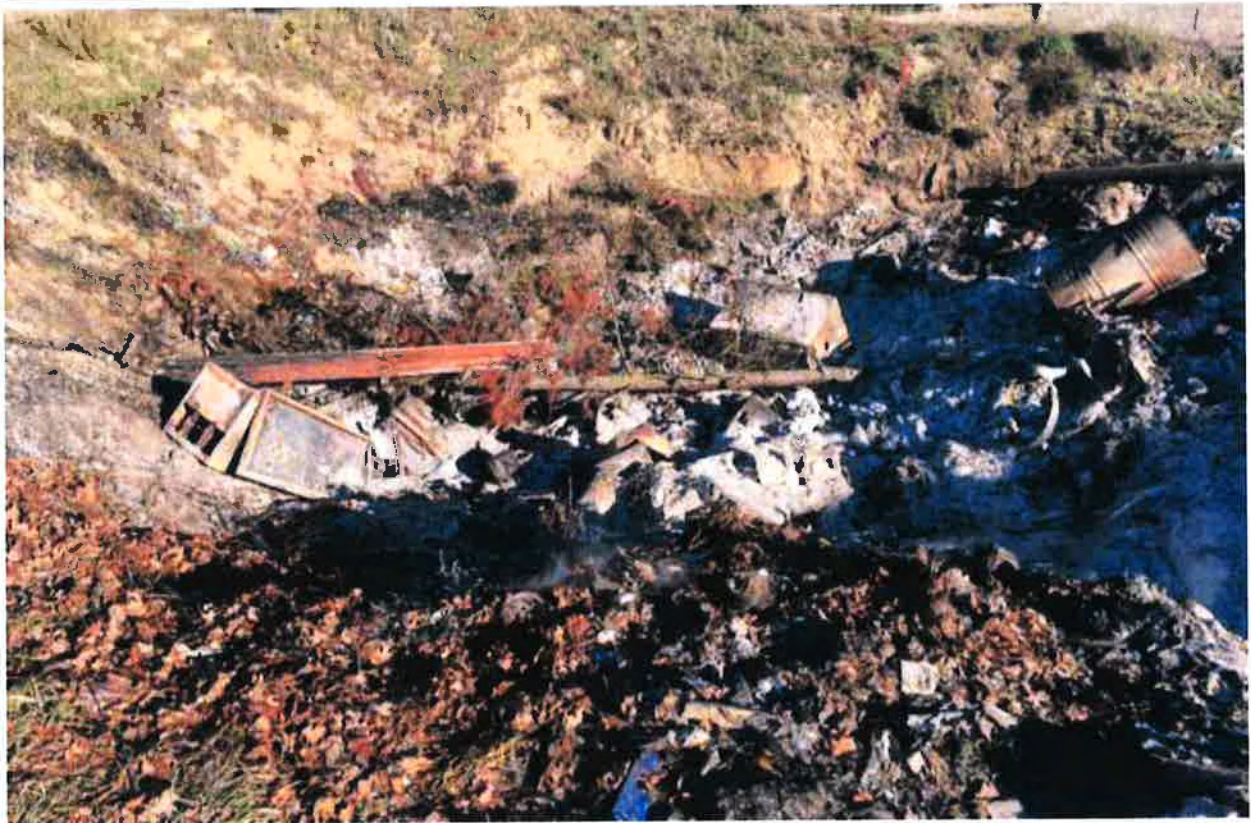
PAH's were screened in a single soil sample collected from next to the pile of rubbish that had been recently burned during the PSI. The results returned were below their relevant SGV for the type of soil (silty sand) that was identified on site.

Pit containing recently burnt still slightly smoking rubbish close to the southern site boundary.

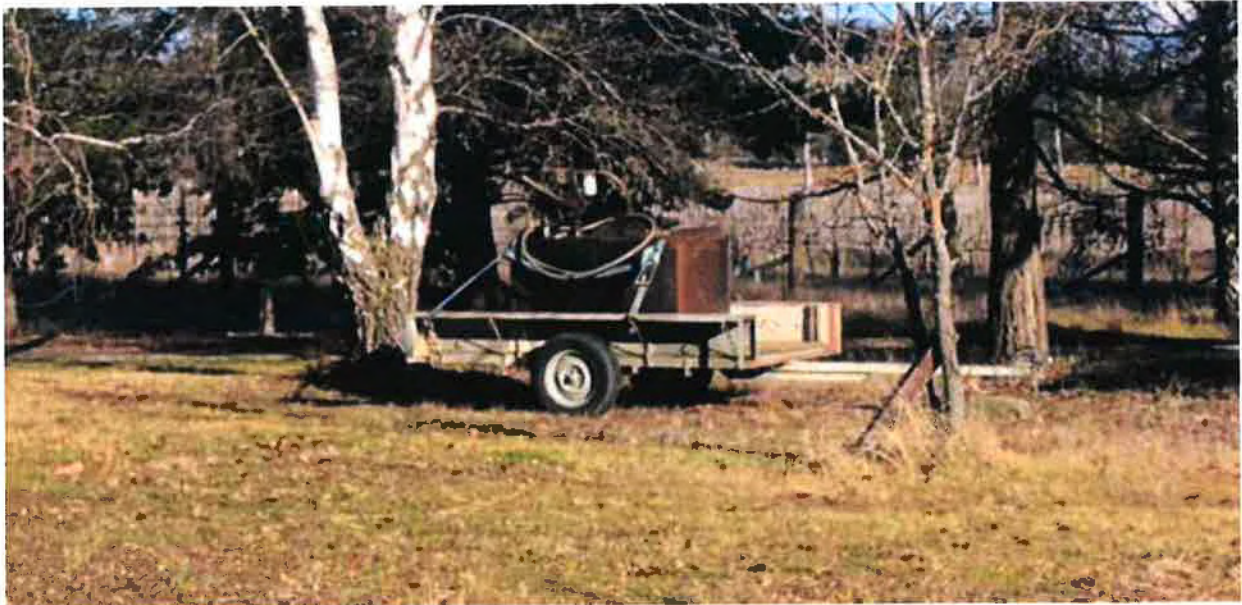
Mobile diesel tank for filling house heating system, next to the existing house.

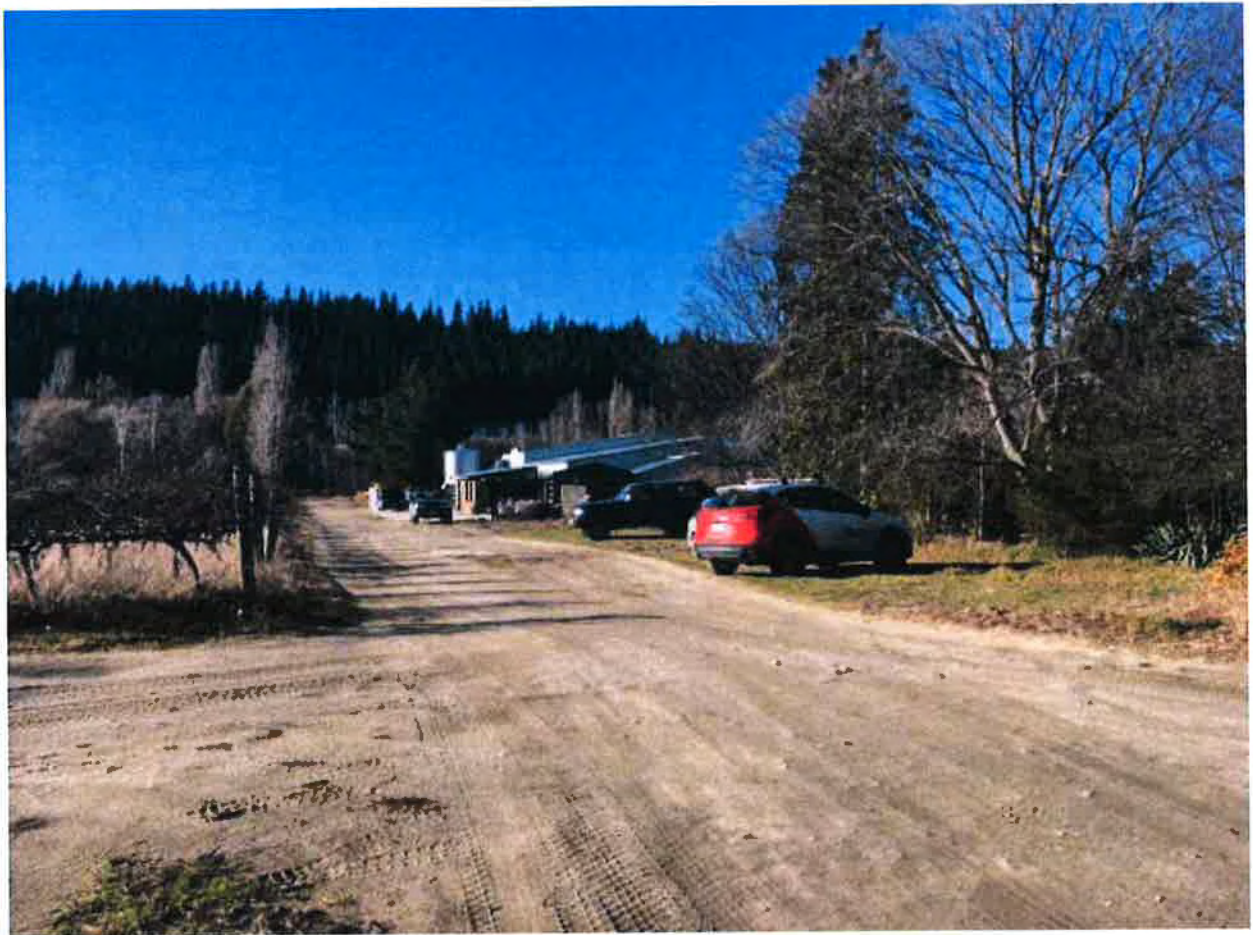
Vehicles parking on the grass next to the winery.
