**Project Number 19377.000.001**

**Geotechnical Investigation**

Lot 4 Water Race Hill, Bannockburn,

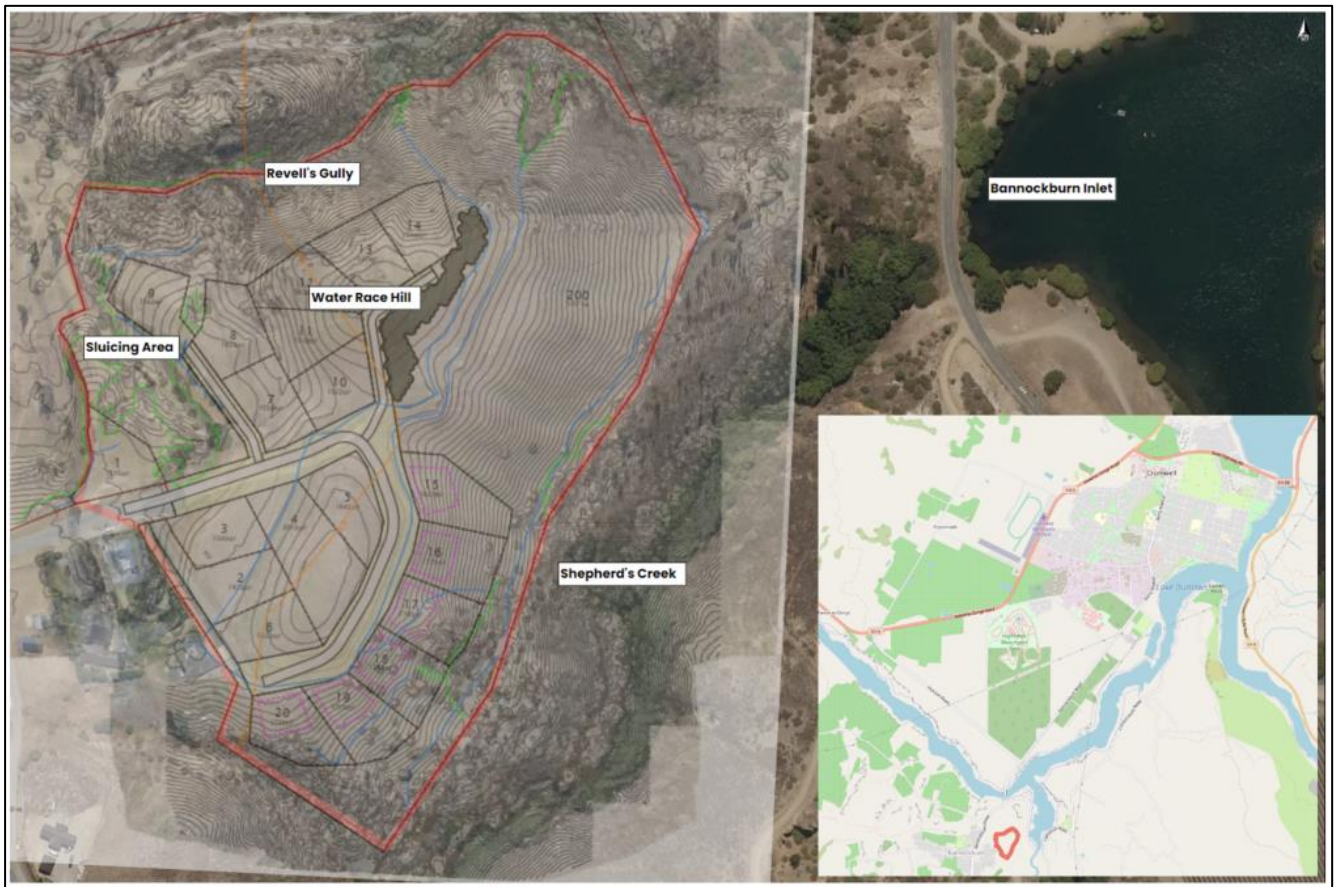
Figure 1: Site Location Plan (LINZ data service, 2021 & Rough & Milne Landscape Architects, 2021)

The ground surface within the subdivision area comprises an undulating terrace between 270 m and 275 m approximately, before dropping steeply to the north towards Revell's Gully, east towards Bannockburn inlet and south towards Shepherds Creek (Figure 1).

ENGEO has been supplied with a conceptual subdivision layout drawings by Rough & Milne landscape architects (R&M), dated 21 September 2021. Subdivision layout plan indicates 20 rural residential lots ranging from 1500 m<sup>2</sup> to 3010 m<sup>2</sup> in size with associated accessways (Figure 1).

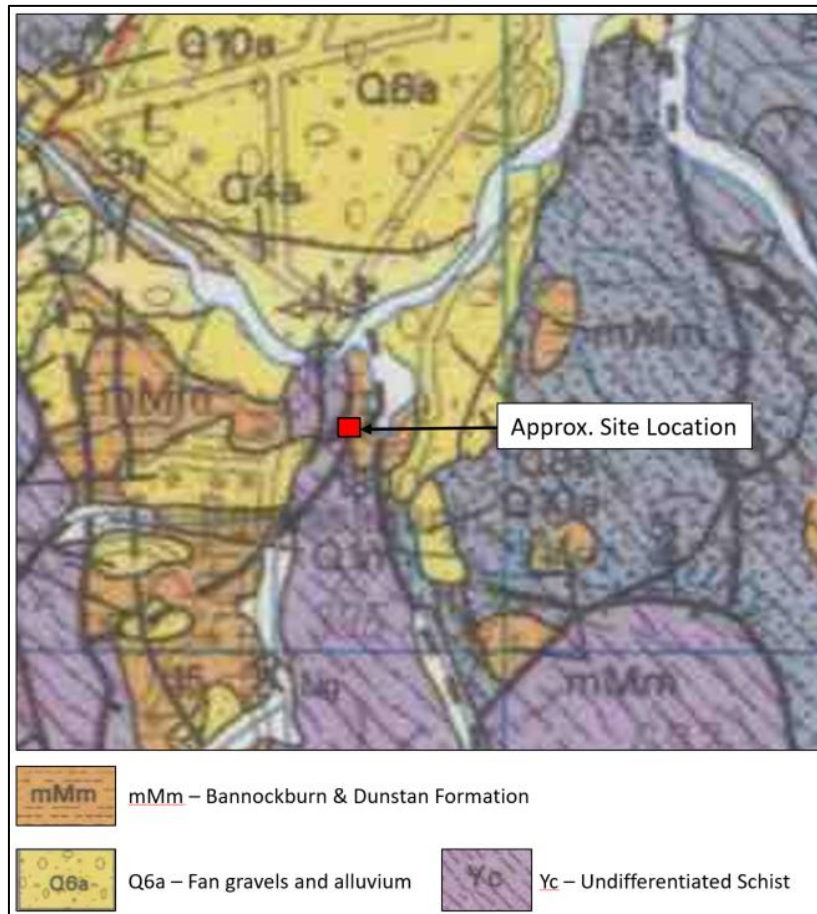
**Figure 2: Regional Geology Map (image modified from Turnbull, 2000)**

The subject site is geologically mapped at 1:250,000 as being underlain by Bannockburn and Dunstan Formations of the Manuherikia Group and basement Schist bedrock (Turnbull, 2000). Manuherikia Group consists of lake clays, silts, oil shales and lignite. These sediments are Miocene in age (24 - 5.3 million years old) and were deposited in a freshwater lake that extended across most of the Wakatipu region east of The Remarkables and north toward Lindis Pass.

Alluvial Gravels, derived from alluvial fan deposits sourced from the nearby Carrick Range have been mapped in close vicinity to the site (Pedley, K, GNS Science 2017). It is possible a mantle of colluvium is also present, particularly on the steeper south-eastern aspect slopes of the site. Colluvium (if present) is likely to comprise remobilised lacustrine sediments and / or alluvial gravels.

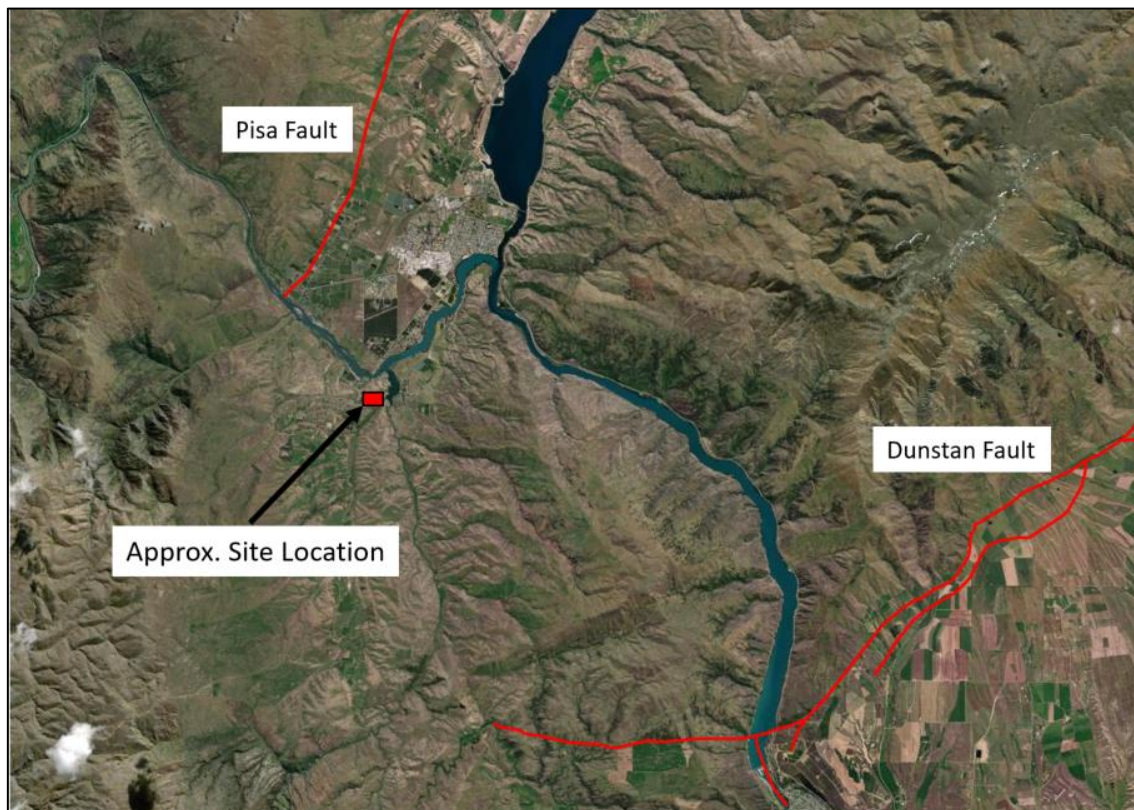
Figure 3: Active Fault Traces in the Region (image modified from GNS NZ Active Fault Database)

No active fault traces were observed in the field nor have been reported in the vicinity of the site. The only known active faults within the 20 km of the site are the Dunstan Fault (comprising north and south splays) which is approximately 15 km to the east and the Pisa Fault which is approximately 5 km to the west (Figure 3). The Dunstan Fault is noted in the GNS Active Faults Database to be a reverse fault and has a recurrence interval of c. 5,000 to 10,000 years. It is estimated that a magnitude 7 earthquake on either the Dunstan North or South Faults could result in shaking equivalent to a Modified Mercalli VIII or 'severe' level of shaking. The Pisa Fault is also noted by GNS to be a reverse fault and has a recurrence interval of c. 10,000 to 20,000 years (Barrell, 2019a). While these are the closest known faults to the site, the Alpine Fault is expected to be the greatest seismic hazard to the region (Mackey, 2015).

The Alpine Fault is an oblique strike-slip fault and is located approximately 100 km northwest of the site. The fault has an estimate recurrence interval of < 2,000 years, with four documented earthquakes occurring in the past 900 years. A magnitude (M<sub>w</sub>) 8.1 alpine fault earthquake along the Alpine Fault is expected to result in a ground shaking intensity of MMVII (Modified Mercalli intensity scale) across the Cromwell area (Mackey, 2015).

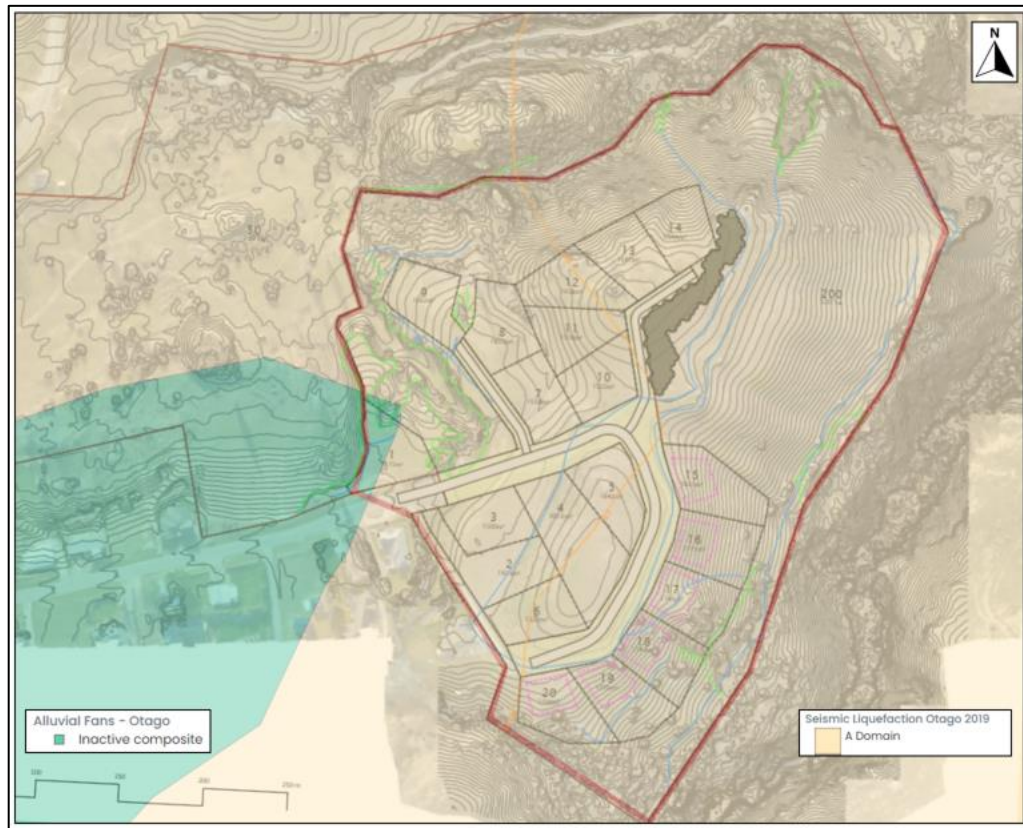
Figure 4: ORC Hazard Map (Sourced from ORC Hazard Database).

- The site is mapped as having a liquefaction susceptibility of 'Domain A' (nil to low susceptibility) due to being underlain by rock or firm sediments (Barrell, 2019b) (Figure 4).
- An inactive alluvial fan is mapped as entering the site in the far western extent (Figure 4.) No landslides (active or inactive) have been mapped within the site area.

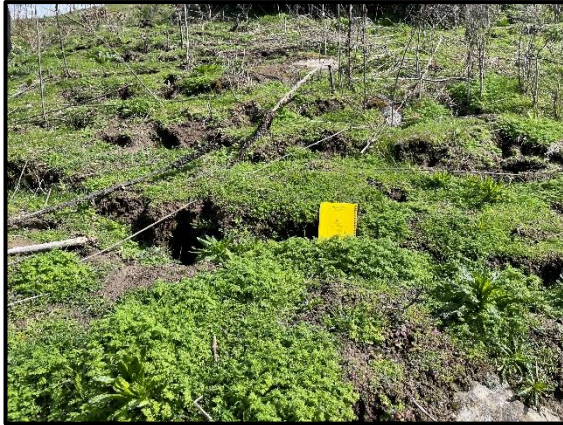
- Lots 15 to 19 are located on moderately sloping (approximately 20°) relief on the southeast aspect of the site.
- Ground cracking observed within Lot 18 was initially considered to indicate possible signs of slope movement (Photo 1). This is discussed further in Section 5.

Photo 1: Ground cracking within Lot 18 boundaries.

Geomorphic mapping in Lot 18 observed *in situ* schist bedrock outcrops in close vicinity to where ground cracking was observed suggesting shallow depth to rock. An historic water race feature was also identified approximately 20 m directly up slope that has potential to provide seepage to the area. However, ENGEO could not observe a toe bulge down-slope of the ground cracking to suggest localised slope failure.

HA and DCP investigation across Lot 18 slope alignment confirmed shallow depth to inferred bedrock, between 0.3 m (where ground cracking was observed) to 1 m. Investigation results returned a lack of evidence in the subsoil to suggest localized slope failure e.g., no changes in moisture, no disturbed or void zones and the density of subsurface material was consistent and generally increased with depth. These findings have been illustrated on the interpreted geologic cross section included in Appendix 3.

As such, it is our opinion that ground cracking has occurred from long term creep of surficial soils over shallow bedrock and not as a result of larger scale landslide failure.

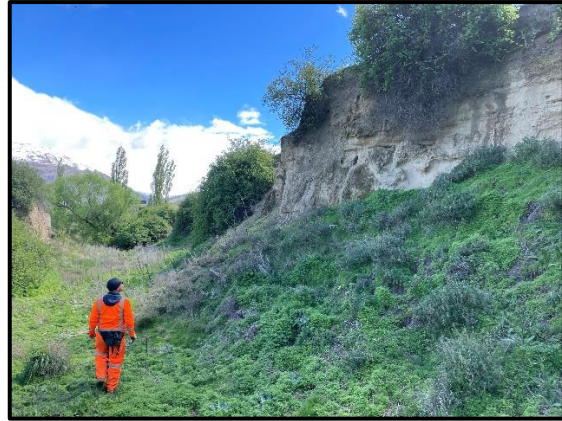
- Lots 1 and 9 are constrained to the west by vertical unsupported banks that are between approximately 4 to 6 m high (Photo 2). Evidence of ground displacement (tension cracking) was observed approximately 3 m from the crest of the bank in Lot 9 (Photo 3).
- *In situ* schist bedrock outcrops were mapped in various locations across the site. Foliation in these outcrops were measured as generally dipping approximately  $16^{\circ}$  –  $22^{\circ}$  towards  $125^{\circ}$  –  $165^{\circ}$  (Photo 4).

Photo 2: Image looking north through main sluicing gully between proposed Lots 1 and 9. Lot 9 is located above on right hand side.

Based on our site assessment observations, ENGEO recommends setback zones are applied along the western crests of both Lot 1 and 9 to reduce crest loading from nearby structures and promote slope stability of the adjacent banks.

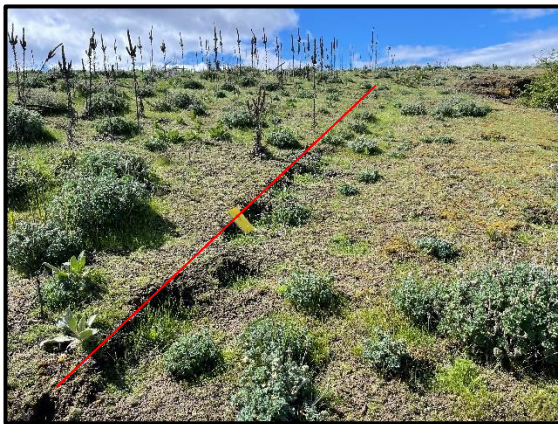
Photo 3: Image showing slope displacement on crest of bank in Lot 9.

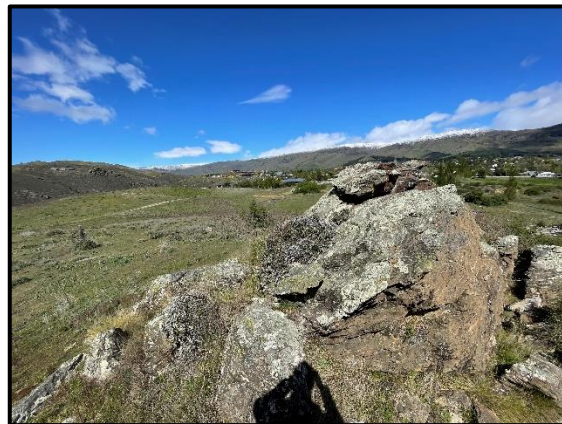
Photo 4: Schist outcrop located at the high point of Water Race Hill within Lot 13.

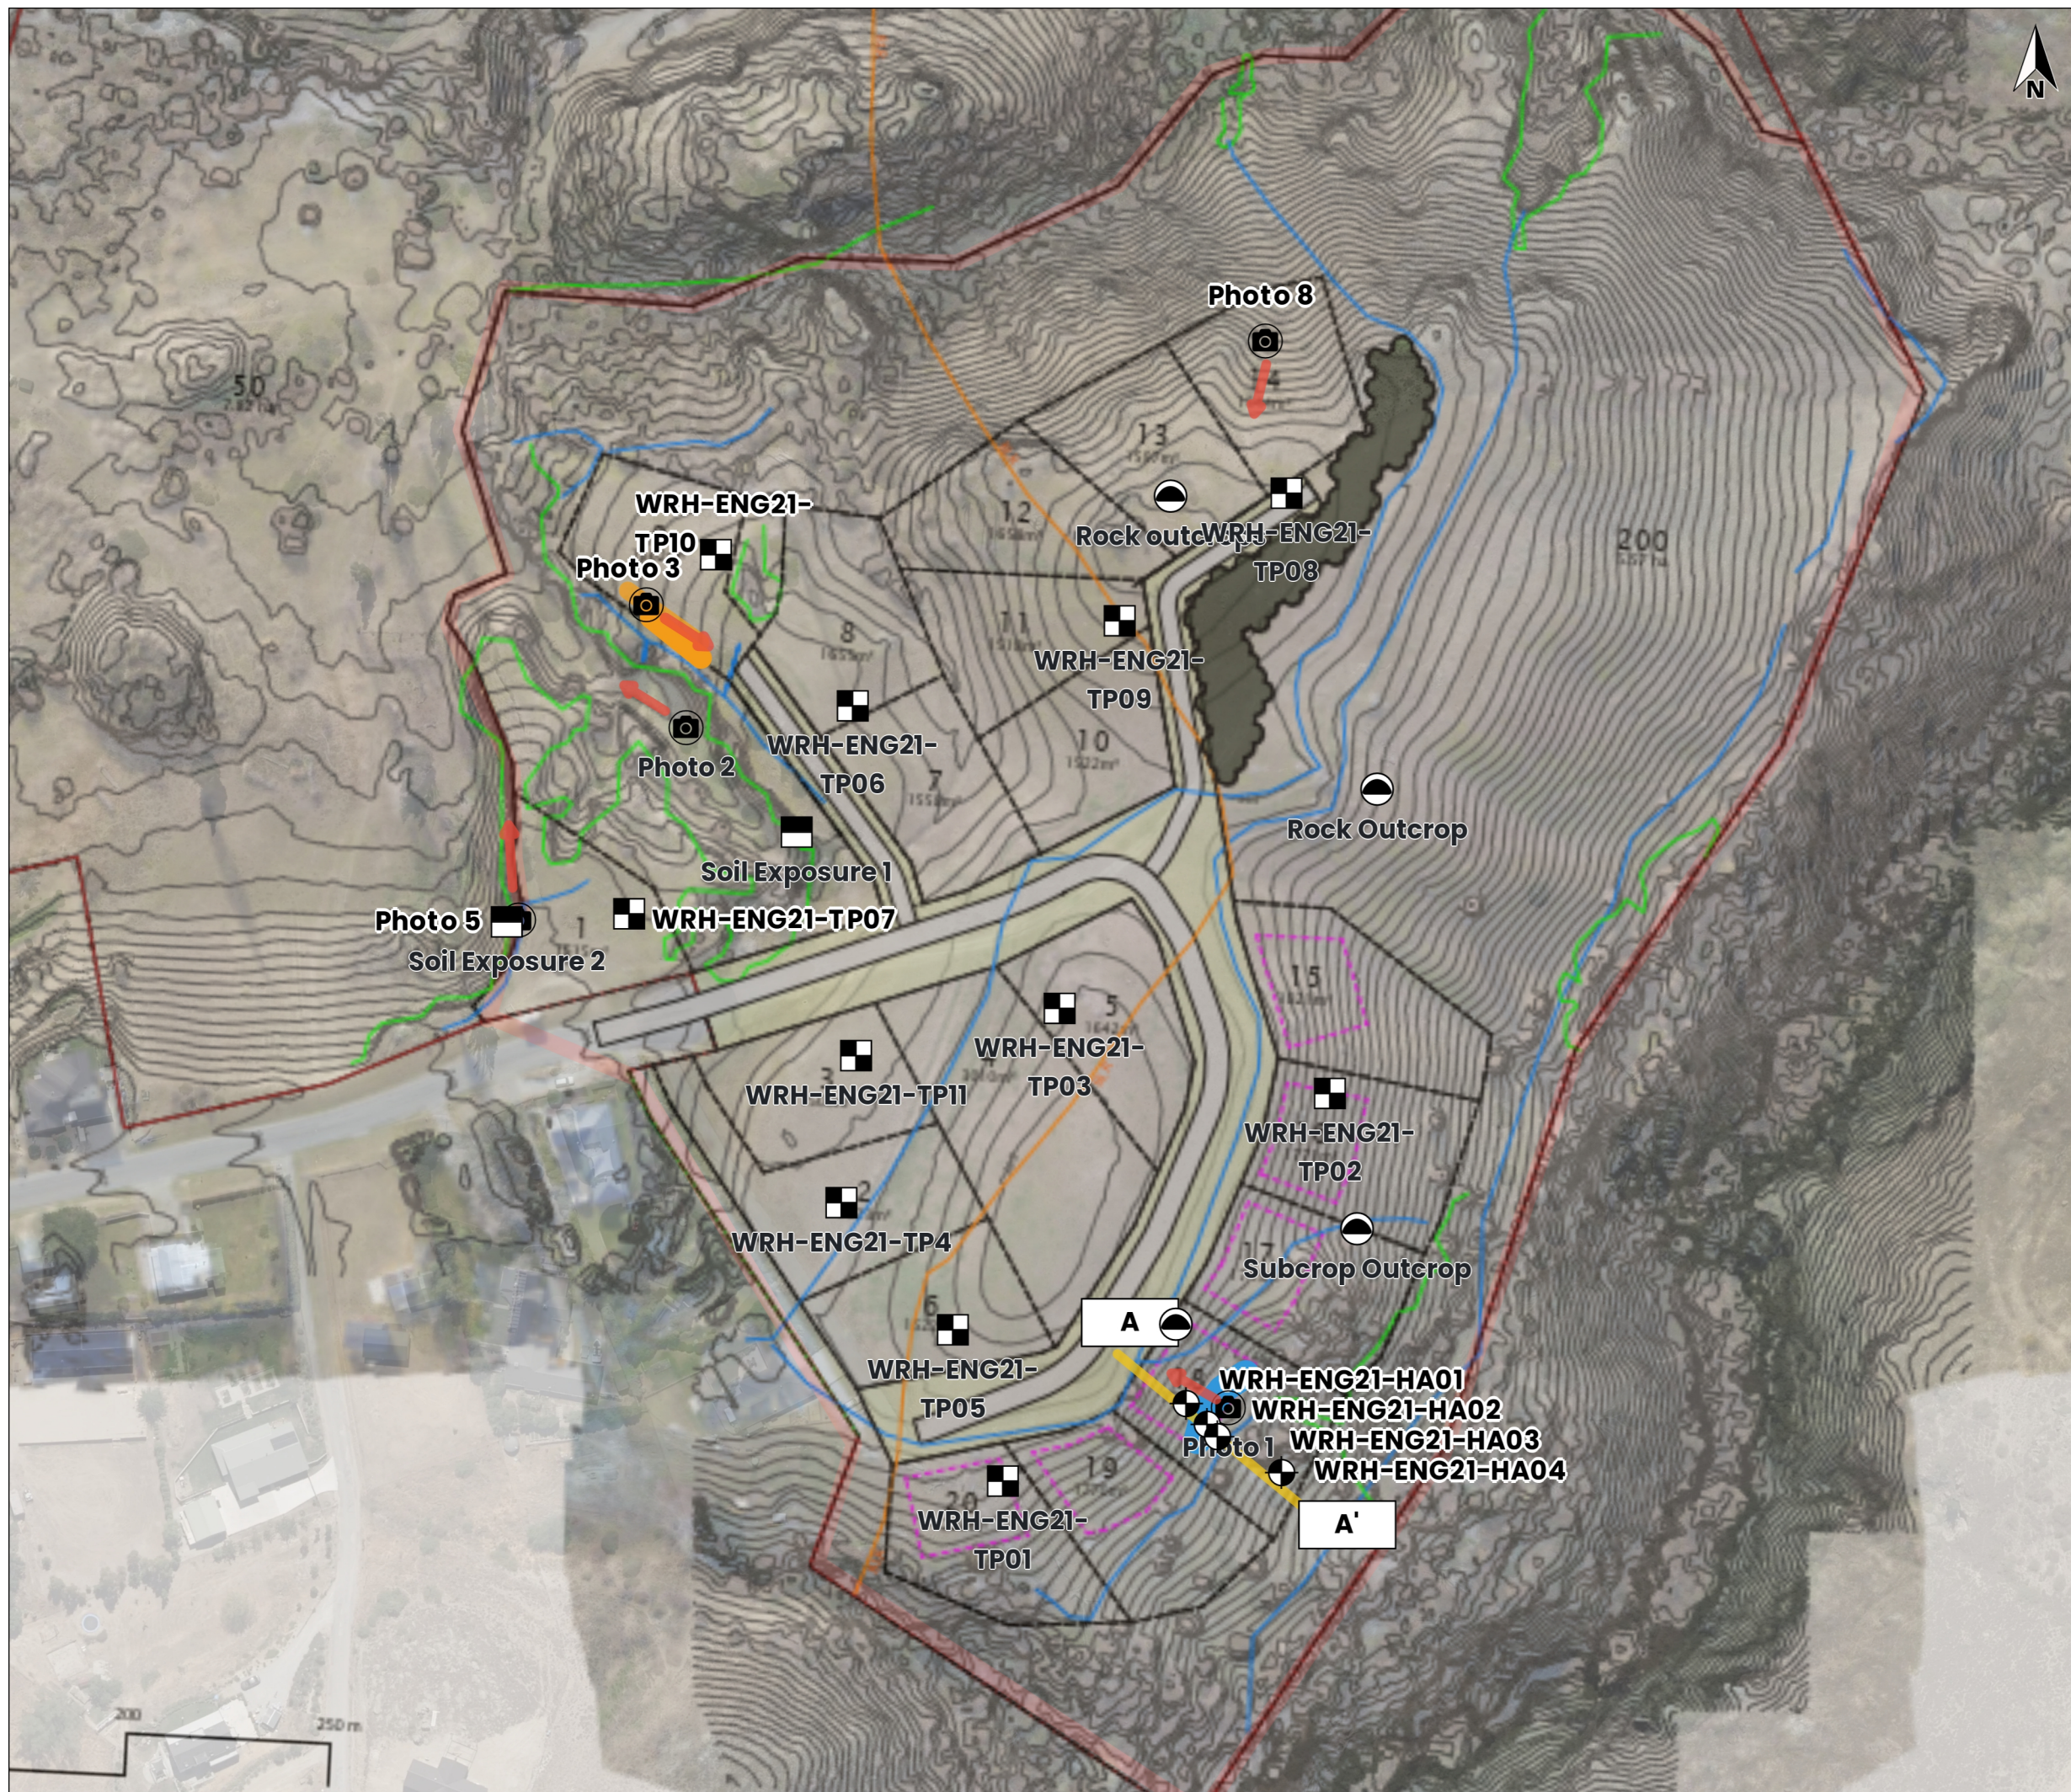
Site Investigation and Geomorph Mapping

- Legend**
- ENGEO Hand Auger Investigation Locations
  - ENGEO Test Pit Investigation Locations
  - Soil Exposure Location
  - Outcrops
  - Site Photo Locations
  - Cross Section Alignment
  - Lot 9 Soil Creep
  - Lot 18 ground cracking
  - Site Boundary

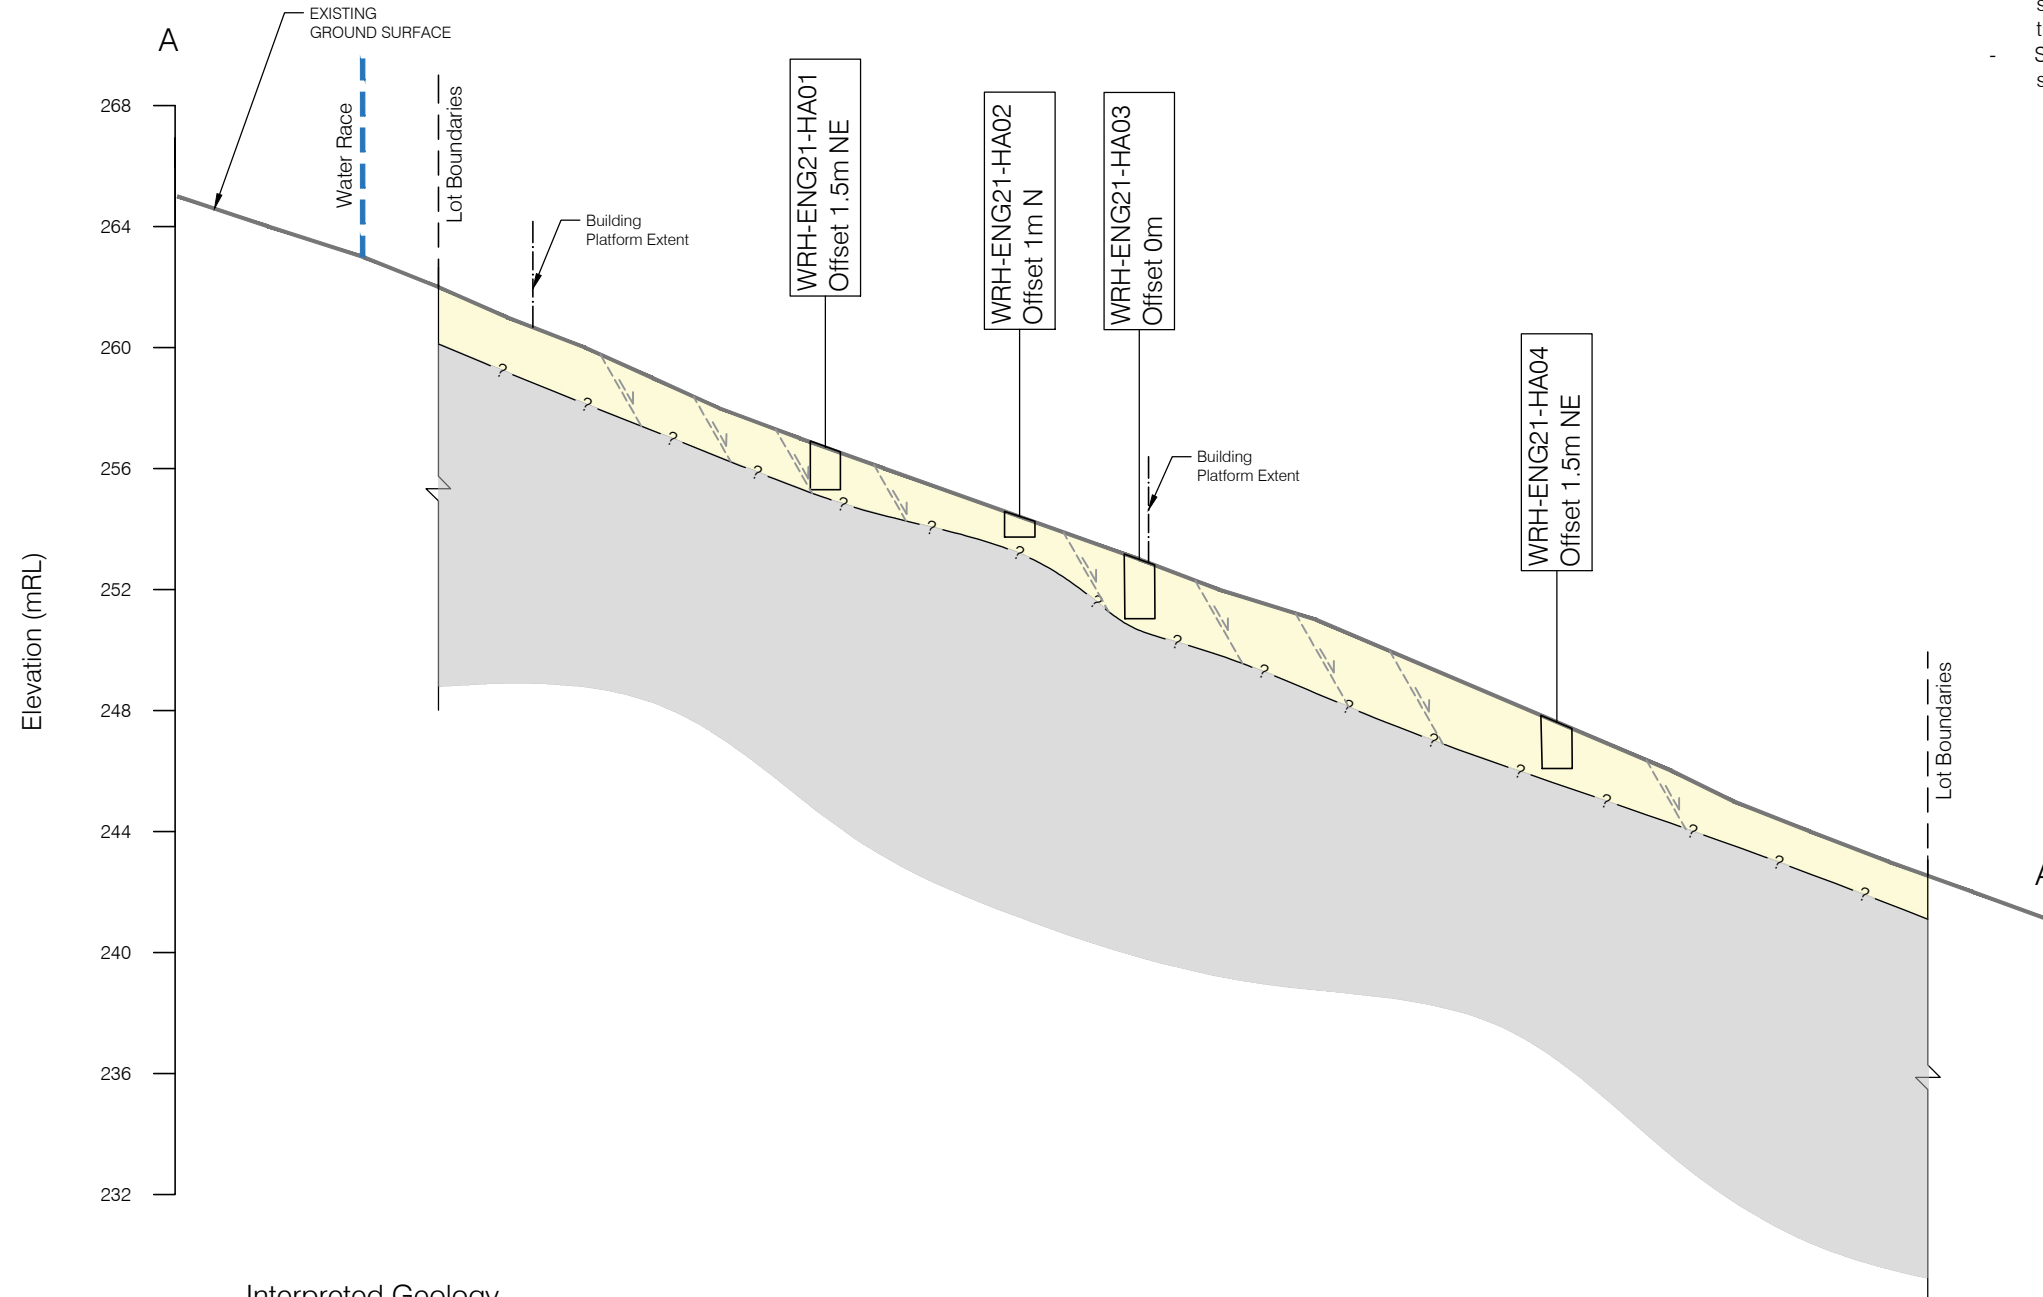
- Subsurface profile inferred from site observations and shallow soil testing. Actual conditions may vary from that shown.
- Section profile generated from 2016 drone survey completed by Land Pro Ltd. A & A' Section

Interpreted Geology

Lacustrine derived Colluvium(Silty Fine Sand, medium dense)

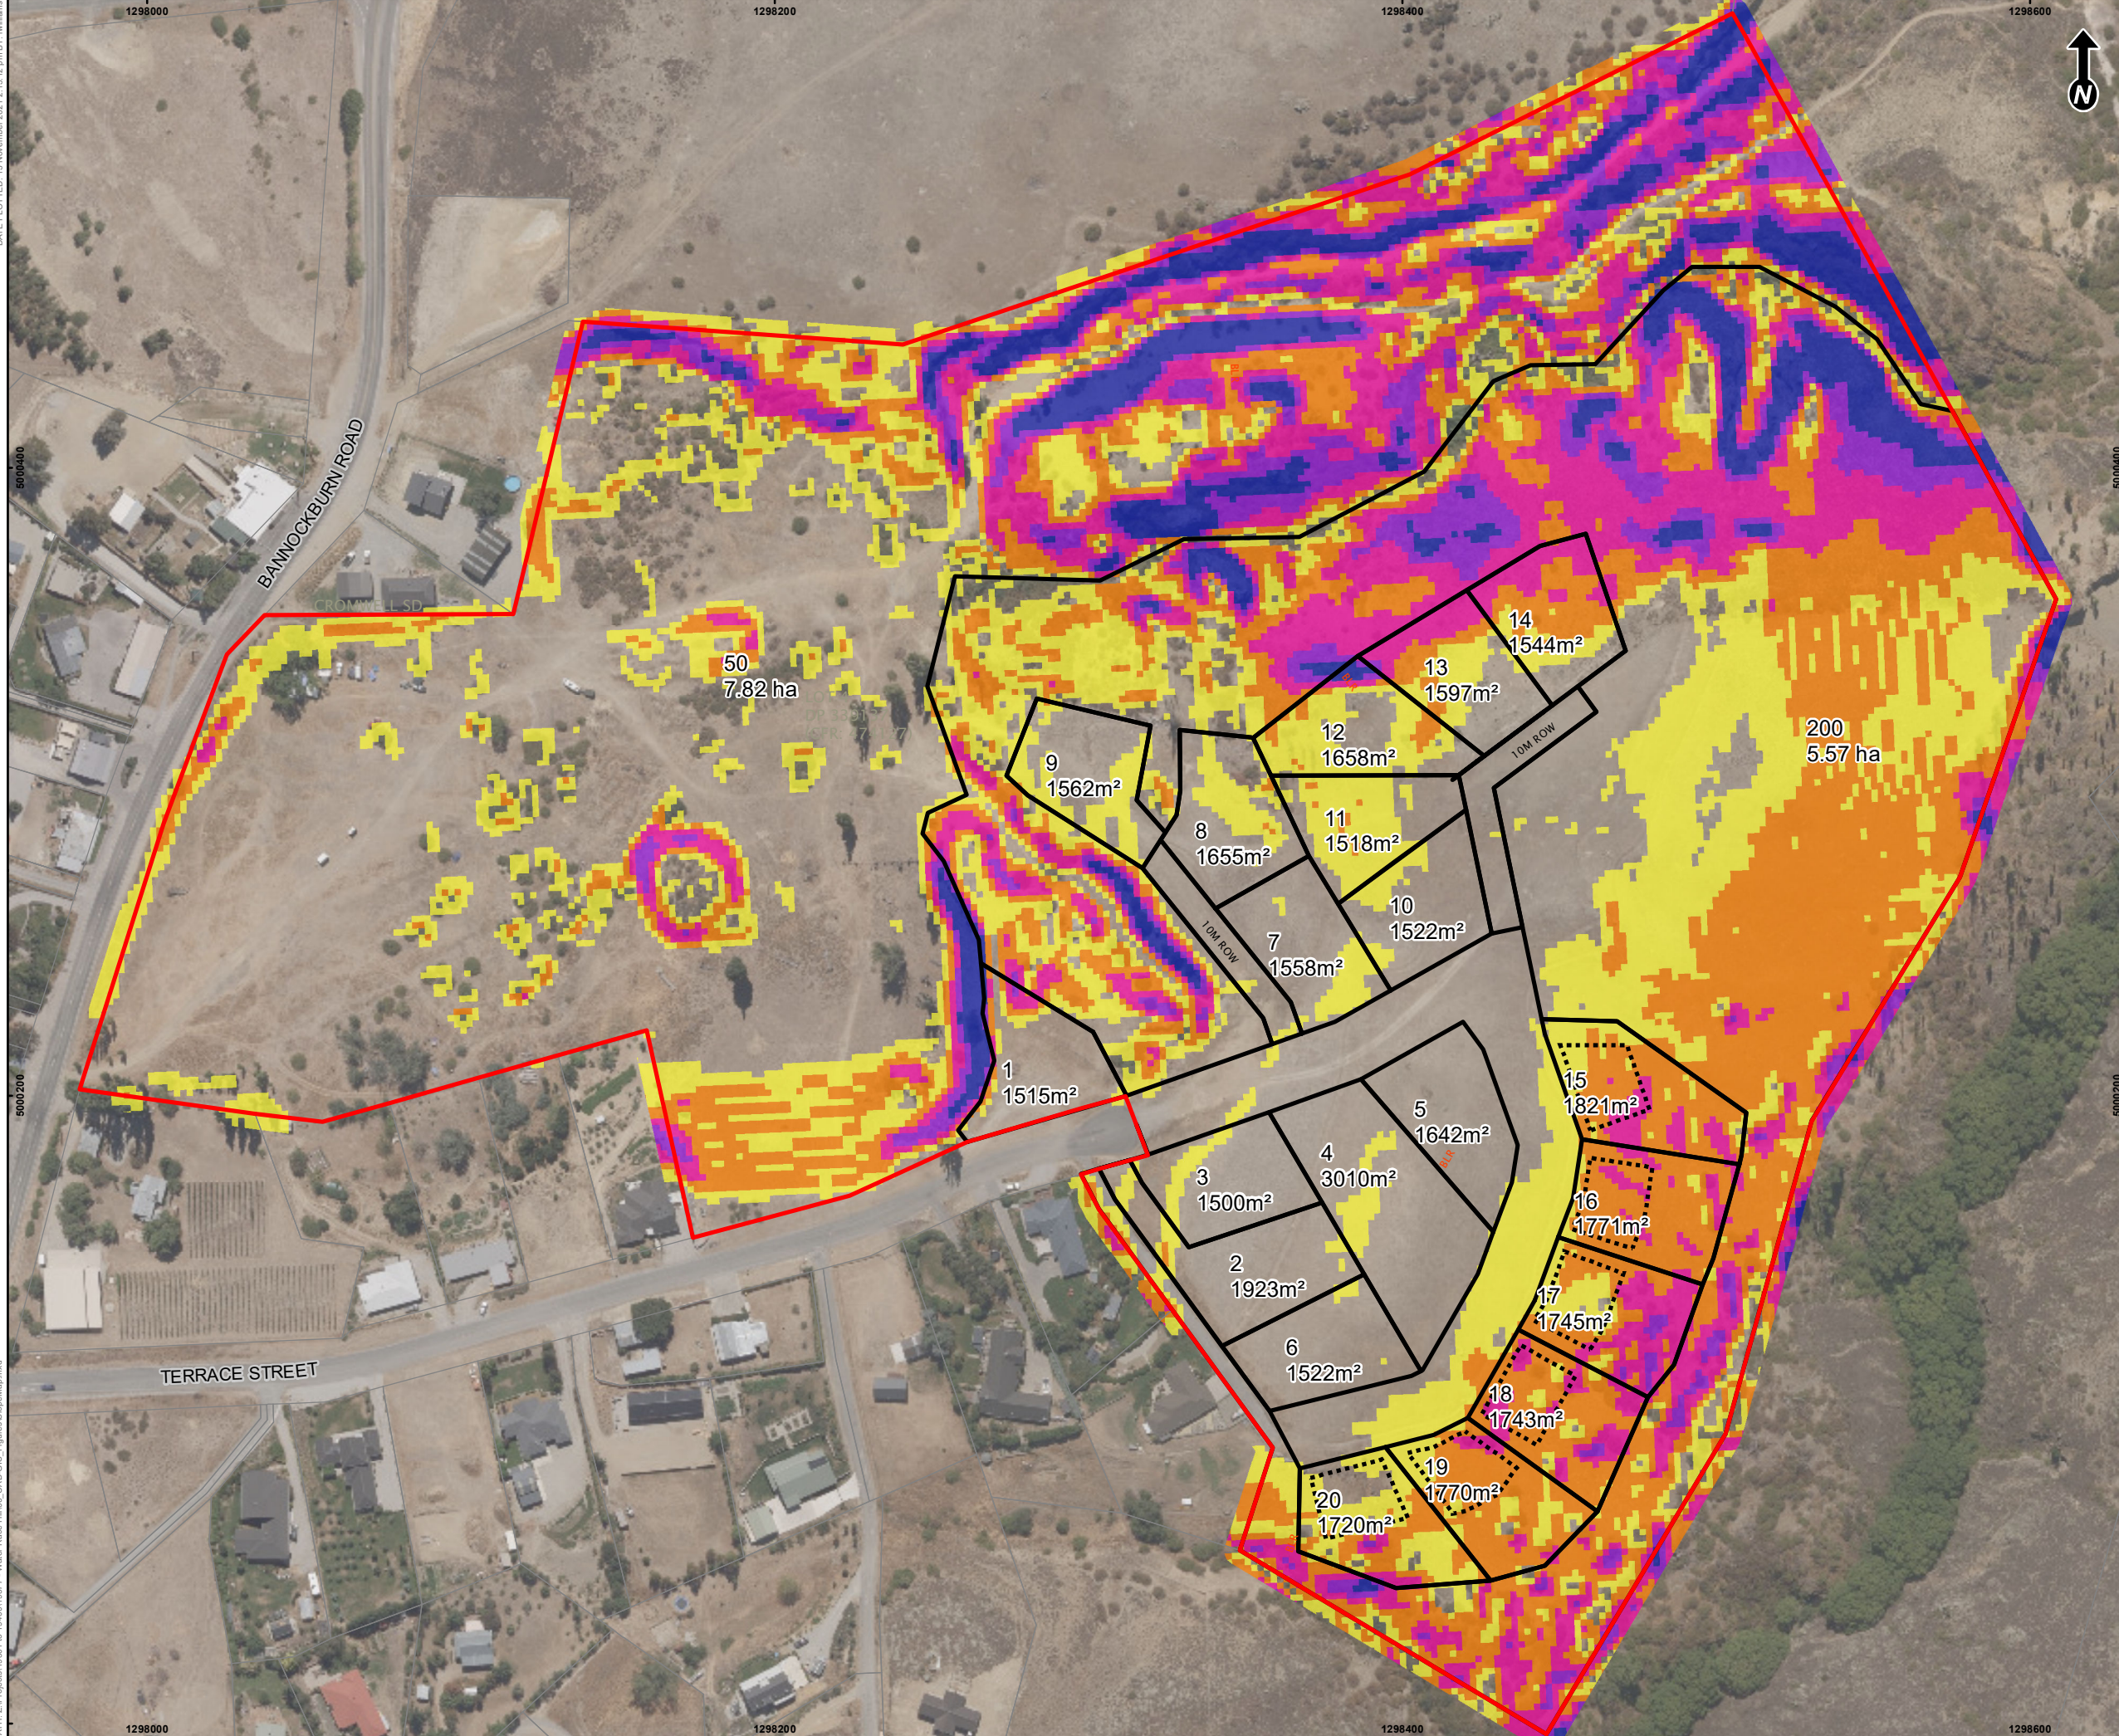
Title: <b>Site Slope Plan</b>		
Client: DJ Jones Family Trust & Searell Family Trust No. 2	Figure No: <b>1</b>	
Project: Water Race Hill Lot 4 Terrace Street	Designed: RD Drawn: RW Checked: XX Date: Nov 21	Size: A3
Proj No: 19377.000.001	Scale: 1:2,000	Revision: A

Our resulting slope hazard assessment is presented in Appendix 4. The resultant hazard mapping is limited by resolution of the drone and the vegetation coverage in specific areas that slightly alter the contours.

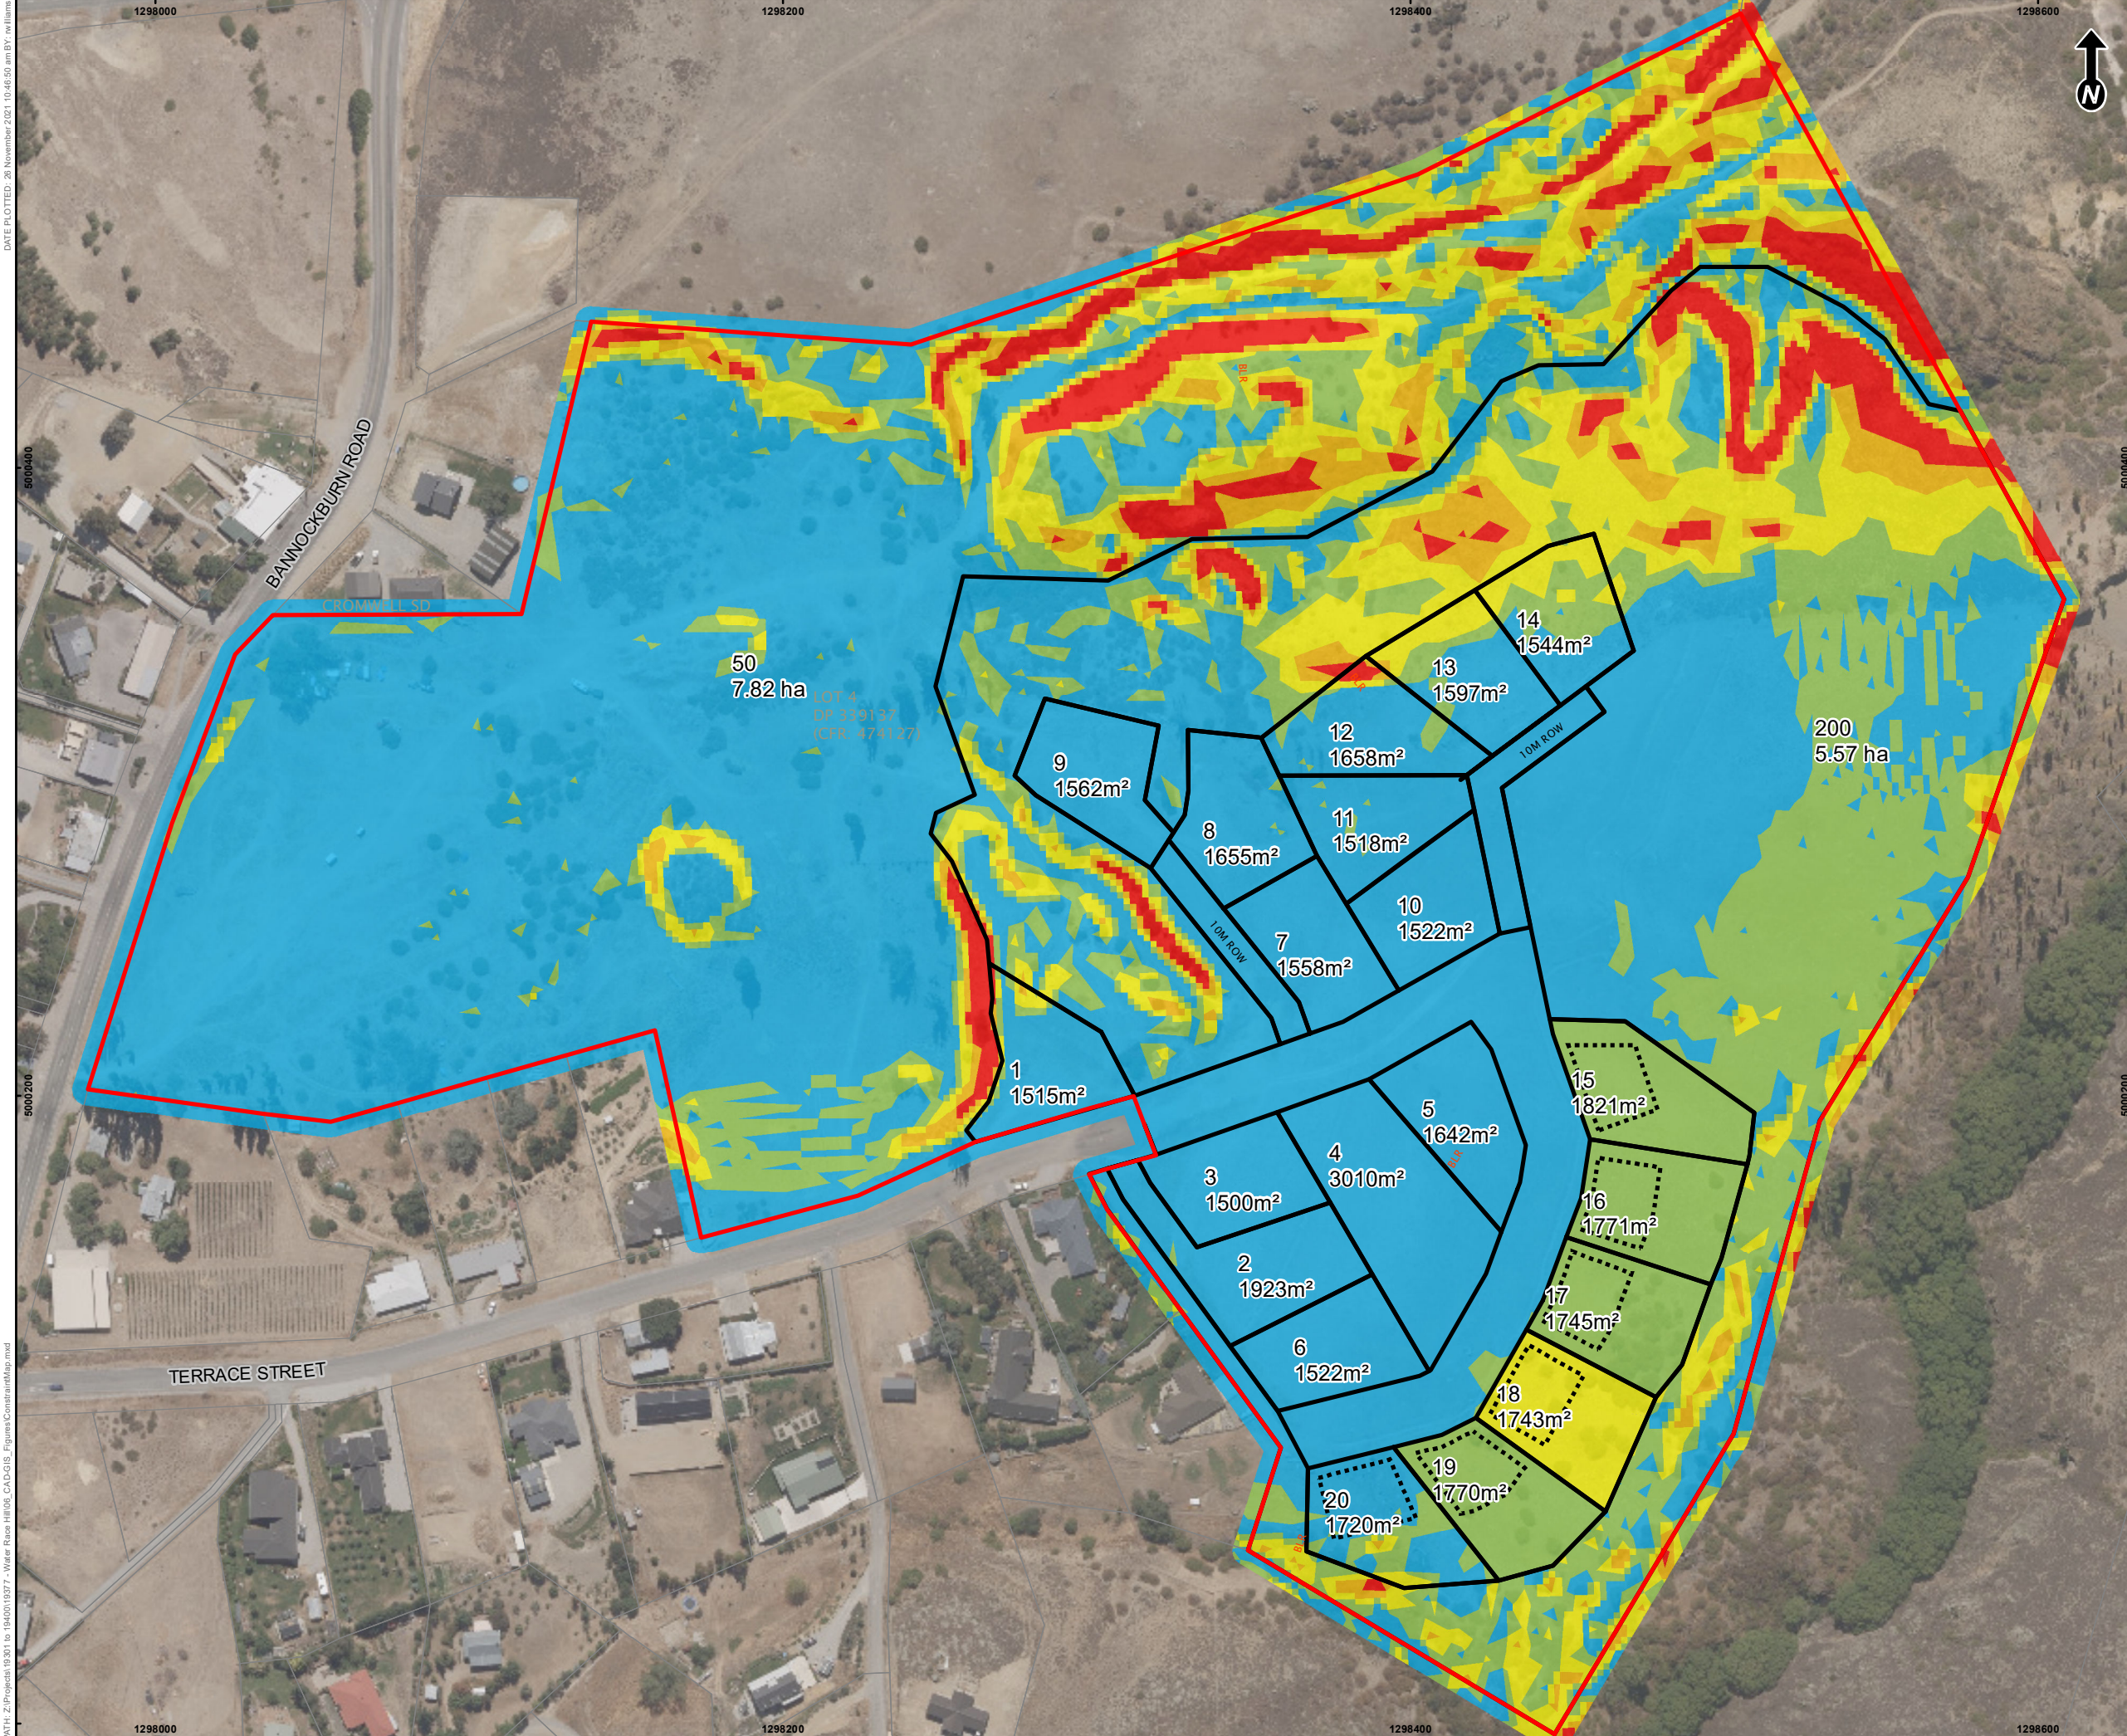
## **APPENDIX 5:** Constraint Map

To provide guidance for future development, we have prepared a constraints map outlining potential risk to the proposed subdivision by combining our knowledge of past and present site conditions to guide future works. The constraints map considers interactions between the following:

In some areas the map within Appendix 5 indicates higher development risk classes immediately adjacent to a lower risk category. In this instance, we recommend that the lot specific geotechnical investigation takes into consideration risk posed by the adjacent area such that appropriate mitigation solutions are incorporated into the development works.
