CLYDE MUSEUM BLYTH STREET, CLYDE

Conservation Plan
August 2018

Conservation Plan

Commissioned by Central Otago District Council

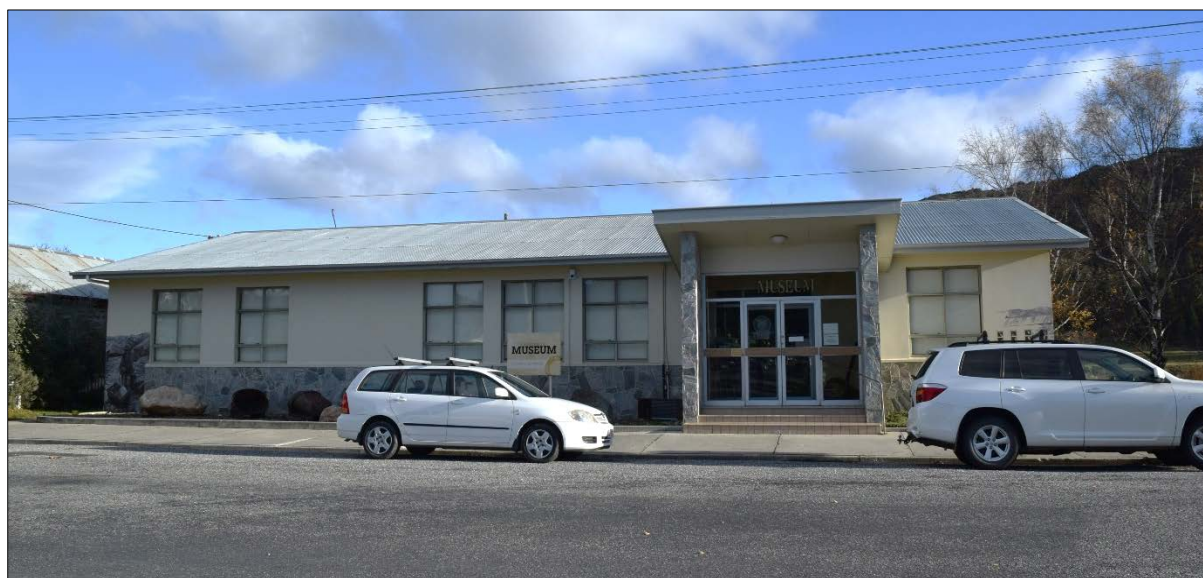
Figure 4: The Blyth Street Museum (north-east entrance elevation) with the former Courthouse just in view to the left.

The museum building is constructed in shuttered concrete covered with a cement render; along the north-western front elevation, a facing of local schist stone extends along the lower half of the building (Figure 4). The museum is covered with a corrugated galvanised iron-clad steel roof and features steel-framed glazing throughout. The entrance is covered with a square, solid canopy roof and the interior lobby is accessed via three steps covered with ceramic tiles; a pair of aluminium glazed doors with fixed sidelights leads into the interior.

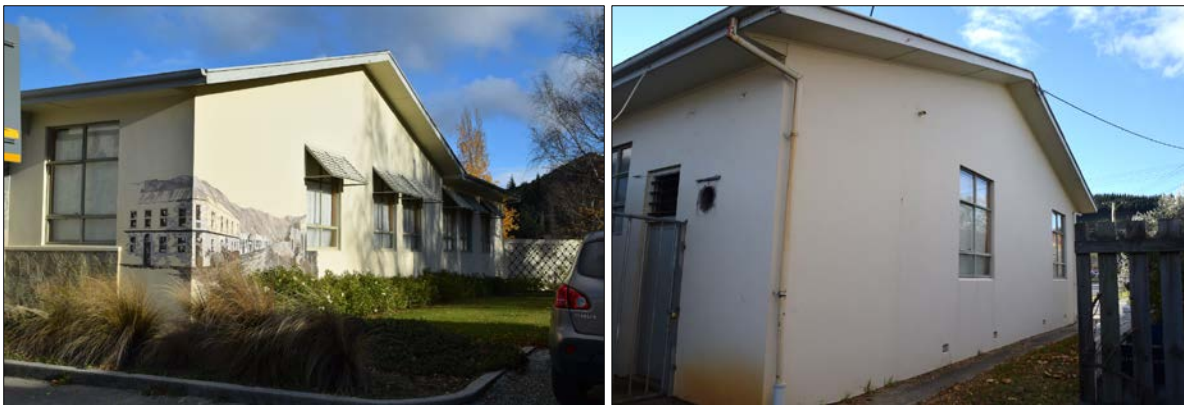
Figure 5: The north-west elevation of the museum with the Clyde mural c. 2007 (left); the south-east elevation (right).

The north-west and south-east elevations are plain rendered; a mural painting extends from the front elevation around the north-west side, which features historic vignettes from Clyde's gold mining past (Figure 5 & 6). The VCC-CHM minutes record that this was started in September 2007 (Hanning 2018).

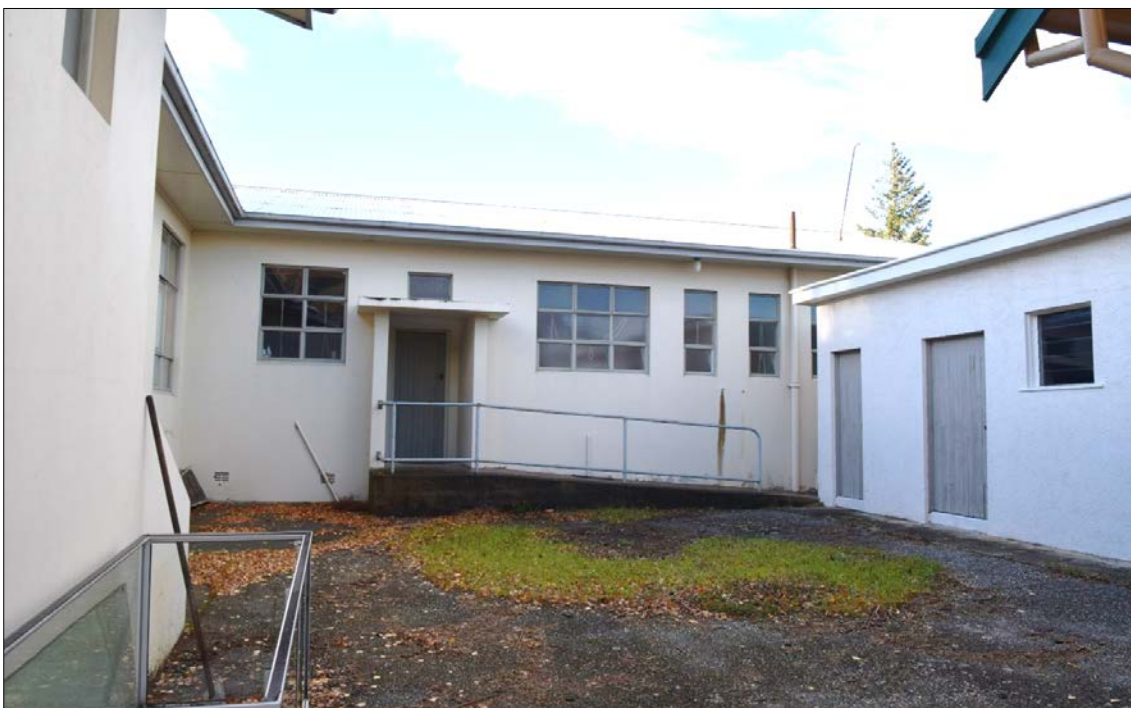
Figure 7: The rear, south-west elevation with the Ablution Block to the right of view (c.1965) and the return west wing to the left.

The rear of the museum building features a western wing that forms a small open courtyard with the two adjacent outbuildings, and the south-west elevations are rendered (Figure 7). Garden beds run along the north-west side of the building, concrete paving and gravel beds slabs along the front elevation, and rough, gravel and asphalt around the south-east and rear areas of the museum. A modern steel gate restricts access the rear courtyard area.

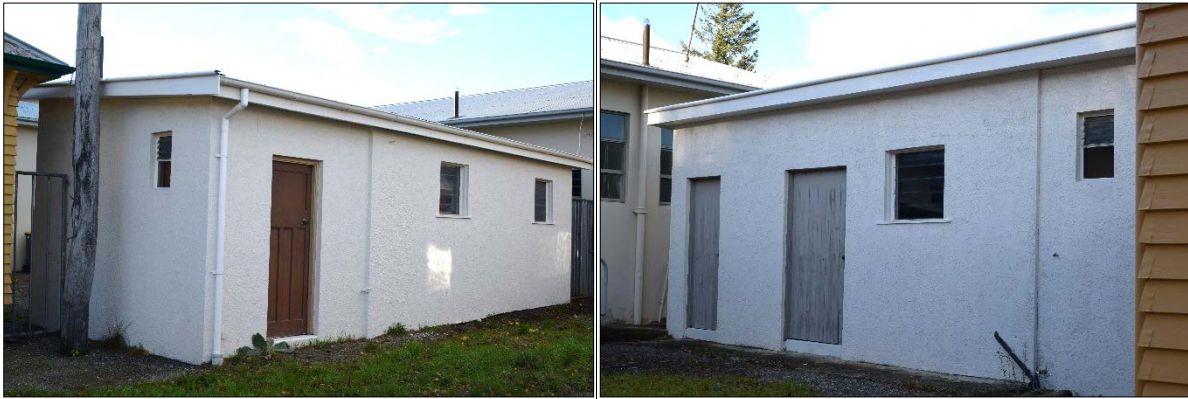
Figure 8: The Ablution Block, south-east elevation (left) and north-west elevation (right).

The outbuildings comprise a rectangular plan, cement rendered, timber framed Ablution Block covered with a mono-pitched, corrugated galvanized iron-clad roof that formerly housed toilets and additional office space (Figure 8). It has two louvre glazed windows and a timber door in the south-east elevation, a single louvre window in the south-west wall and two further louvre windows and two timber doors in the north-west elevation. The building is contemporary with the 1965 VCC office/museum building and is currently used as store rooms.

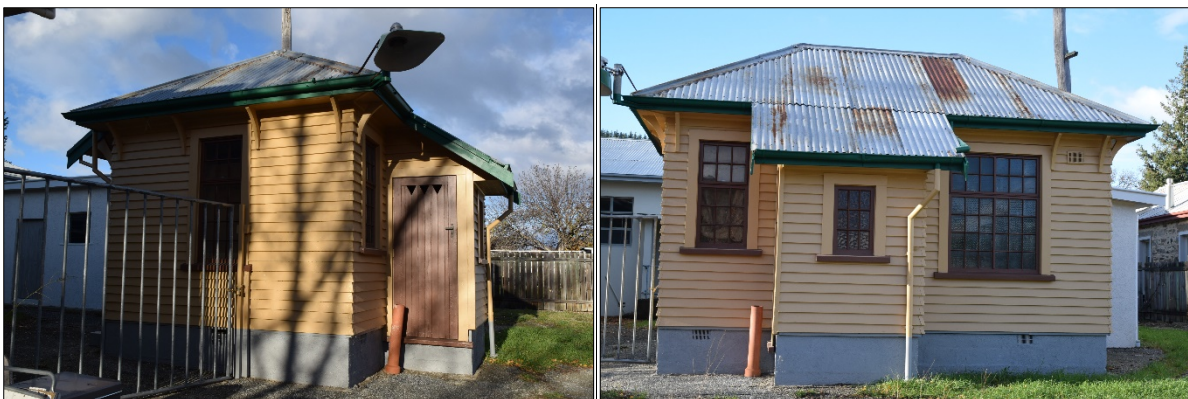
Figure 9: The former police lock-up building (c.1938) in its current location to the rear of the museum building.

The former police lock-up building is a weatherboard, timber structure, with a timber roof clad with corrugated galvanised iron sheeting (Figure 9). The lock-up features large, timber and glazed windows and a timber door in each of the south-west and north-east elevations. The building was constructed c.1938 and subsequently relocated first to the rear of the adjacent Courthouse (1960s) and then to its present position in 1999 (Jackie Gillies & Associates 2014). It is currently used for storage.

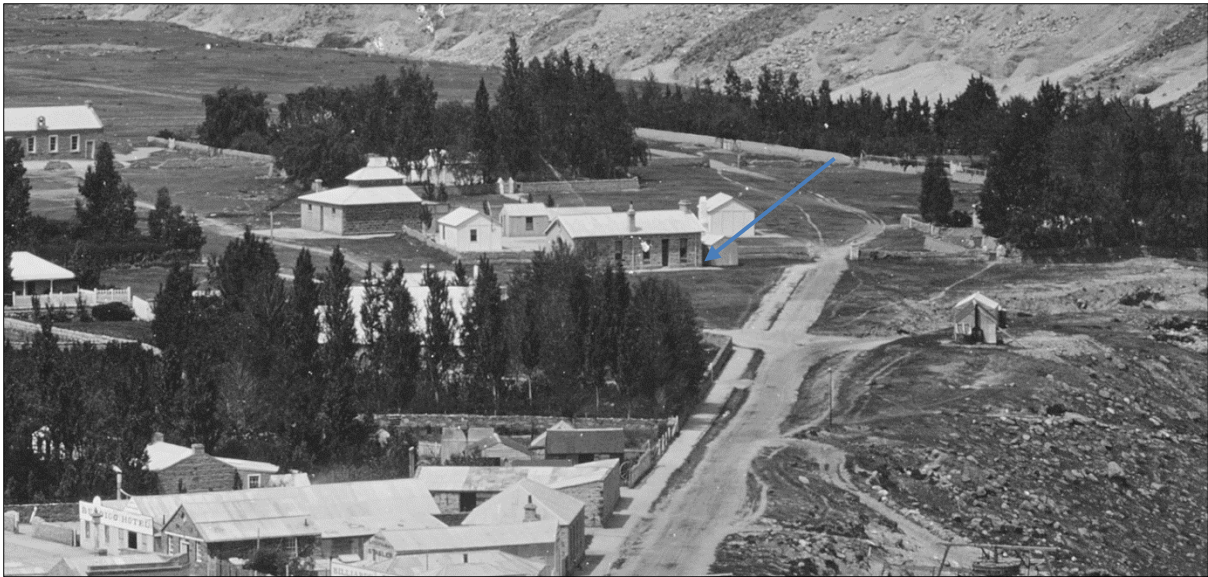
Figure 19: The Government Reserve area and 'Police Camp' around the early 1870s; the 1864 stone Courthouse is clearly visible in the centre (arrowed) with the distinctive Clyde Gaol (prison) building further left. The County Chambers (c.1878) is yet to be erected to the right of the Courthouse. Image: The Museum of New Zealand/Te Papa Tongarewa, MA_1043755.

A photograph taken around 1870 before the construction of the County Chambers building records the layout of the Government Buildings Reserve (Figure 19).

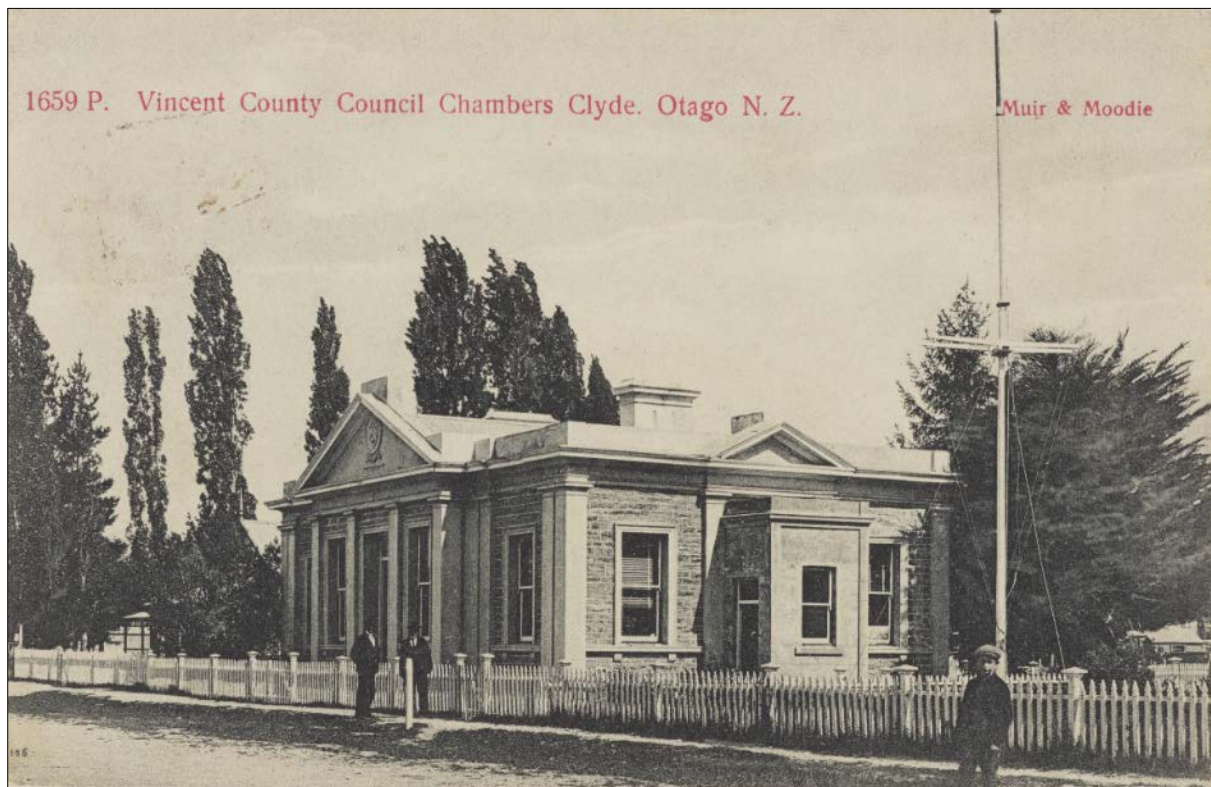
Figure 22: A view of the County Chambers taken c.1905 by Muir & Moodie showing the handsome stone building with its classical architectural detailing. Image: Museum of New Zealand/Te Papa Tongarewa, MA_1407409

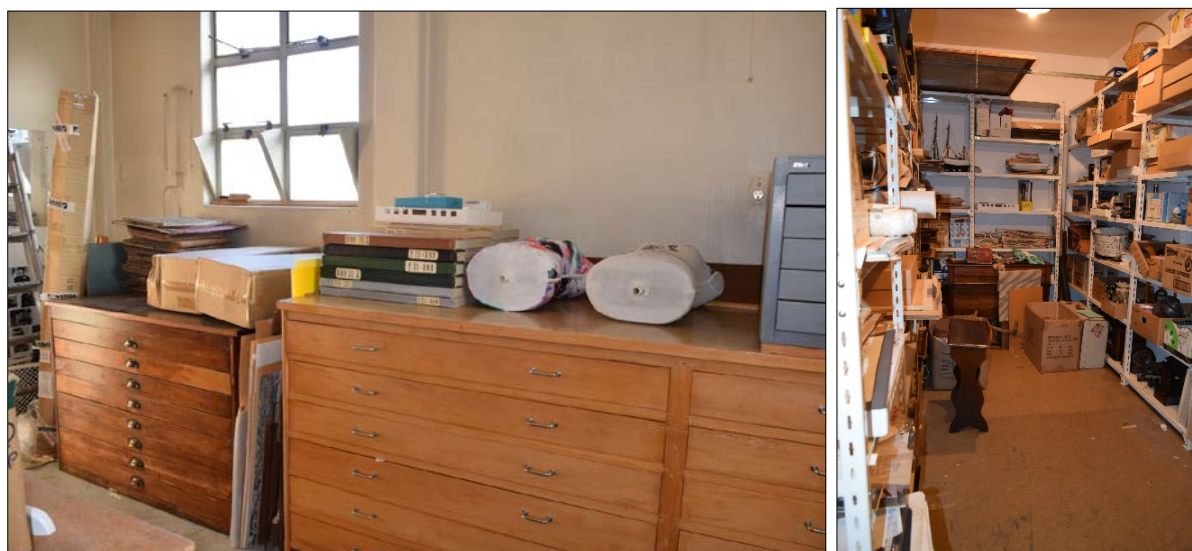
Figure 27: Collections work and storage rooms within the Blyth Street Museum.

focus on the development of Clyde and its surrounding area from the arrival and use of the land and its resources by Māori, the gold rush years, the early development of Dunstan/Clyde as a township, everyday life in the nineteenth and early twentieth centuries, and a changing series of topical displays such as the current World War One focus. The Blyth Street building also houses the collection's records and archives, non-displayed items in storage vaults and provides essential workspaces for the accessioning, treatment and preparation of collection items as they are acquired (Figure 27).
