**In the Matter** of an application to the Central Otago District Council and Otago Regional Council for resource consent to establish and operate a gold mining activity at 1346 – 1536 Teviot Road, Millers Flat

**Reference** RC230325 (Central Otago District Council)  
RM23.819 (Otago Regional Council)

**Evidence of Colin Macdiarmid on behalf Hawkeswood Mining Limited  
(Geotech and Temporary Batter Slope Stability)**

## Slope Stability Analysis - Temporary Mine Batters Millers Flat Goldmine, 1346-1536 Teviot Road

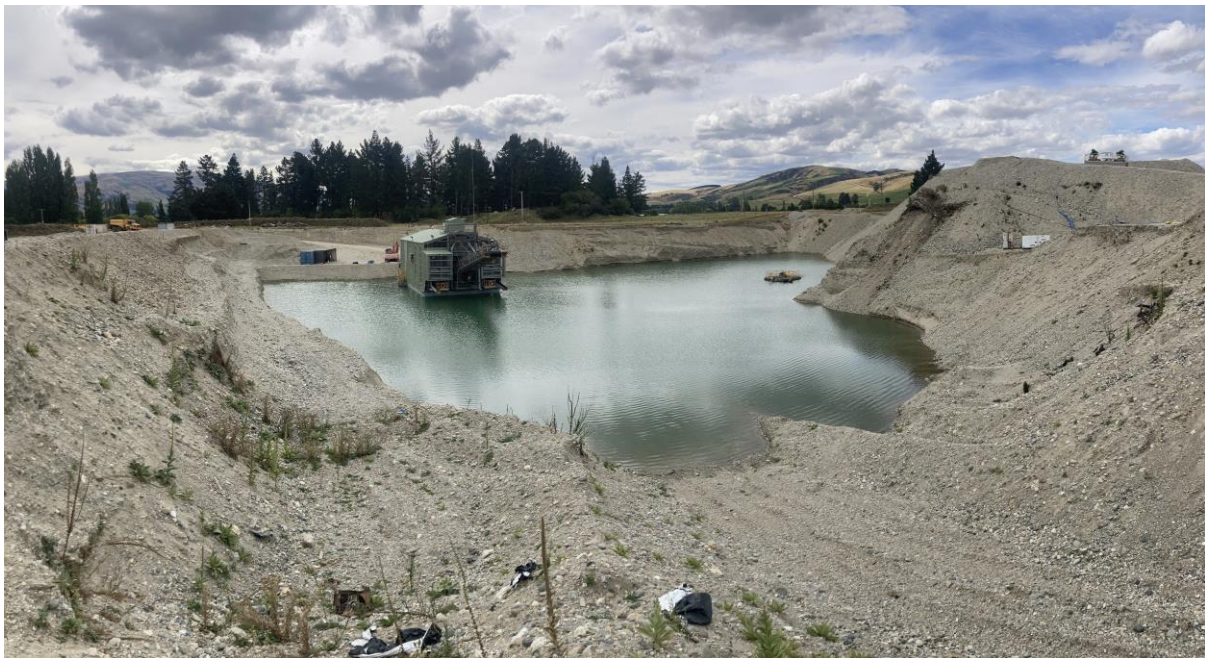
**Photo 1. Panoramic view of the existing test pit at 1346-1536 Teviot Road (17/02/2024).**

Mining will commence within the test pitting (Stage 1), as shown in Photo 1, before advancing towards Stage 2. Stripping of overburden soils, mining of wash gravel and backfilling of the open pit will occur contiguously so that only short sections of batter remain open during the mining process, rather than their full length.

The test pit on site, provides a working example of batter cuts which can be achieved within the onsite outwash deposits. The batters within the test pit were created by forming a series of stepped sub-vertical benches with an overall slope inclination of between 60-70°. The pumped groundwater table below coincides with the wash gravel layer targeted for processing via the floating recovery plant.

The batter cuts within the test pit were left open for around 6 months without any slope instability before being re-buttressed with backfill. Existing slopes within the test pit on the northwestern edge of the pond have also remained open since at least November of 2022, close to 18 months prior to our inspection on 17/02/2024. Despite this, there are no signs of significant instability other than superficial erosion and fretting of the free face.

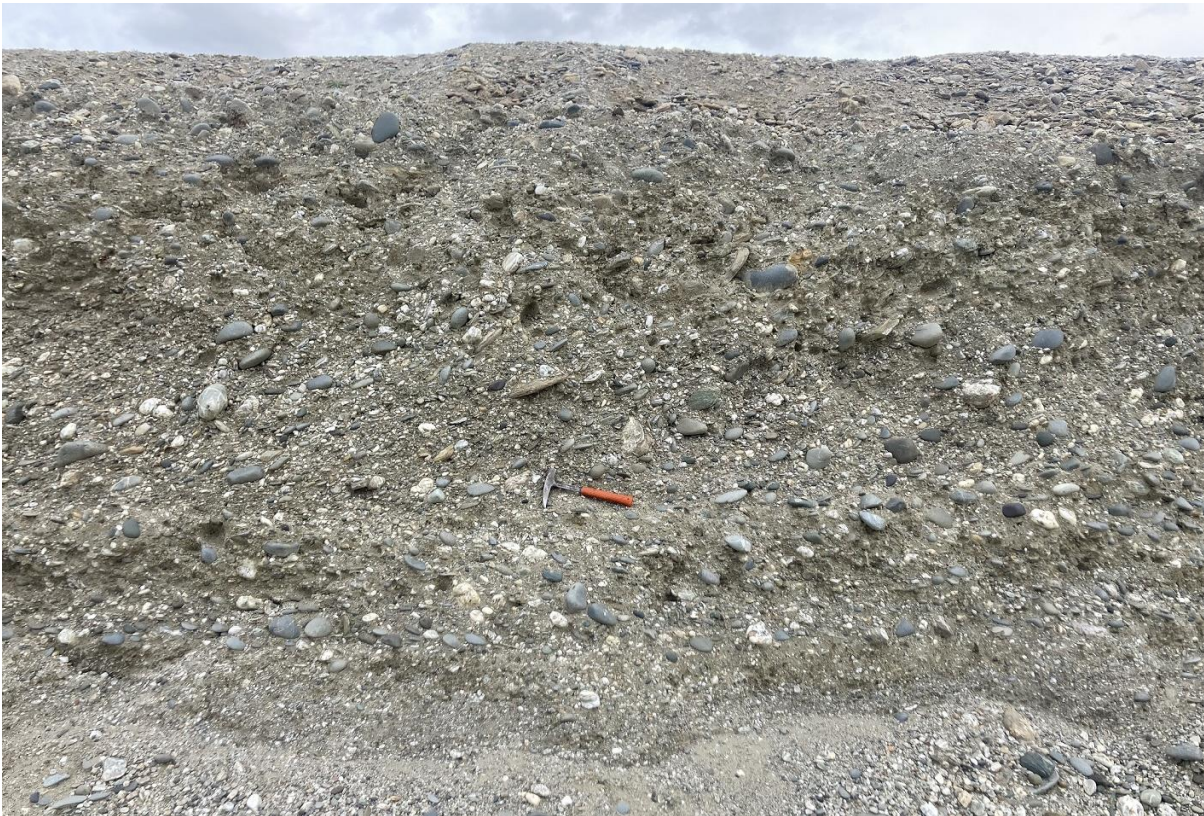
**Photo 2. Outwash gravel exposed in a bench cut within the test pit. This particular face is 4 m high and cut sub-vertically. Geological hammer for scale in the centre of image.**

Subsurface soils observed within the test pit area comprise medium dense (tightly packed) outwash gravel to the full depth of the existing pit, as shown below in Photo 2. A general log of the outwash soils was made during our inspection and comprises the following:

Some thin layers of outwash sand are also present within the pit walls, albeit discontinuous. The outwash gravels exhibit a relatively high degree of apparent soil cohesion enabling batter cuts to be over-steepened beyond the natural repose angle (refer Photo 2 below). The outwash deposits are underlain by regionally extensive schist bedrock which will form the termination depth of the mine pit. Bedding within the outwash terrace is generally expected to be sub-horizontal.

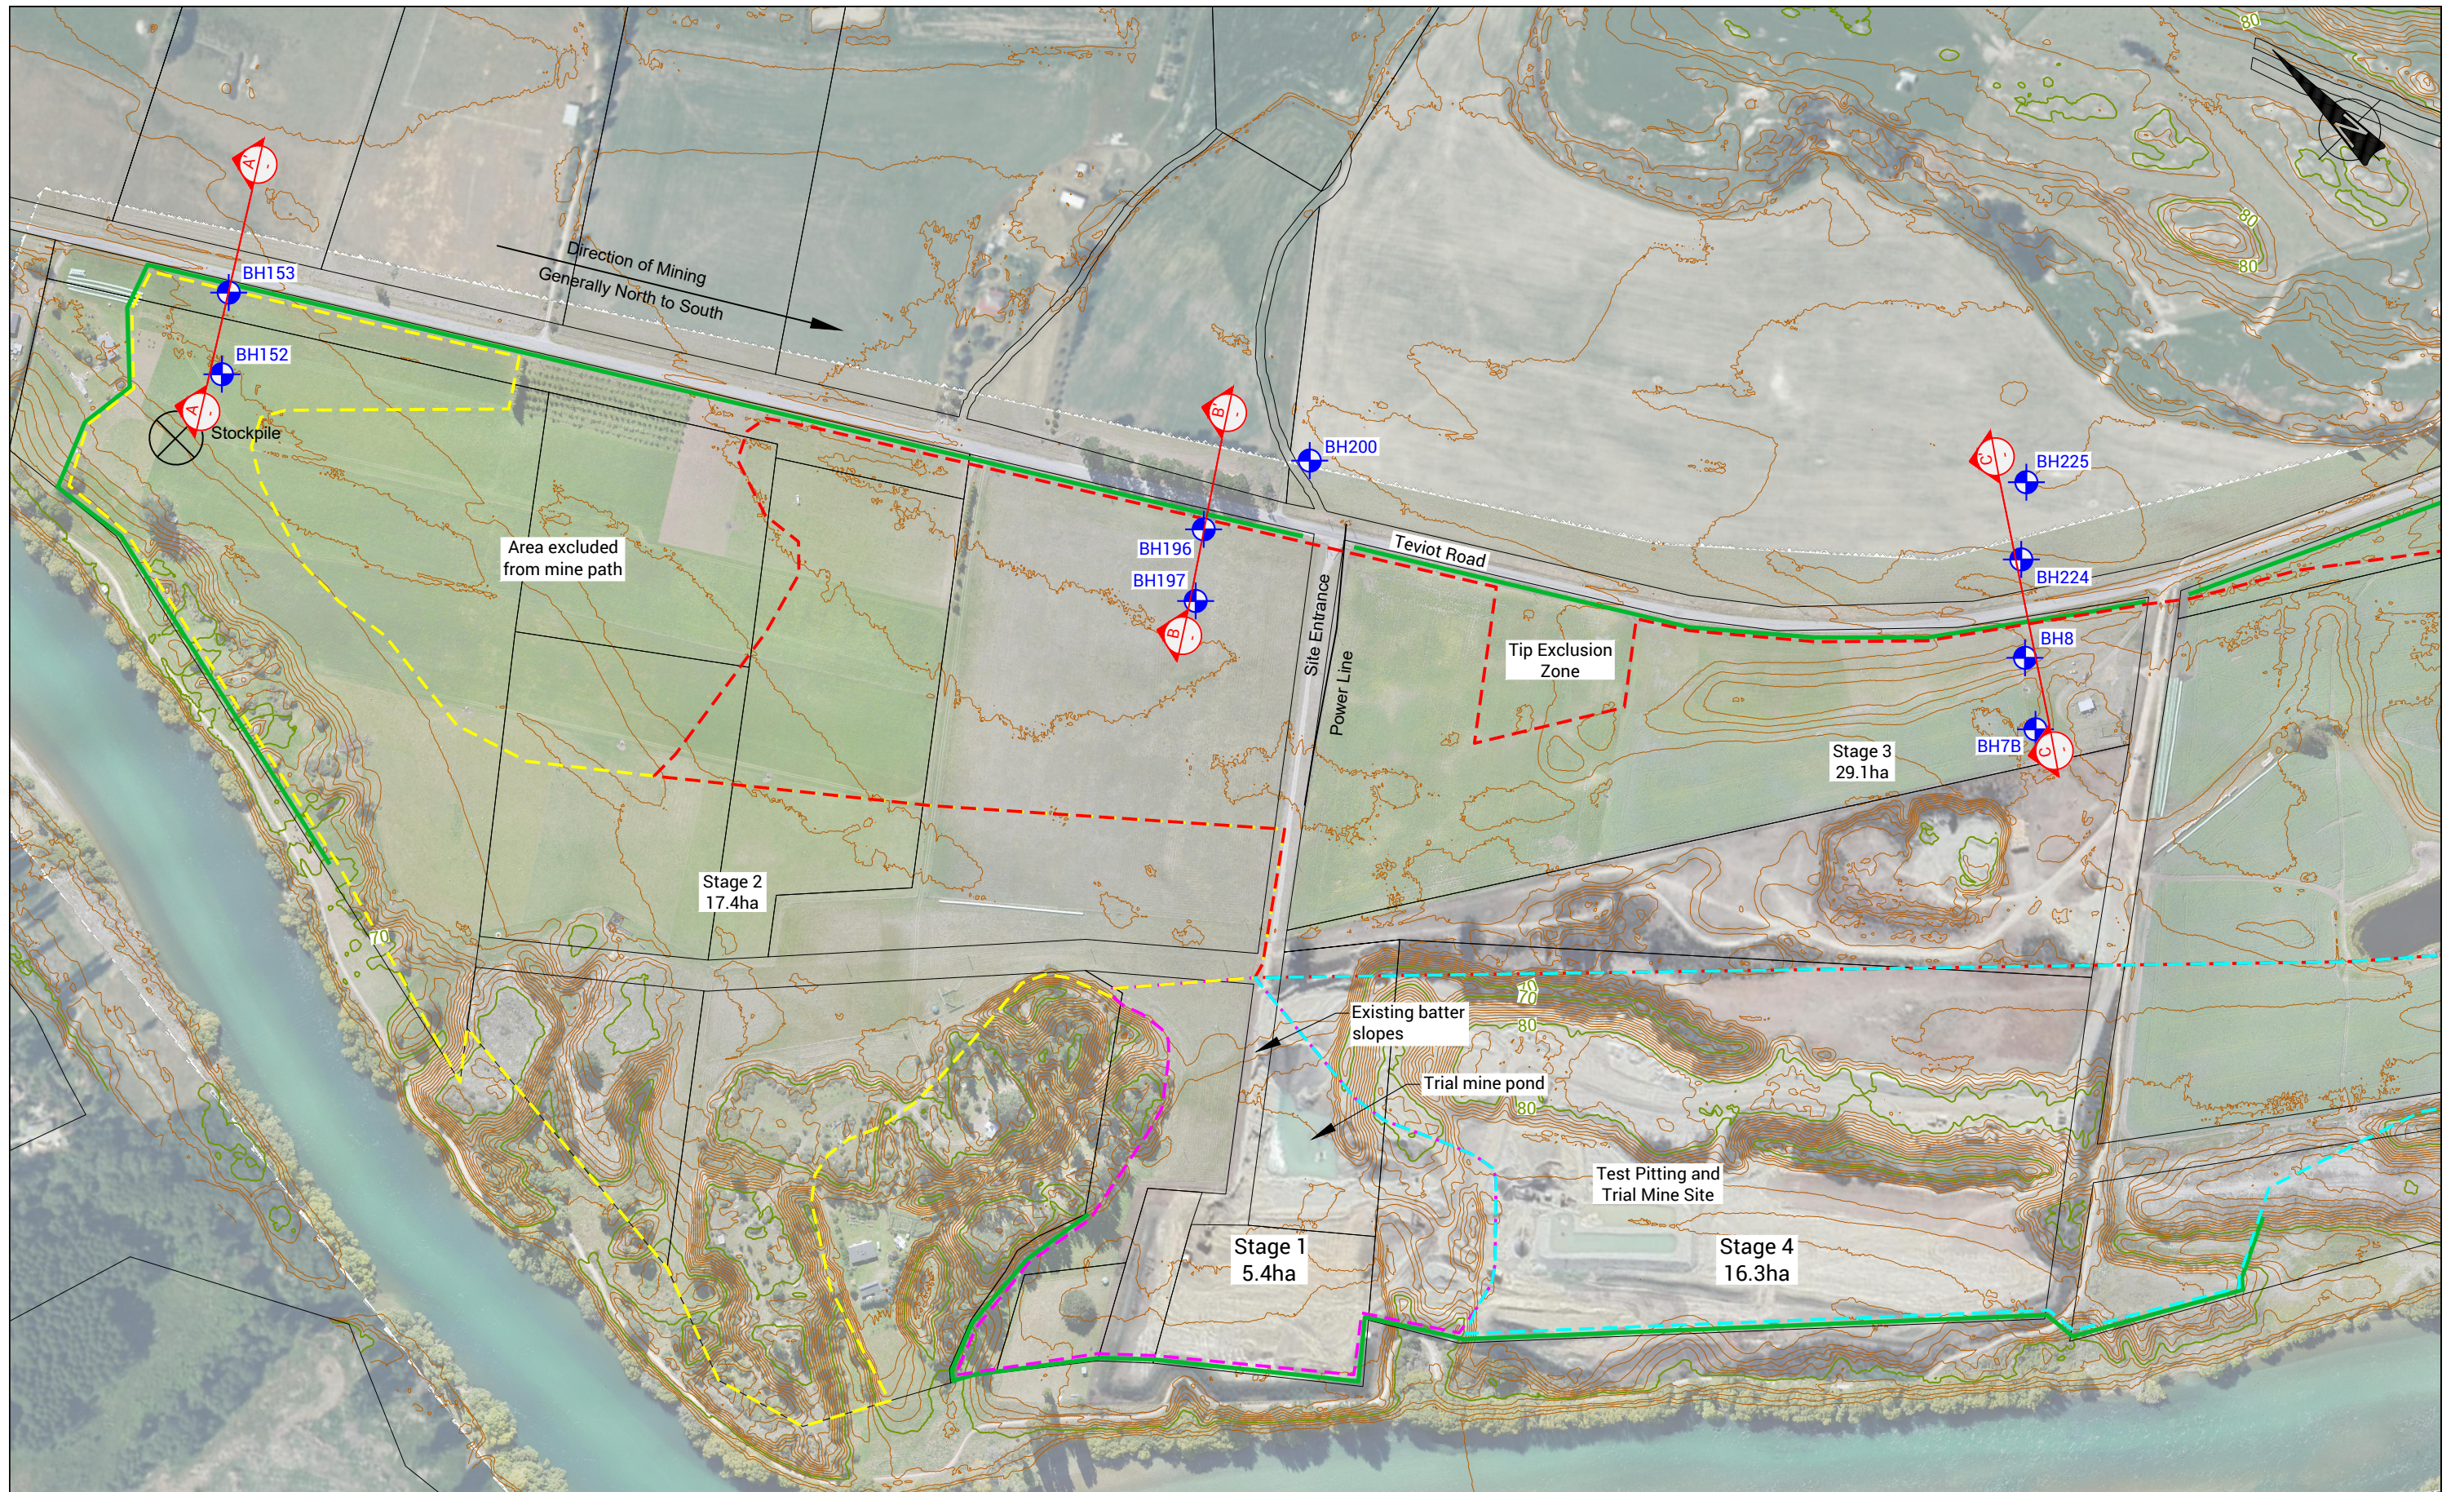
FIG No:  
Appendix A, Figure 1

**Hawkeswood Mining Limited**  
1346-1536 Teviot Road, Millers Flat  
Slope Stability Analysis  
Site Plan

The mine layout and staging plan, as applied for consent, is attached as Figure 2, with relevant features annotated. The existing ground surface through Teviot Road, relative to projected batter cuts, is shown on the geological cross-sections presented on Figures 2a-2c attached.

- Mine Layout and Staging Plan (Figure 1); and,
- Geological Cross-Sections (Figures 2a-2c).

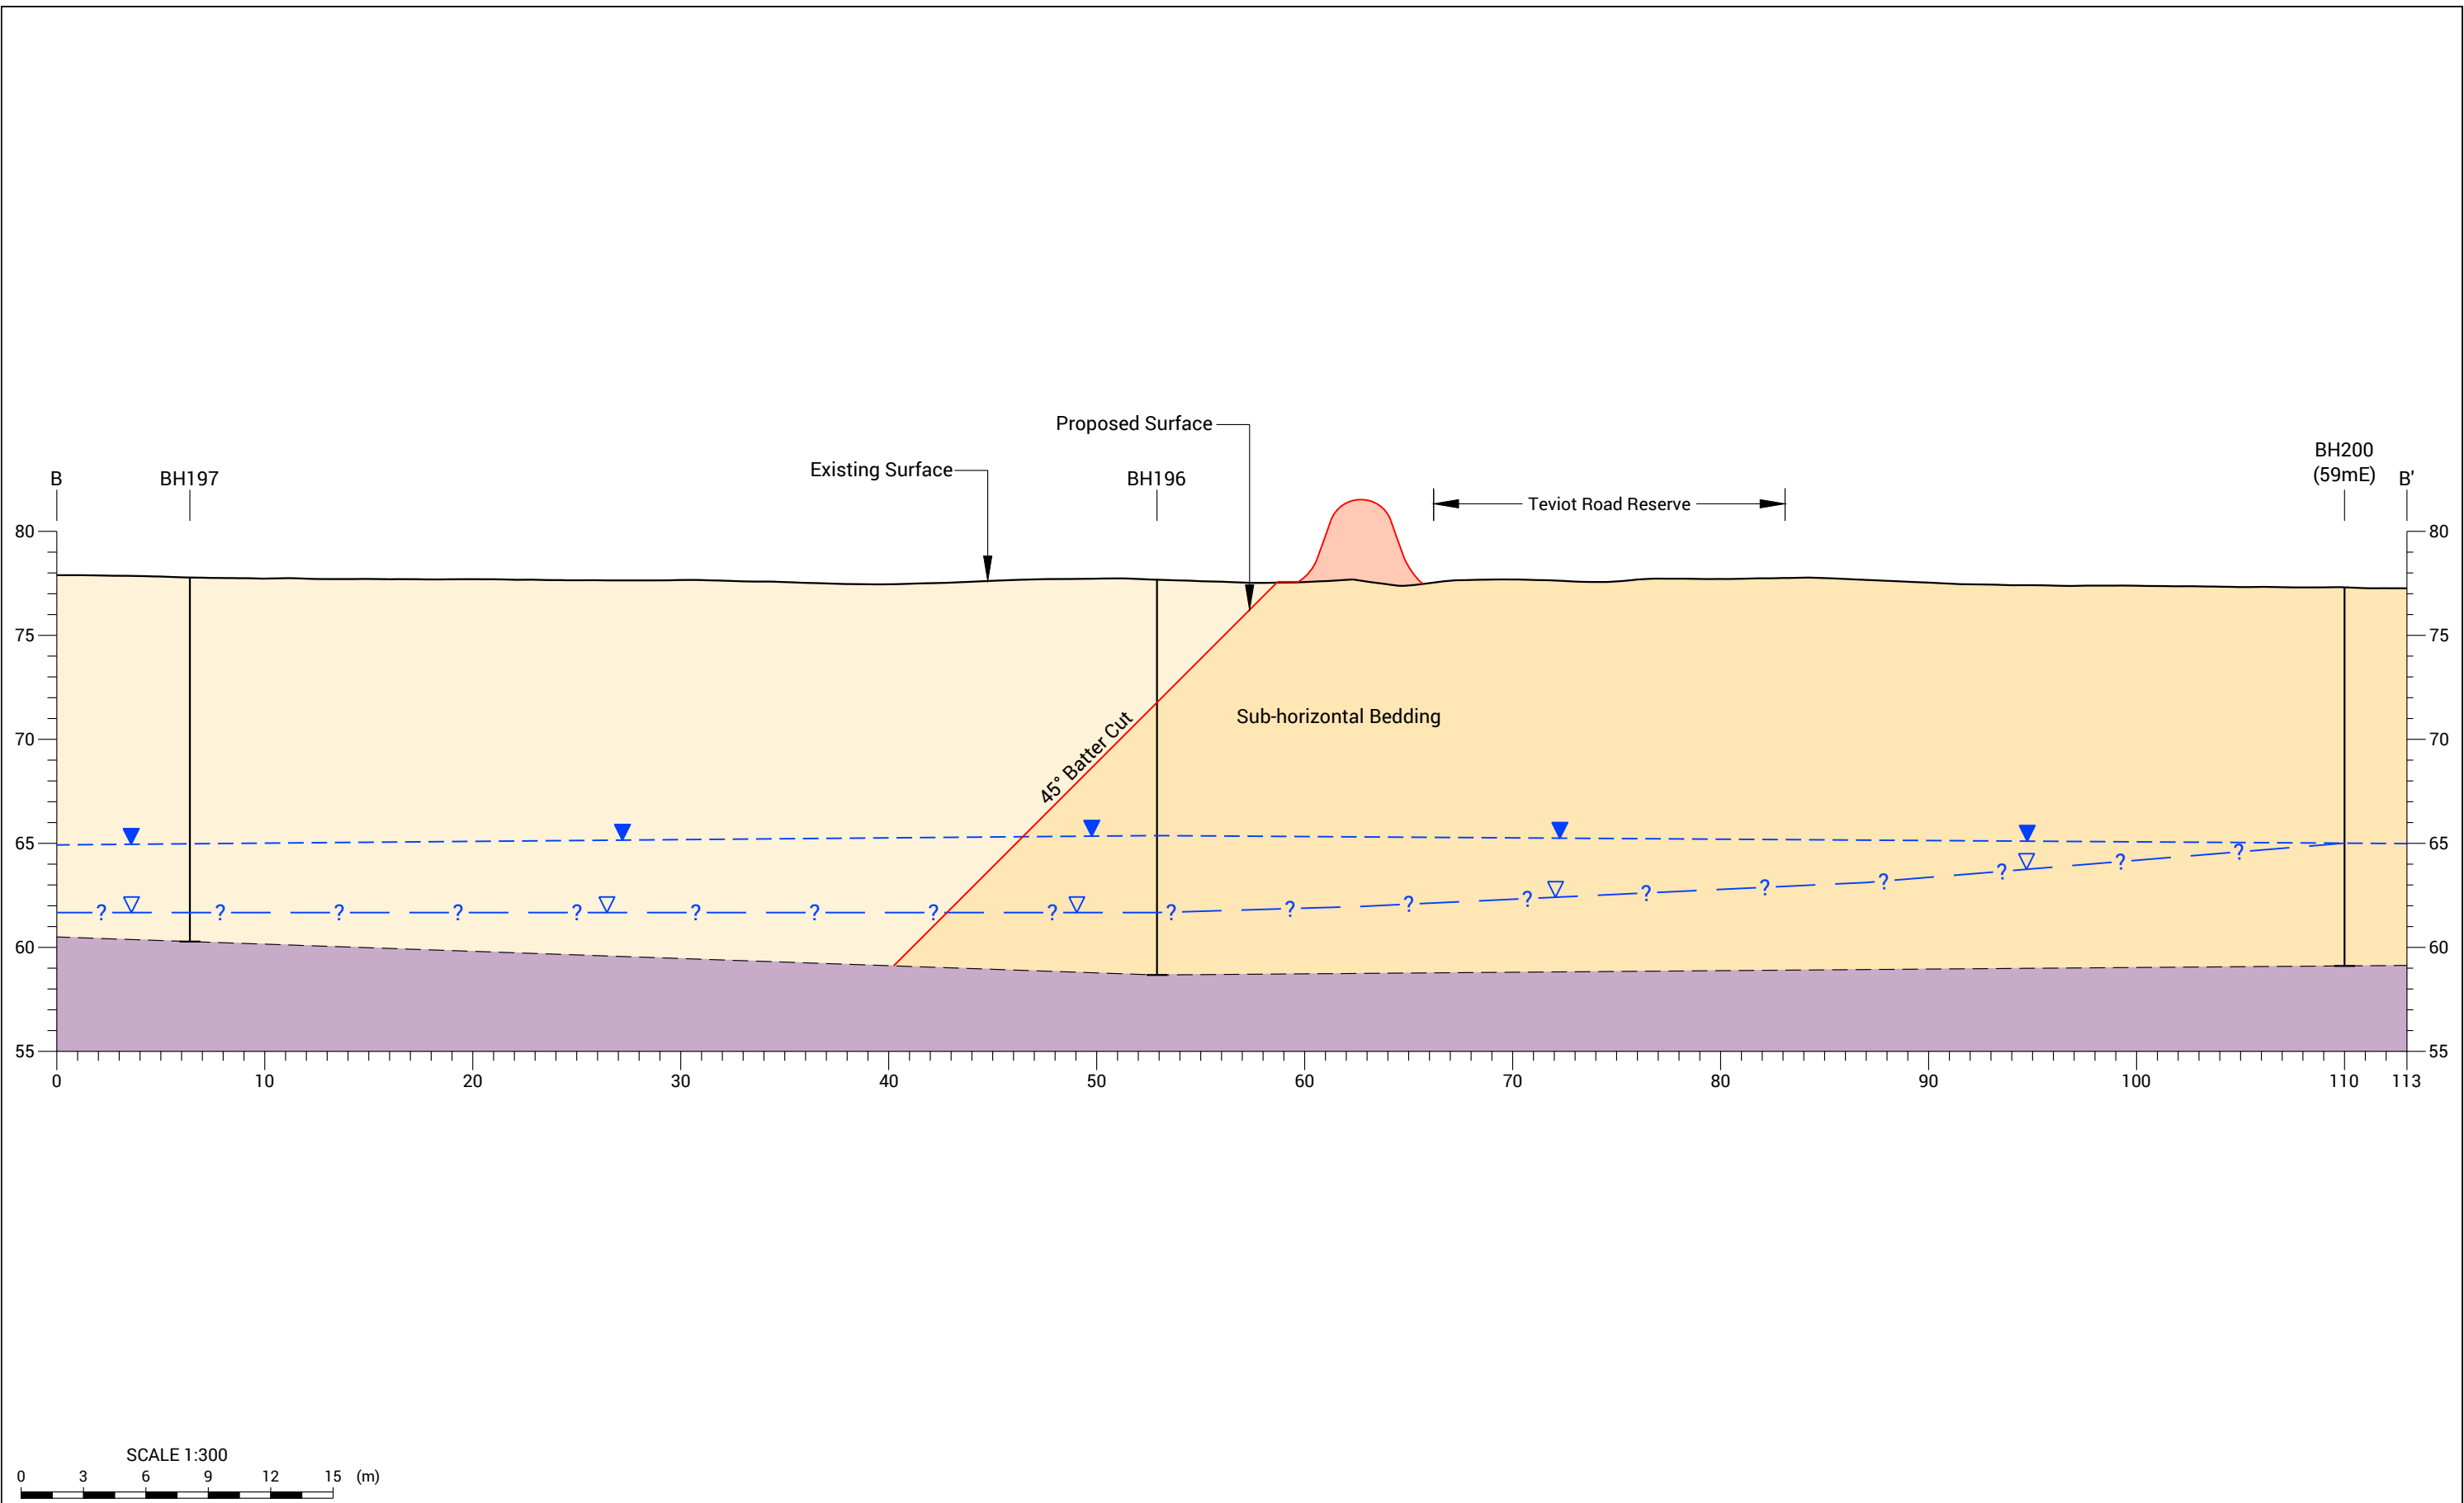
FIG No: Appendix A, Figure 2b	REV. 0
----------------------------------	-----------

**Hawkeswood Mining Limited**  
 1346-1536 Teviot Road, Millers Flat  
 Slope Stability Analysis  
 Cross Section B

The mining method requires a temporary draw-down of the static groundwater table to around 3 m above the bedrock contact to facilitate processing of the wash gravel layer. This is indicated on the geological cross-sections attached.

We have modelled the surcharge from Teviot Road and a soil bund at the batter crest based on the bund profile and setbacks supplied by the Applicant, as shown on Figures 2a-2c. We understand the bund is required for visual screening of the mine site; however, the bund applies loading to the crest of the slope and decreases stability. The provided setback between Teviot Road and the batter crest is around 7.5 m.
