Sampling Summary Report - 1484 and 1534 Teviot Road

Reference: 361-22 Millers Flat Stockyards

Date: 12 February 2024

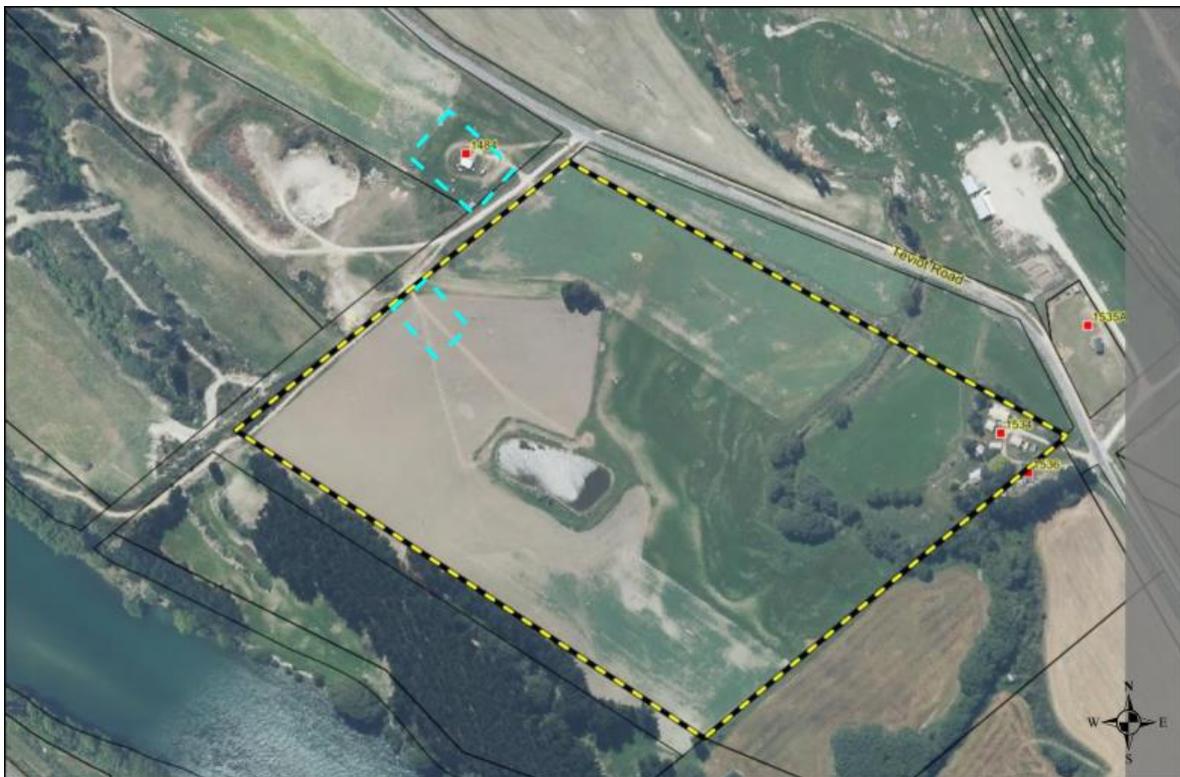
Figure 1: The property at 1534 Teviot Road, outlined in a yellow dashed line with the areas subject of this investigation outlined with a dashed blue line (CODC GIS, Digital map data sourced from LINZ, CC BY 4.0 NZ).

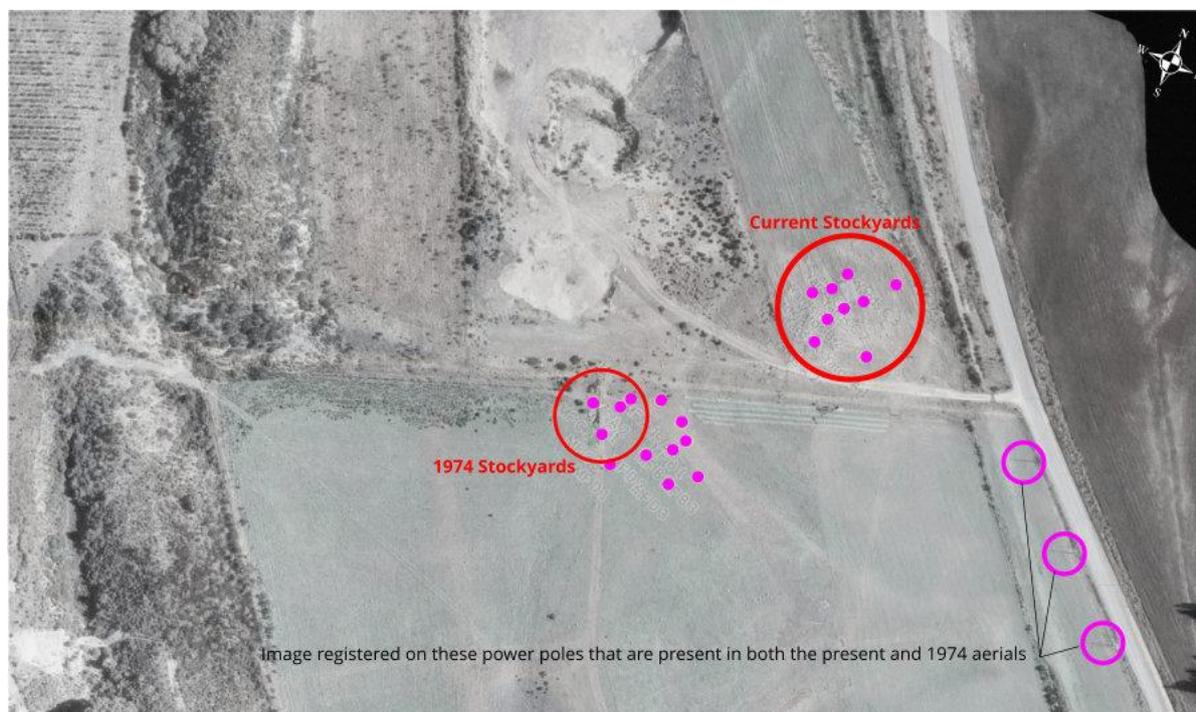
The historical photography shows the old yards within 1534 Teviot Road are not present in any image prior to and including 1968 but are present in the 1974 (Figure 2). The yards are no longer evident in the imagery from 1980 and 1983 (not shown), however these images are of poorer quality. The former yards are confirmed to be absent by the next image in 2005. The current yards are not present in the 1983 image but are present in the 2005 Google Earth image. The farm shed located by the current yards is not present in 2005 but is evident in a Google Street View image dated January 2008.

Figure 2: The stockyard sites are shown as red circles over the 1974 aerial with sampling locations shown with lilac dots. The location of the 1974 stockyards was confirmed by overlaying the 1974 image on a current Garmin Maps image with the sampling locations and scaled and registered against the three power poles circled in lilac (Sourced from <http://retrolens.nz> and licensed by LINZ CC-BY 3.0).

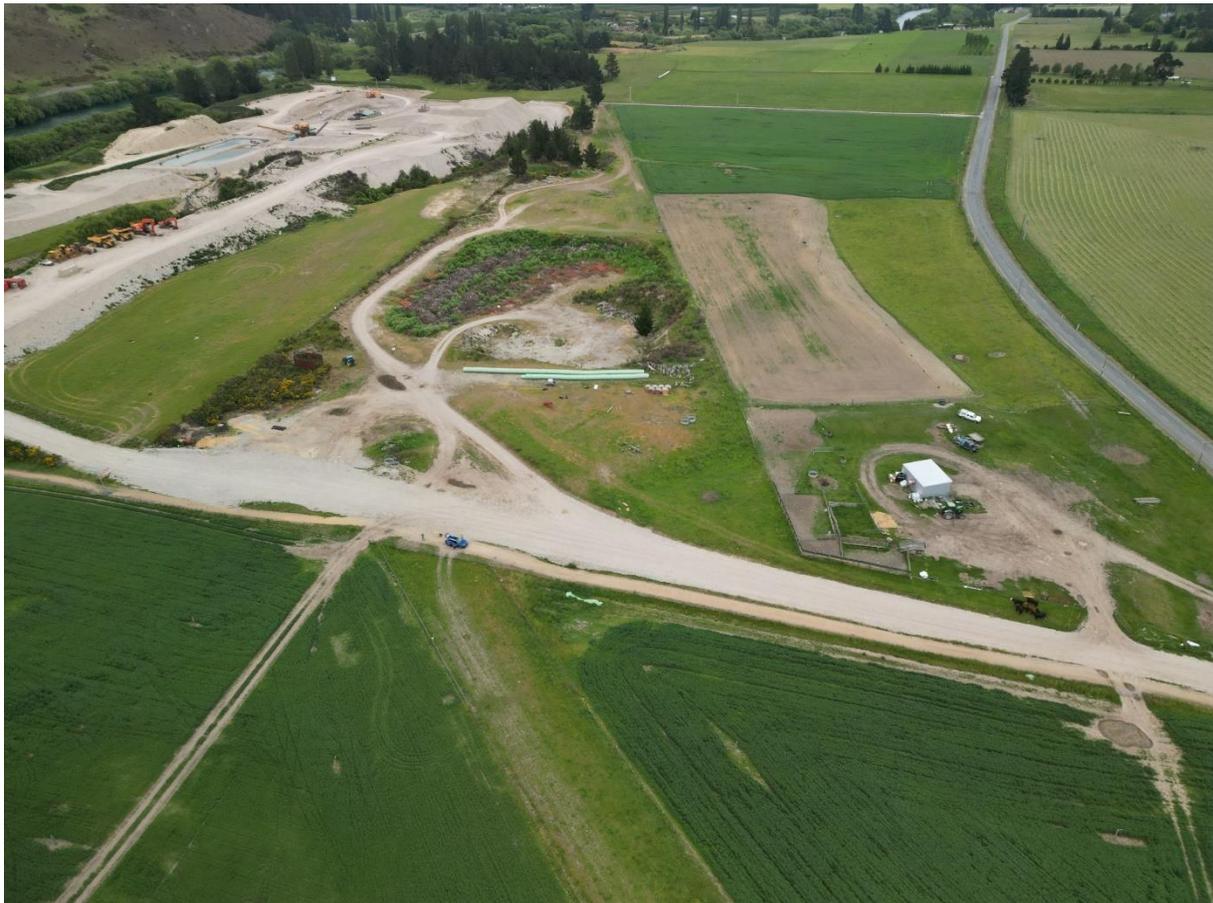
The location of the old yards was on a low gravel ridge to the south of the present gravel access road and farm track. This feature is evident as the more sparsely vegetated feature in the central foreground of Figure 3 to the right of the farm track. There is no evidence of the yards remaining at this location.

The current stockyard area is located beside the farm shed on the right hand side of Figure 3. These yards and shed are a relatively recent construction and post-date the historical use of persistent pesticides such as Organochlorine Pesticides (OCP). The shed is used to garage a tractor and agricultural spray unit and to store bulk agrichemicals. It was used for hay storage in the 2008-2012 Google Street View images. There is a 2,000 l above ground diesel tank at the rear of the shed as shown in Figure 4. The shed includes a walled off chemical store at the rear of one of the shed bays as shown in Figure 5. The only agrichemicals stored were various brands of glyphosate (herbicides) in a mix of bulk containers of between 20 l and 1,000 l capacity. The shed area is tidy but there are extensive areas of bare ground surrounding the shed that would indicate that glyphosate has been spilled or equipment washed out in this area. There is no evidence of significant fuel spillage associated with the fuel tank.

Figure 3: Aerial photo showing the current yards and shed area on the right and former yard location on the left by the intersection of the farm track and access road (27 November 2023).

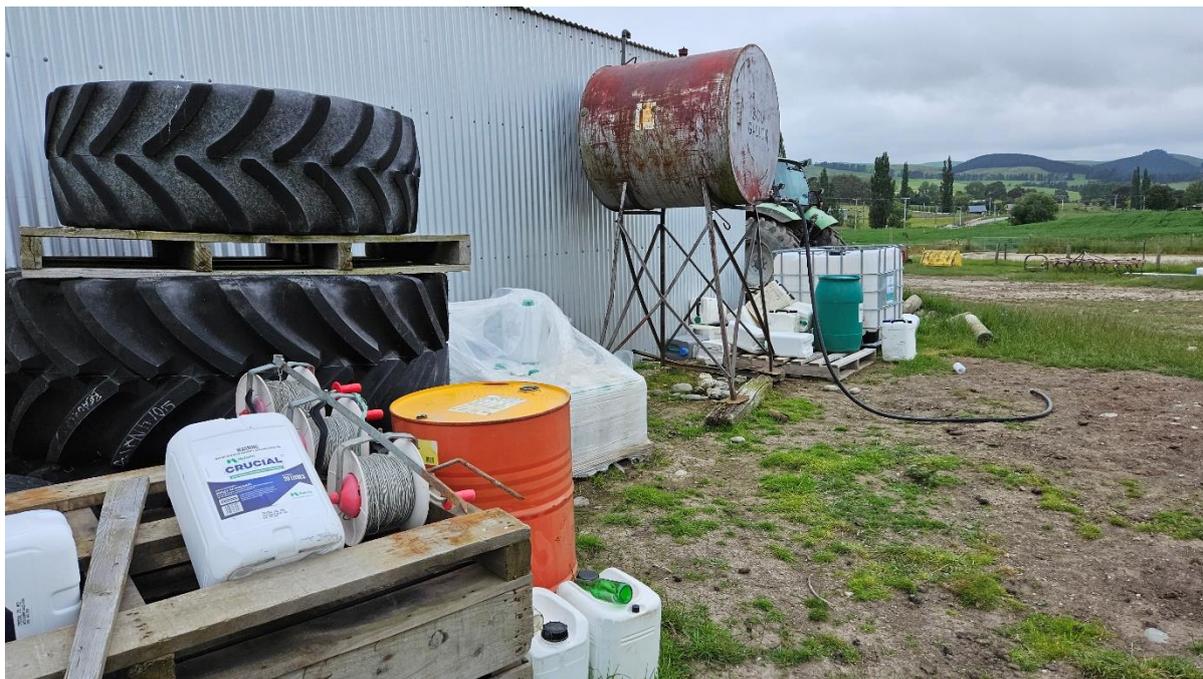
Figure 4: Bulk storage of fuel and glyphosate at rear of shed. The shed housed a tractor and spray unit and also an agrichemicals store that contained bulk glyphosate. The land around the shed shows vegetation that appears to have been affected by chemical spillage.

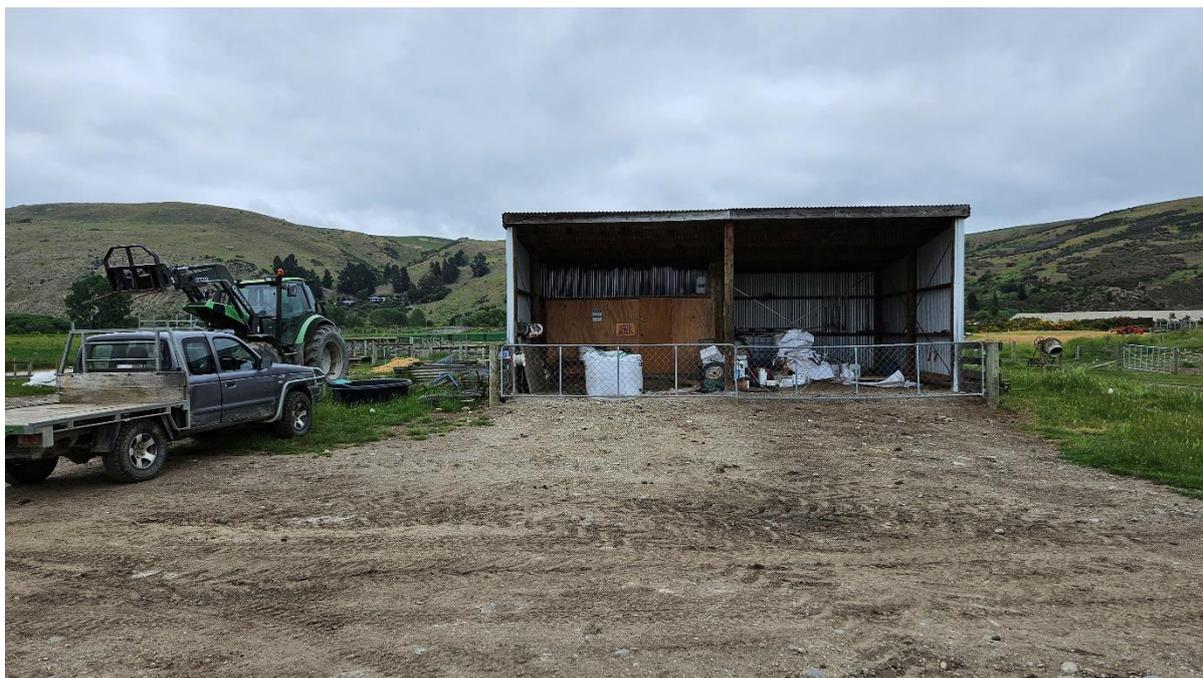
Figure 5: The farm shed with agrichemical enclosure at rear of left-hand bay.
