Project Number 19377.000.001

Geotechnical Investigation

Lot 4 Water Race Hill, Bannockburn,

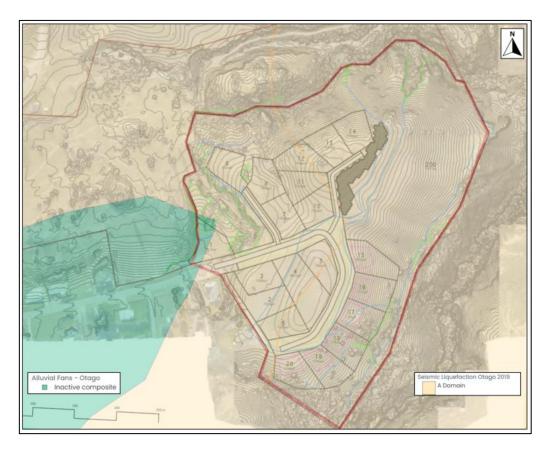
Figure 4: ORC Hazard Map (Sourced from ORC Hazard Database).

- The site is mapped as having a liquefaction susceptibility of '*Domain A*' (nil to low susceptibility) due to being underlain by rock or firm sediments (Barrell, 2019b) (Figure 4).
- An inactive alluvial fan is mapped as entering the site in the far western extent (Figure 4.) No landslides (active or inactive) have been mapped within the site area.
