Flood Hazard Assessment

114 Ripponvale Road,
Cromwell

GeoSolve Ref: 180137.01

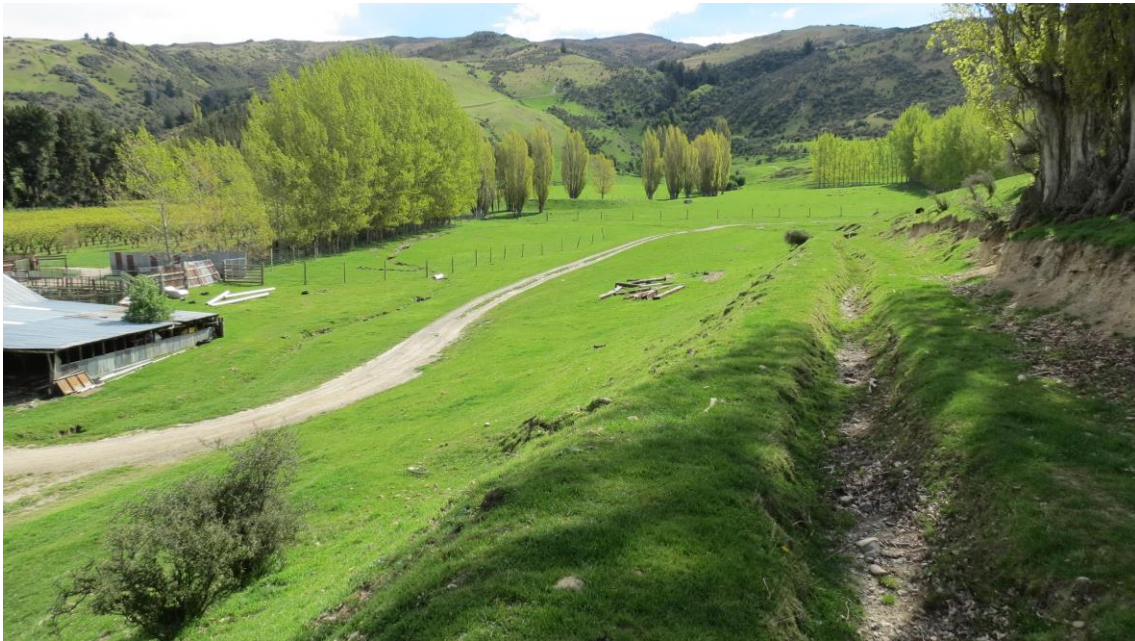
Photo 3509: Looking from water race up western gully, dam in middle distance. Flood path to left of road.

Gate structures can be altered, and flows distributed in several directions. Branches, debris, dead animals, etc. can accumulate and block culverts resulting in overspill. If purposefully manipulated however, the flows could be spread out and minimise concentrated flows at any one point (as apparently occurred in the November 1999 floods) – refer photos 3509 and 3511 below.

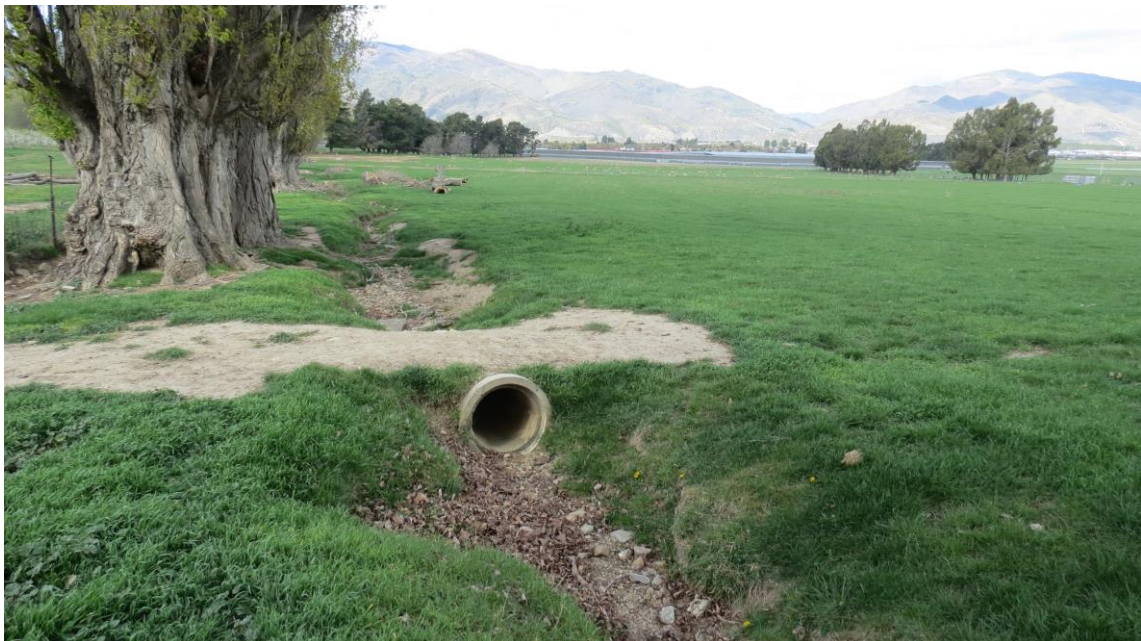
Photo 3511: Water race downstream of western gully outflow. 450mm culvert could block and overtop

450 mm diameter concrete culverts within the water races will have a capacity of approximately 110-170 l/s (~4 to 6 heads in irrigation terms) depending on slope and may choke or attenuate incoming flows.

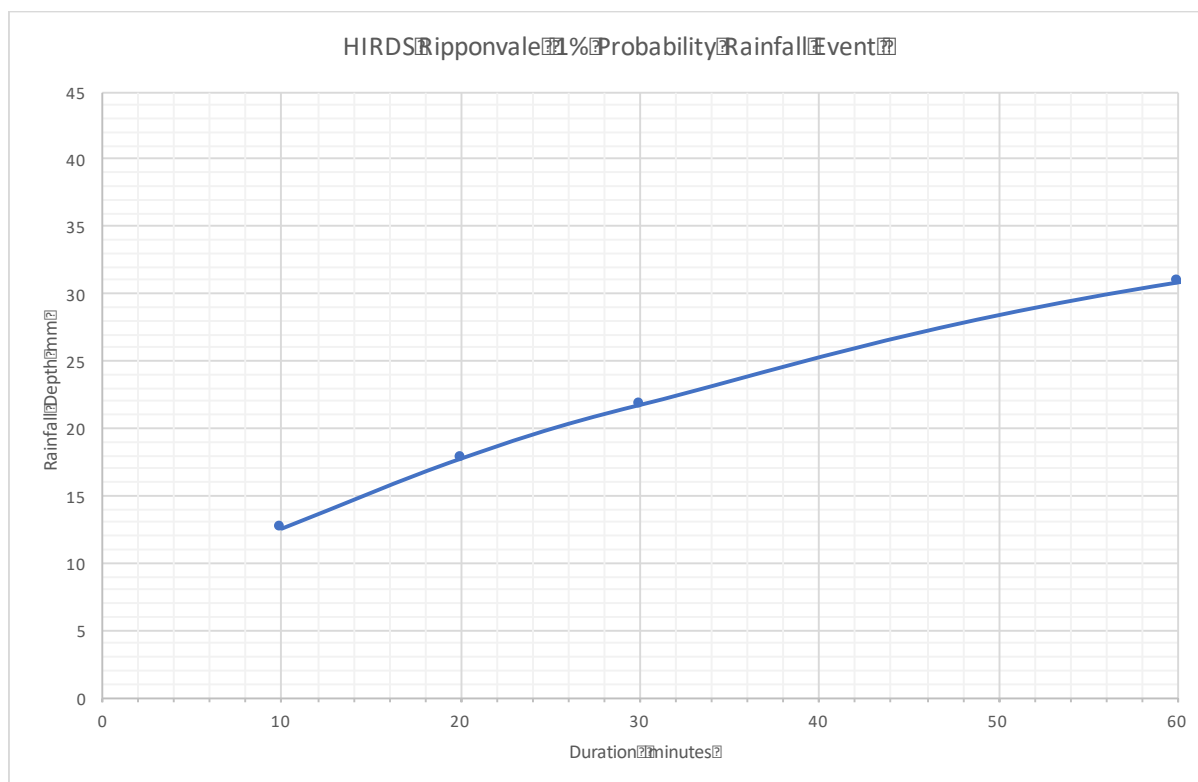
Figure 2. High Intensity Rainfall data for 1% AEP event. Source: <https://hirds.niwa.co.nz/>

The rainfall for durations of up to one hour are plotted for the 1% annual exceedance probability (AEP) event. This is shown as Figure 2 below.

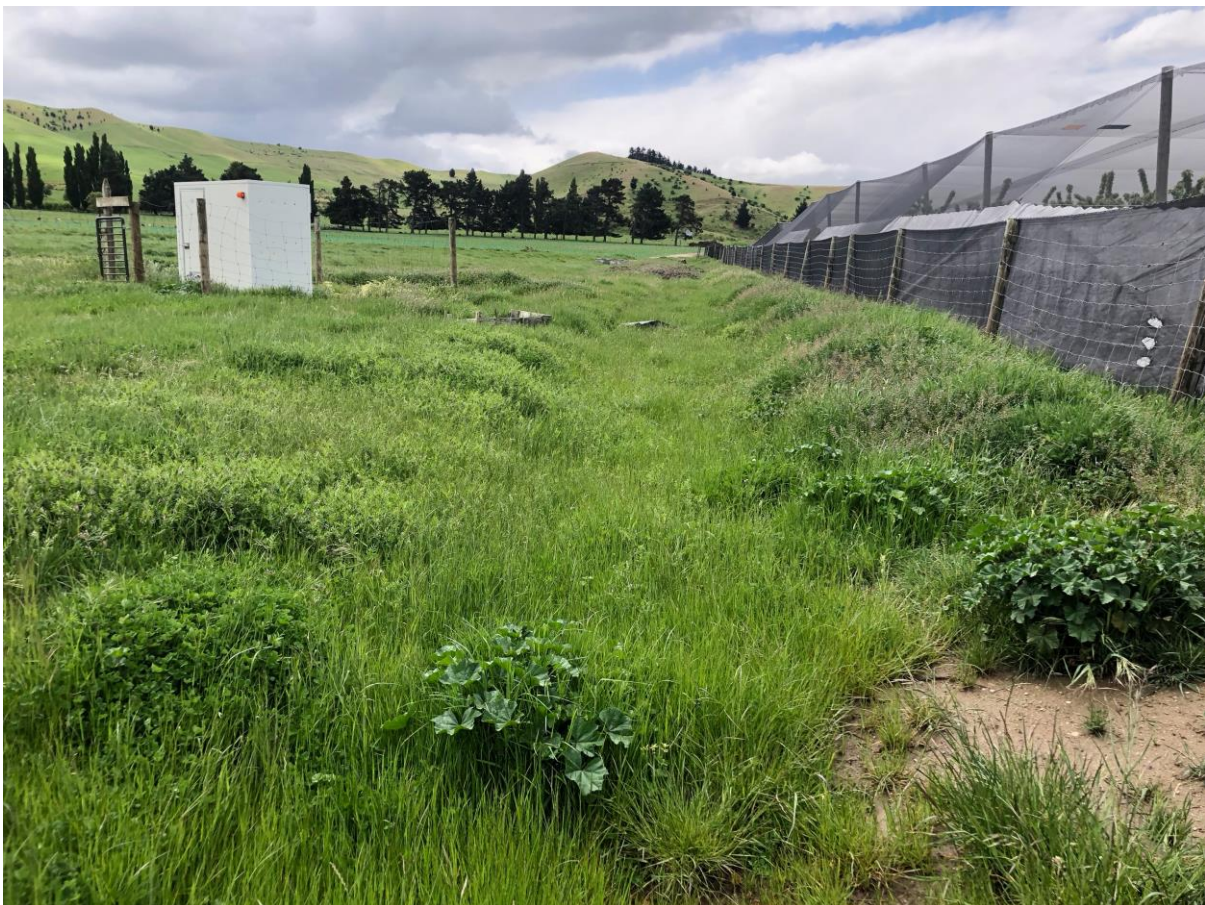
Image 2130: Existing channel about 1.5 m bottom width 0.6 m deep along SE boundary looking upstream from Ripponvale Road (taken: 30 October 2018)

There is an existing formed channel along the South-eastern boundary that directs flows along the boundary towards Ripponvale Road (refer Image 2130). The proposed flood channel zone will discharge into this channel so that outflow locations from the property will remain the same.

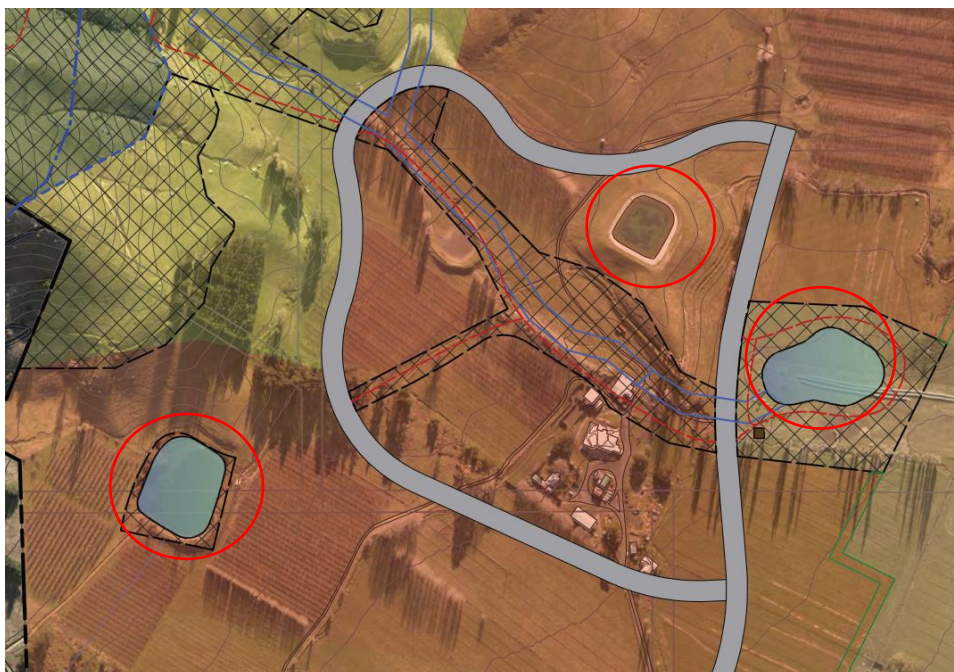
Figure 3. Location of existing small dams circled in red

Three small water storage dams are present on the site as illustrated on Figure 3:

The largest of the dams is located on the Southwestern catchment and is fed by a Ripponvale Irrigation Company water race as well as the natural catchment – see bottom left on Figure 3. It has an estimated surface area of $\sim 6,000 \text{ m}^2$, is up to about 3.5 m deep and has a storage potential of about $8,000 \text{ m}^3$. On the basis of these estimates, it would note be classified as a 'Large Dam' in the Building Act.
